**STOUGHTON HIGHWAY TRAILER BUILDING COMPLEX
SURVEY REPORT
STOUGHTON, WISCONSIN**

July 12, 2017

The following is a summary report on our findings of onsite conditions and our recommendations for the treatment of the Highway Trailer Building Complex. We have based this report on a facility inspection conducted on May 18, 2017. This inspection was preceded by a drone survey to provide a safe close-up inspection of the exterior materials. Focus of inspection was to assess and make recommendations related to safety issues associated with potential structural collapse along E. South St., and to assess and make recommendations regarding existing structural masonry shell salvage and reuse throughout the facility. Partial and full deconstruction of connected structural systems considered for demolition is also addressed in our record of observations and opinions.

Stoughton Highway Trailer Building Complex Survey Image Report

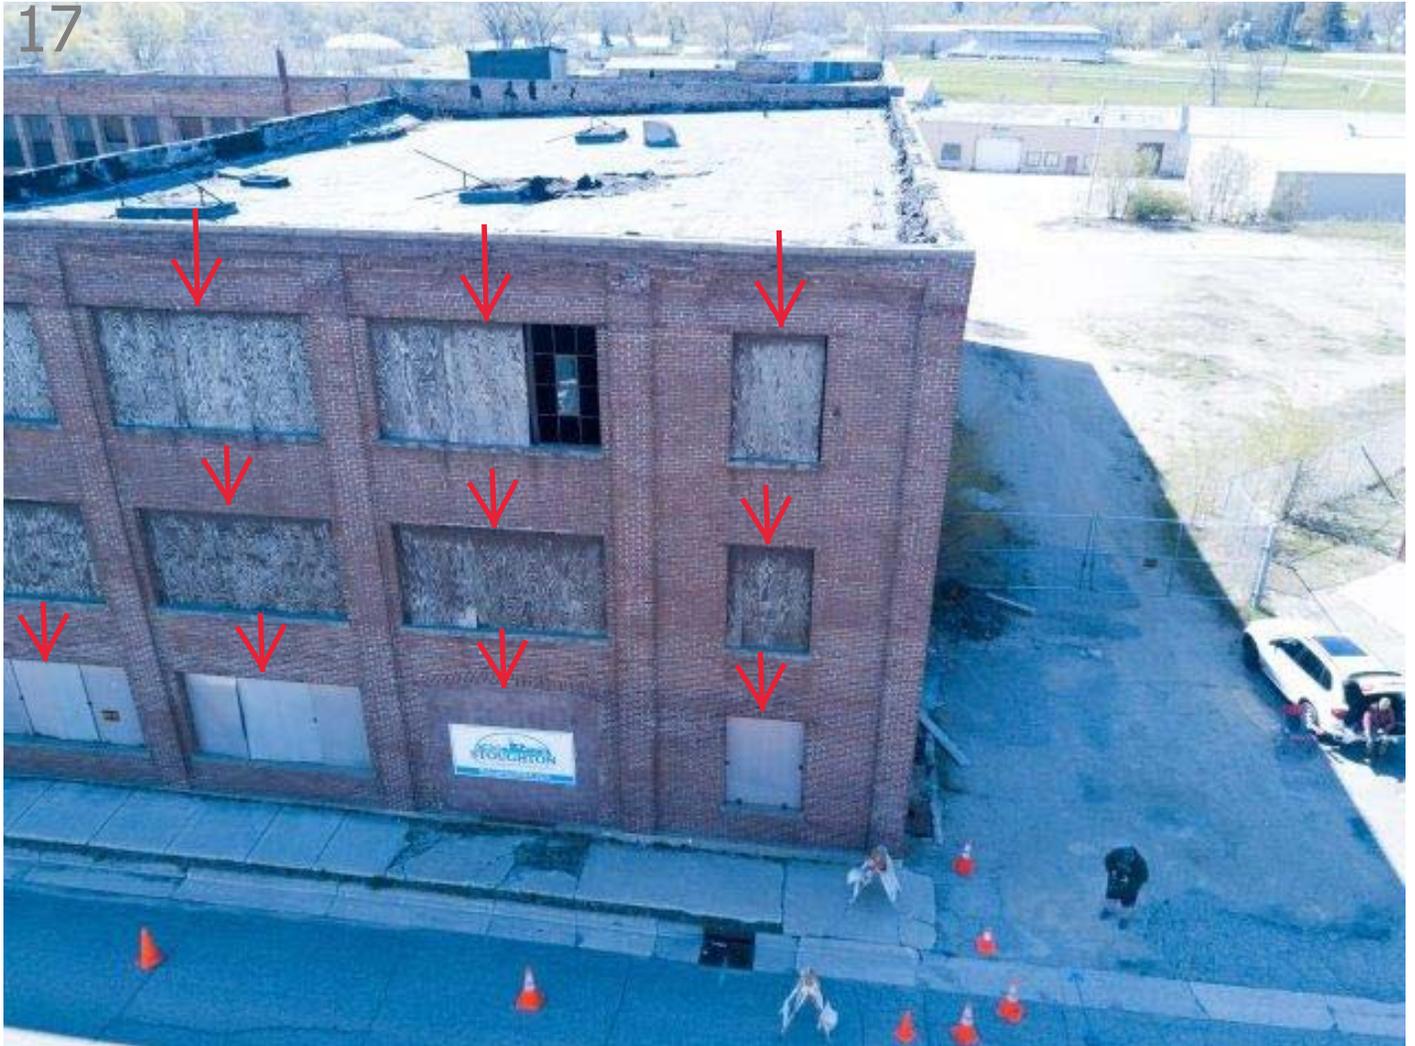
Overall view of elevation at North Façade - East South Street

Note: Lintel "Rust-Jacking" distress is minimal. This condition is fully restoration worthy.

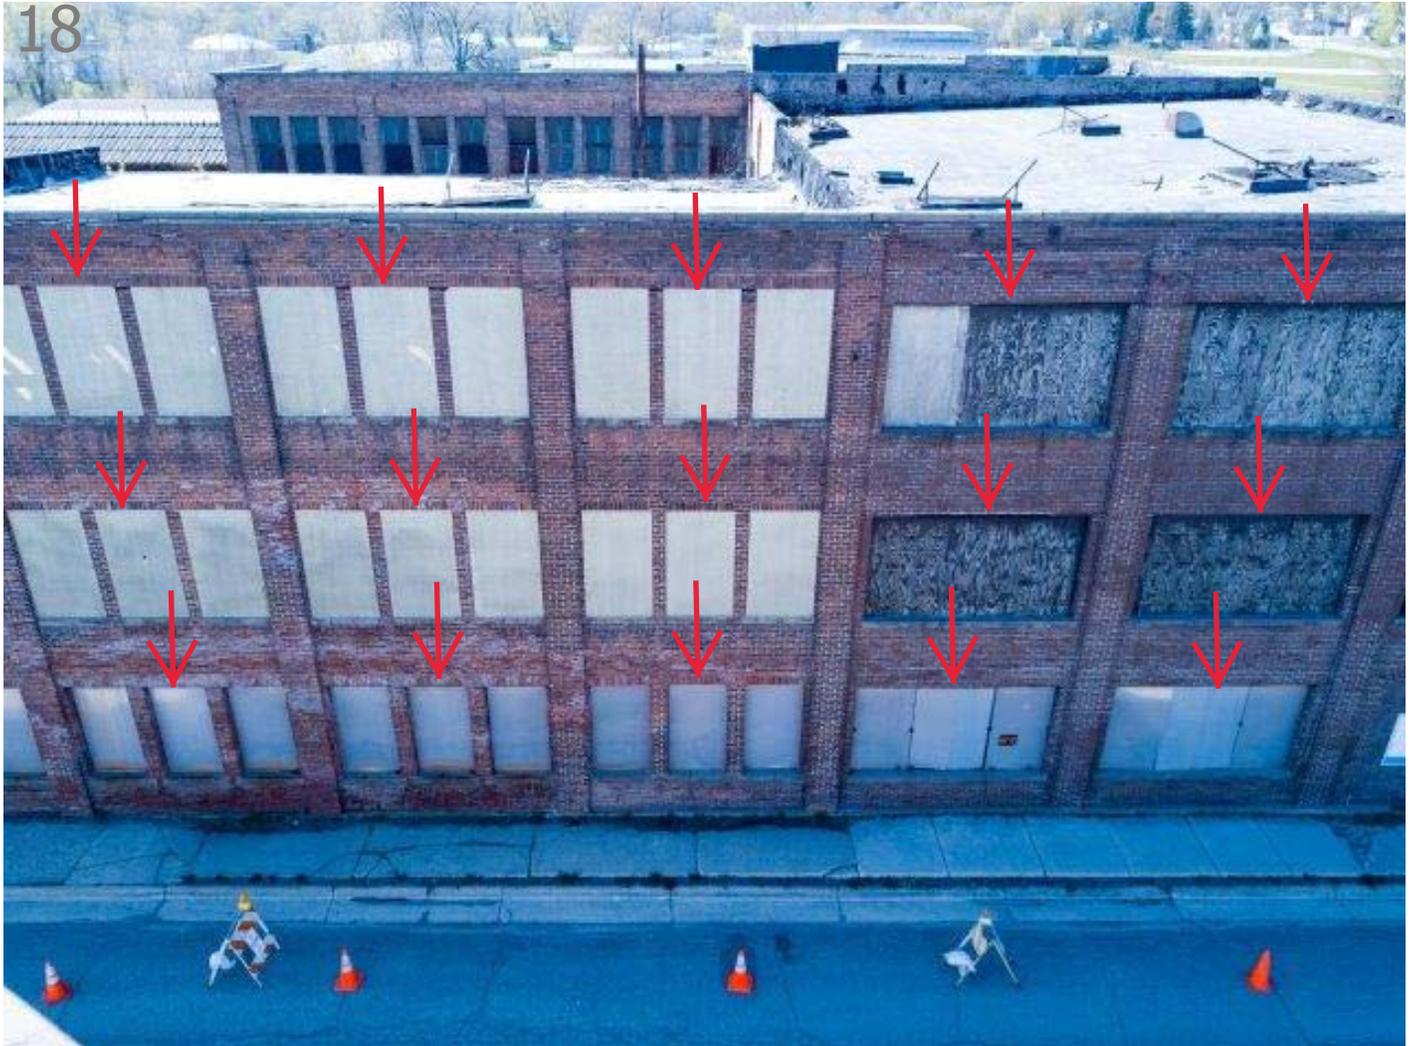
Overall view of elevation at Central Façade - East South Street

Note: Lintel "Rust-Jacking" distress is minimal. This condition is fully restoration worthy.

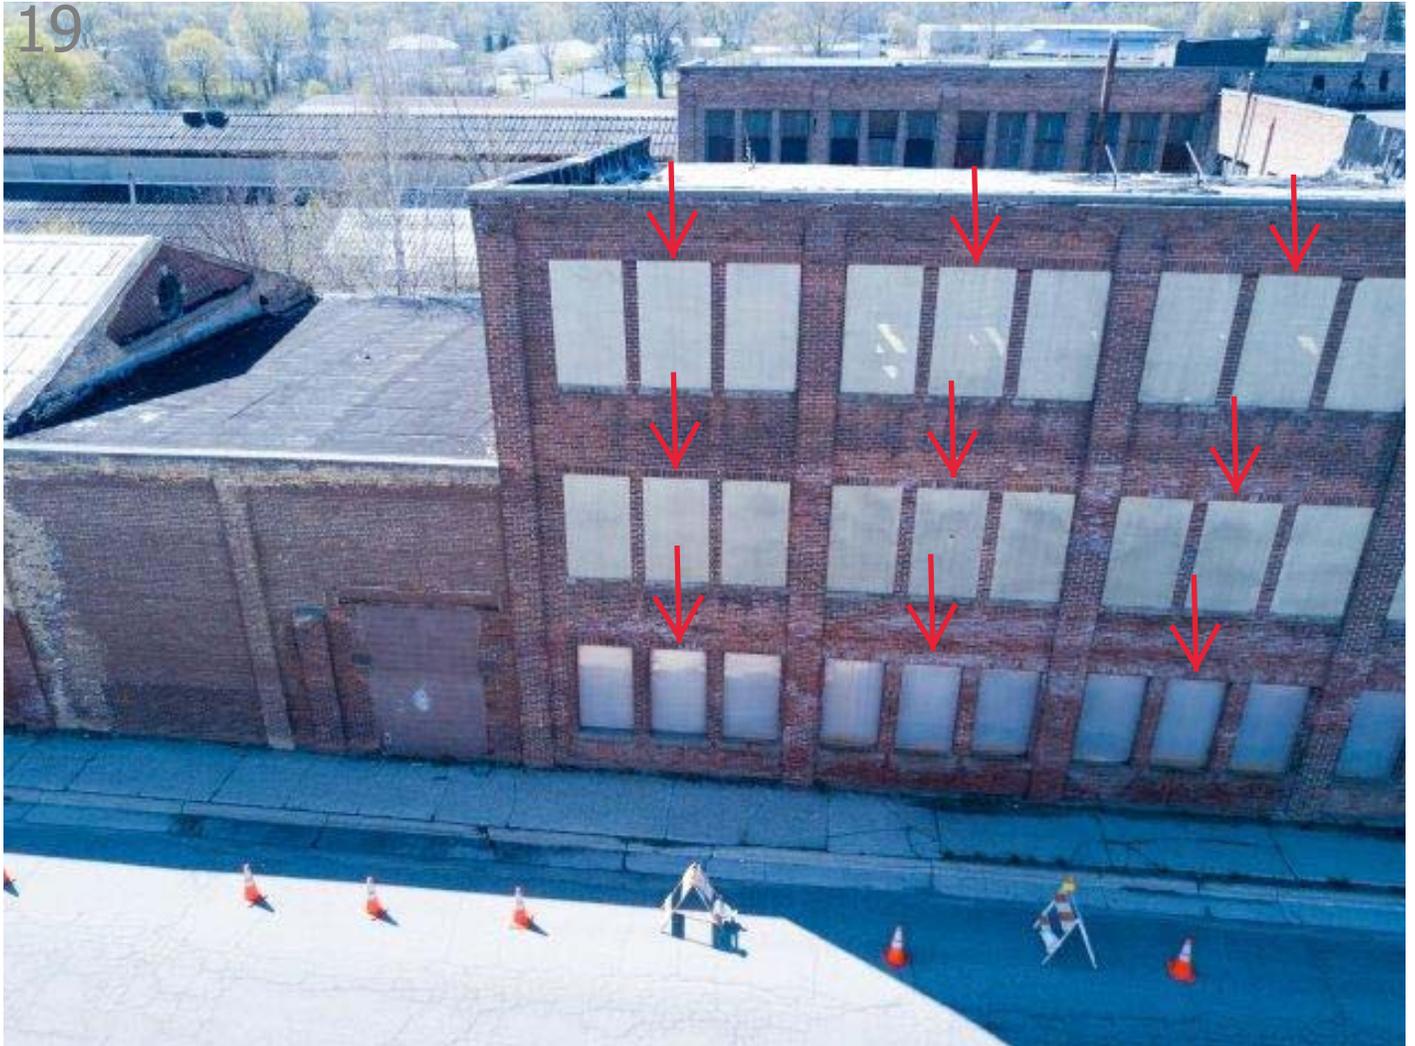
Overall View of Elevation at Central North Façade - East South Street

Note: Lintel "Rust-Jacking" distress is minimal. This condition is fully restoration worthy.

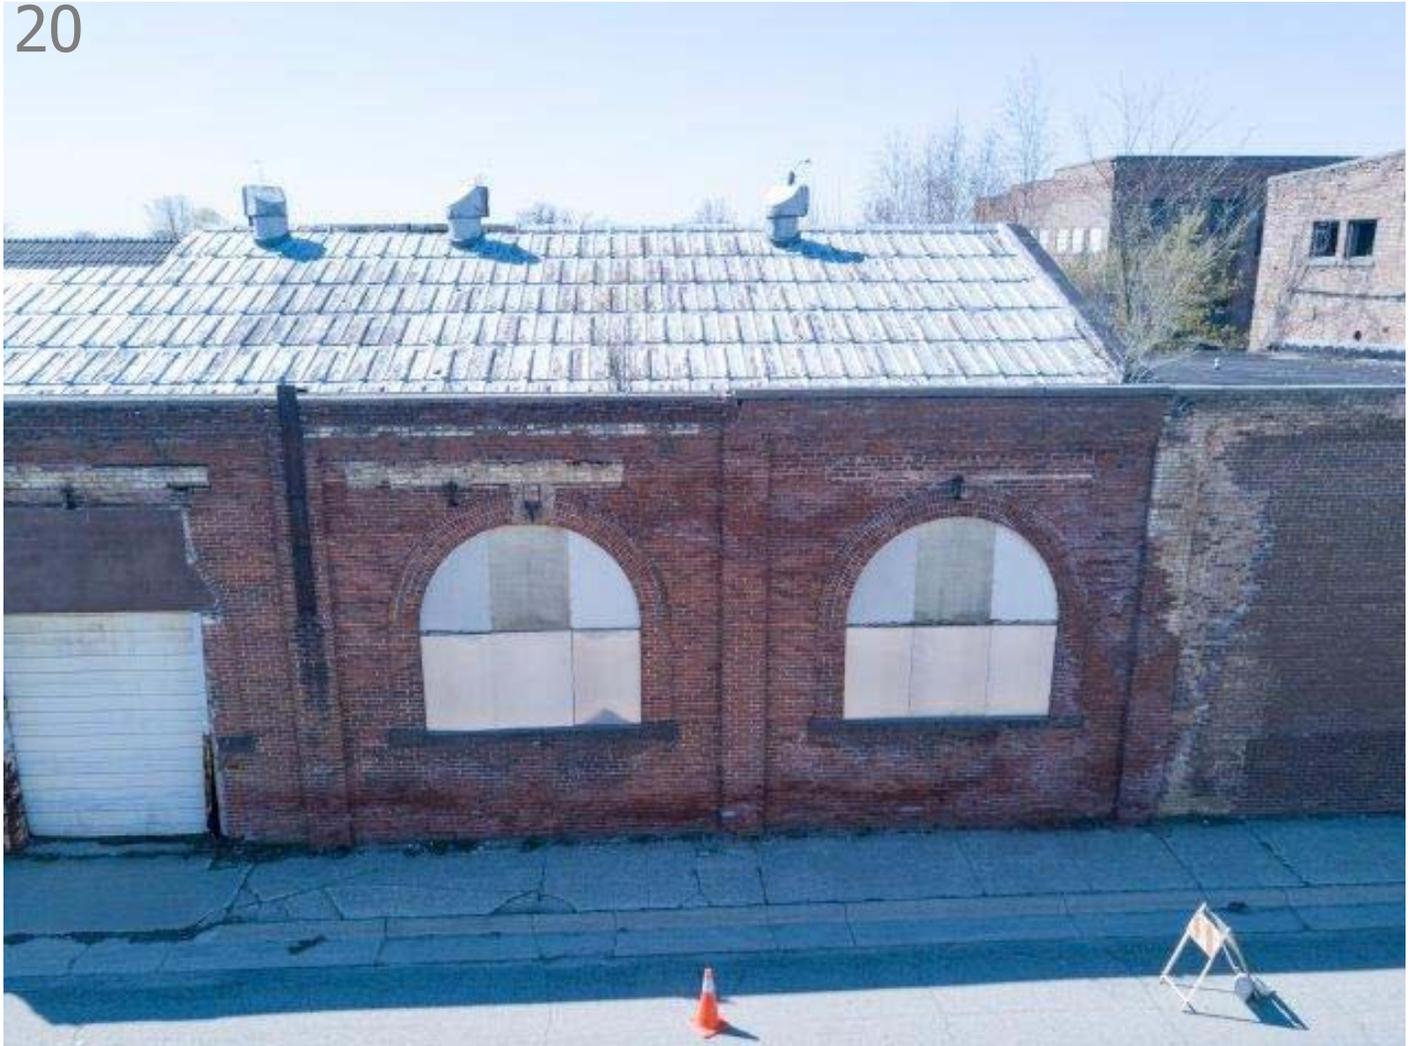
Overall View of Elevation at Power Plant

Modifications and non-conforming repairs to this facade have rendered it ineligible for inclusion on the NRHP. Most of these conditions are reversible.

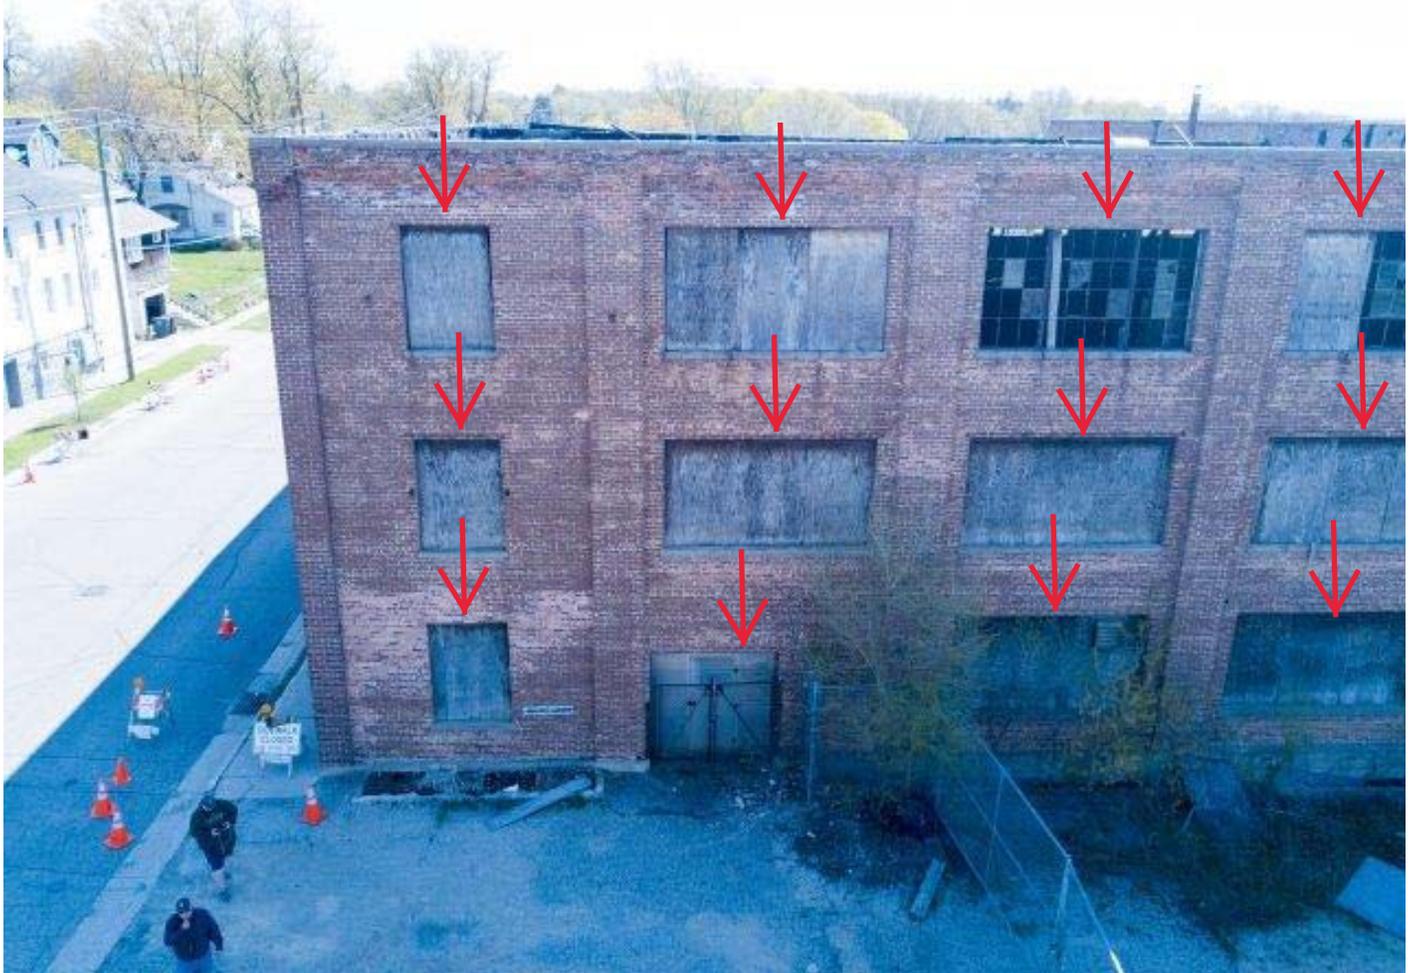
Overall View of Elevation at West Façade (North)

Note: Lintel "Rust-Jacking" distress is minimal. This condition is fully restoration worthy.

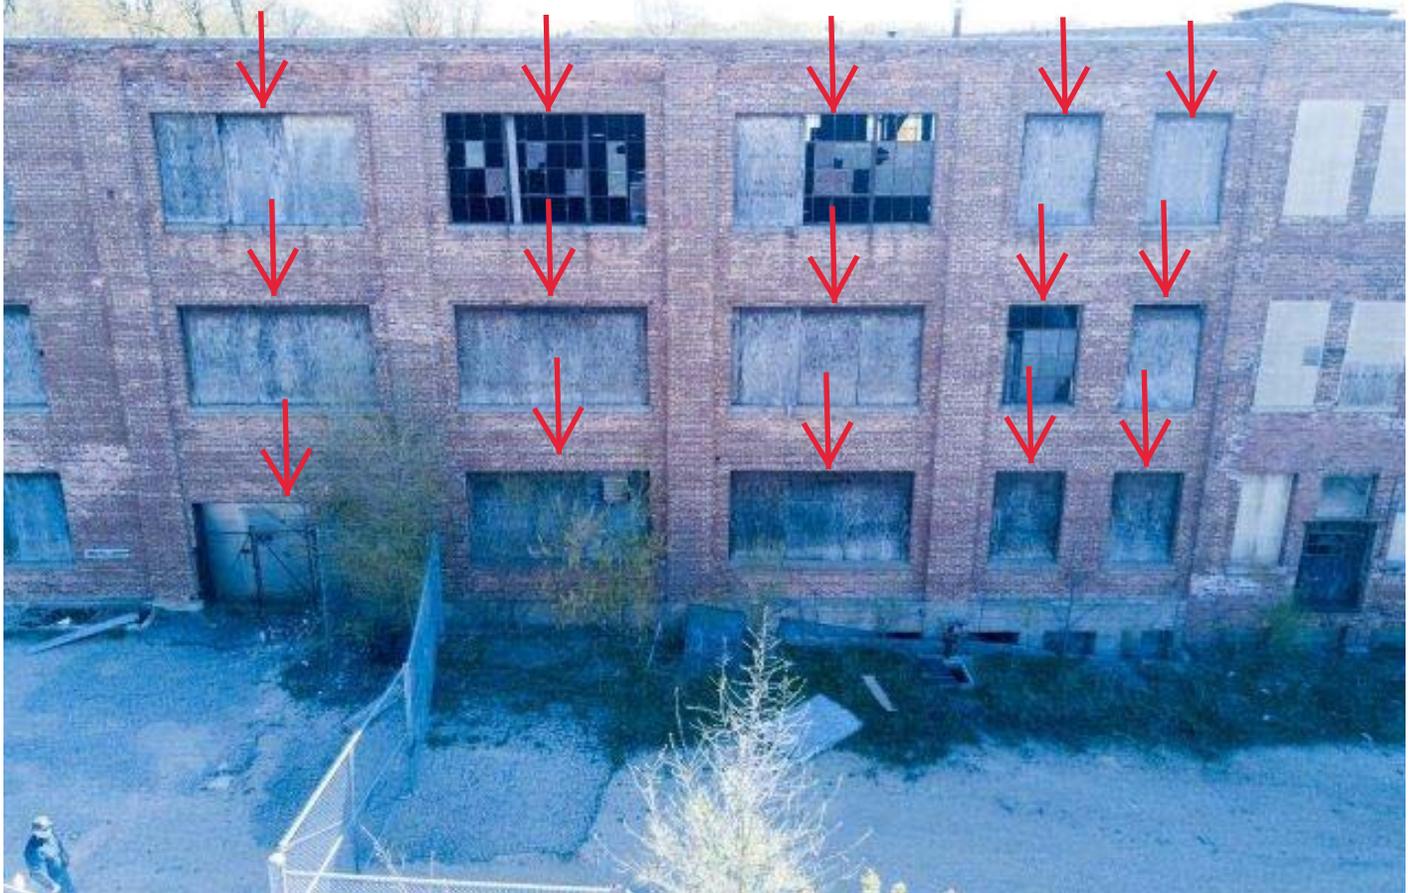
Overall View of West Façade

Note: Lintel "Rust-Jacking" distress is minimal. This condition is fully restoration worthy.

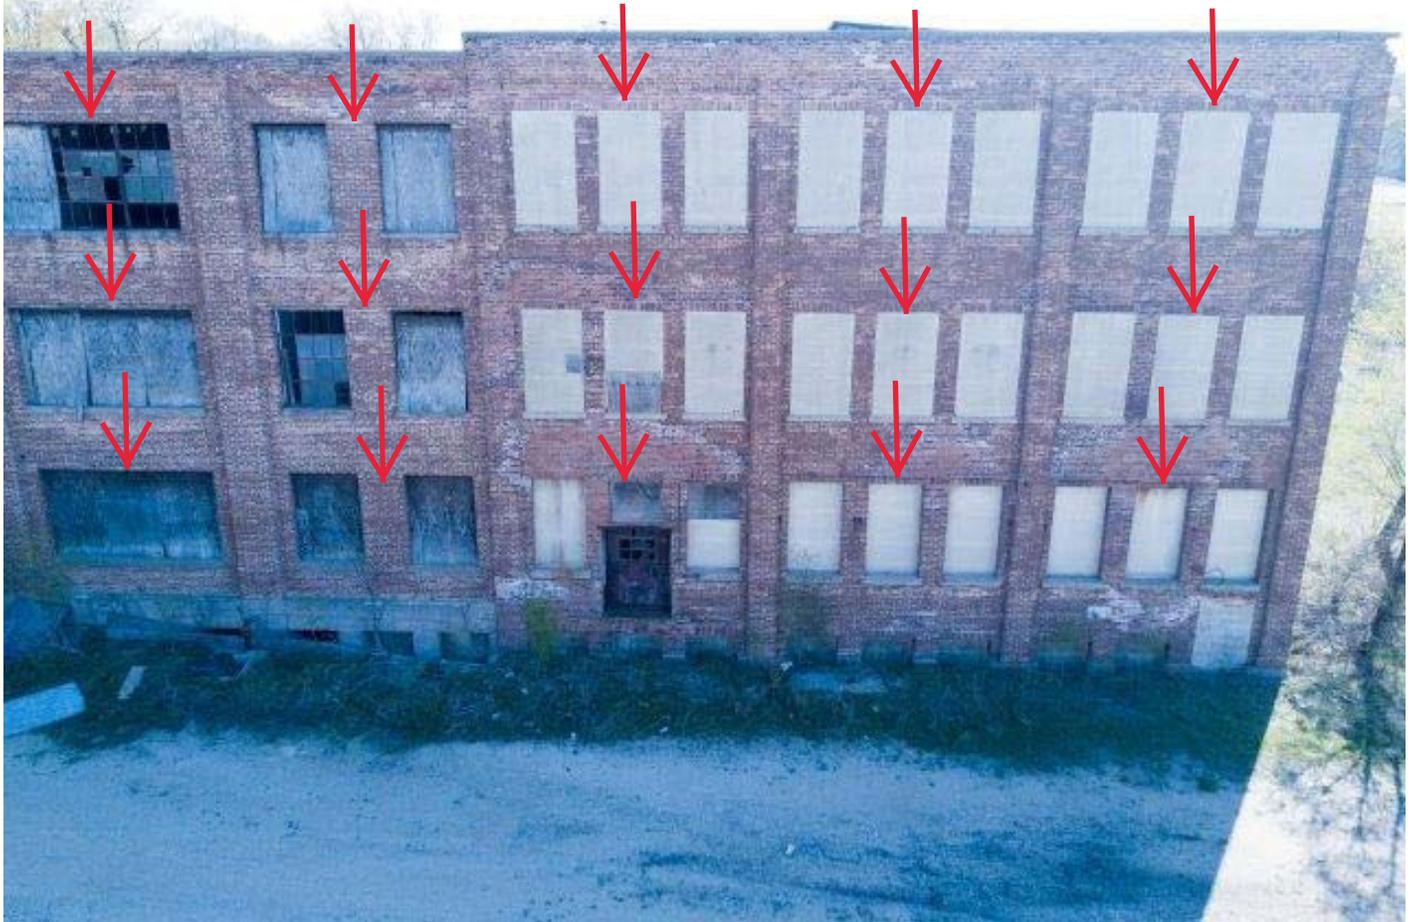
Overall View of West Façade

Note: Lintel "Rust-Jacking" distress is minimal. This condition is fully restoration worthy.

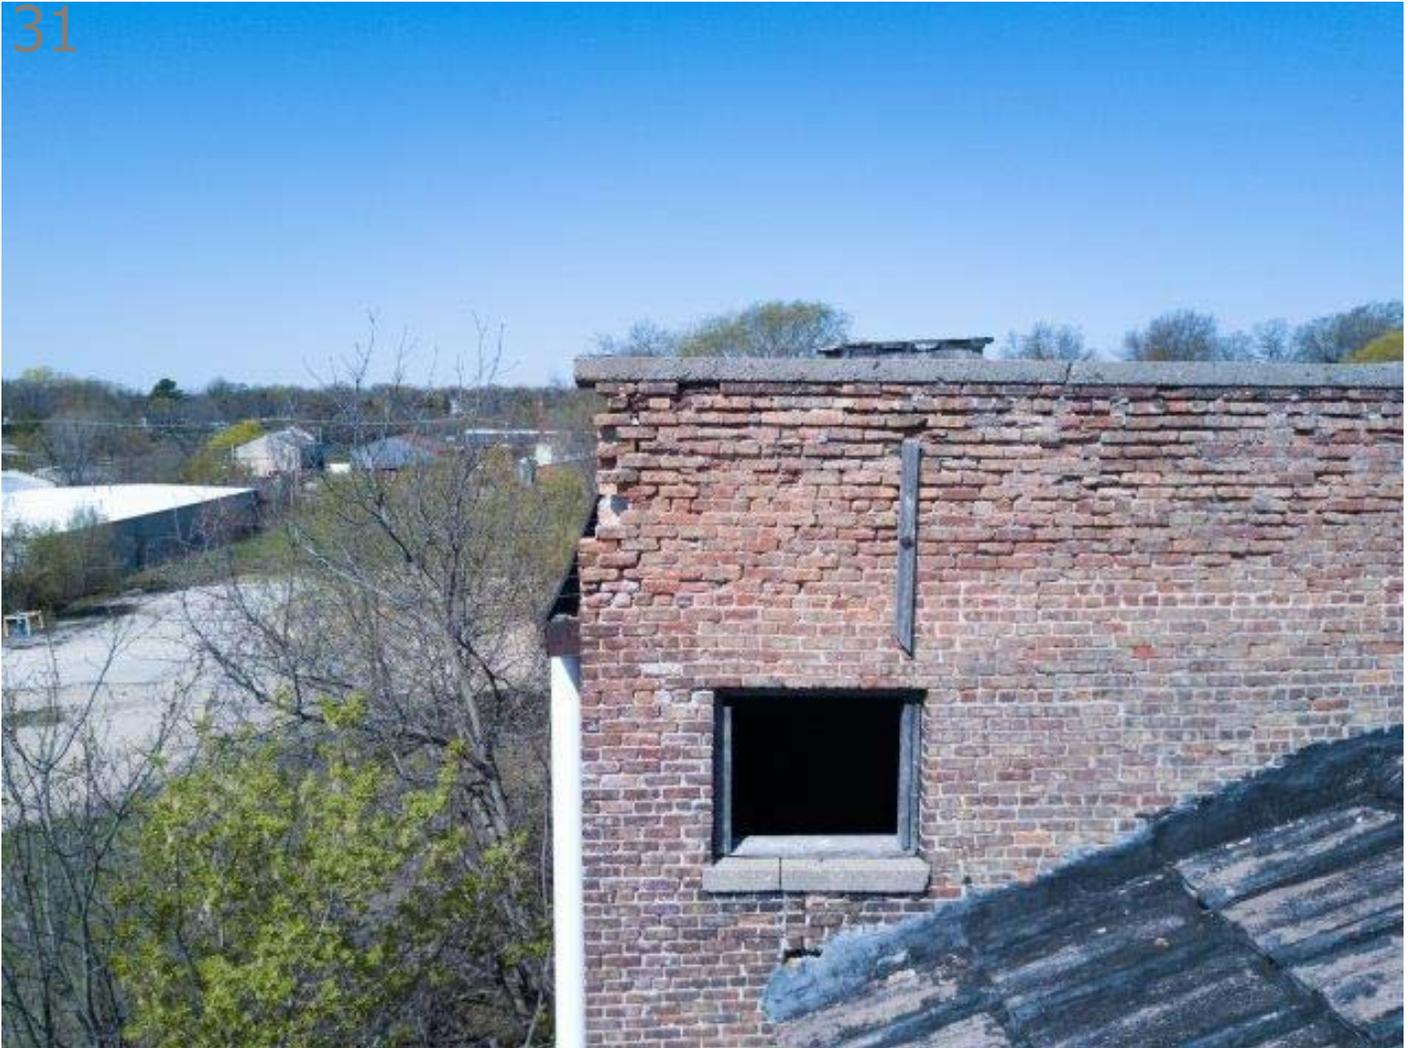
View of deteriorated parapet - This condition, while it looks severe it is a very restorable condition because the mortar has been "removed" from between the bricks and by the mass of masonry that remains intact.

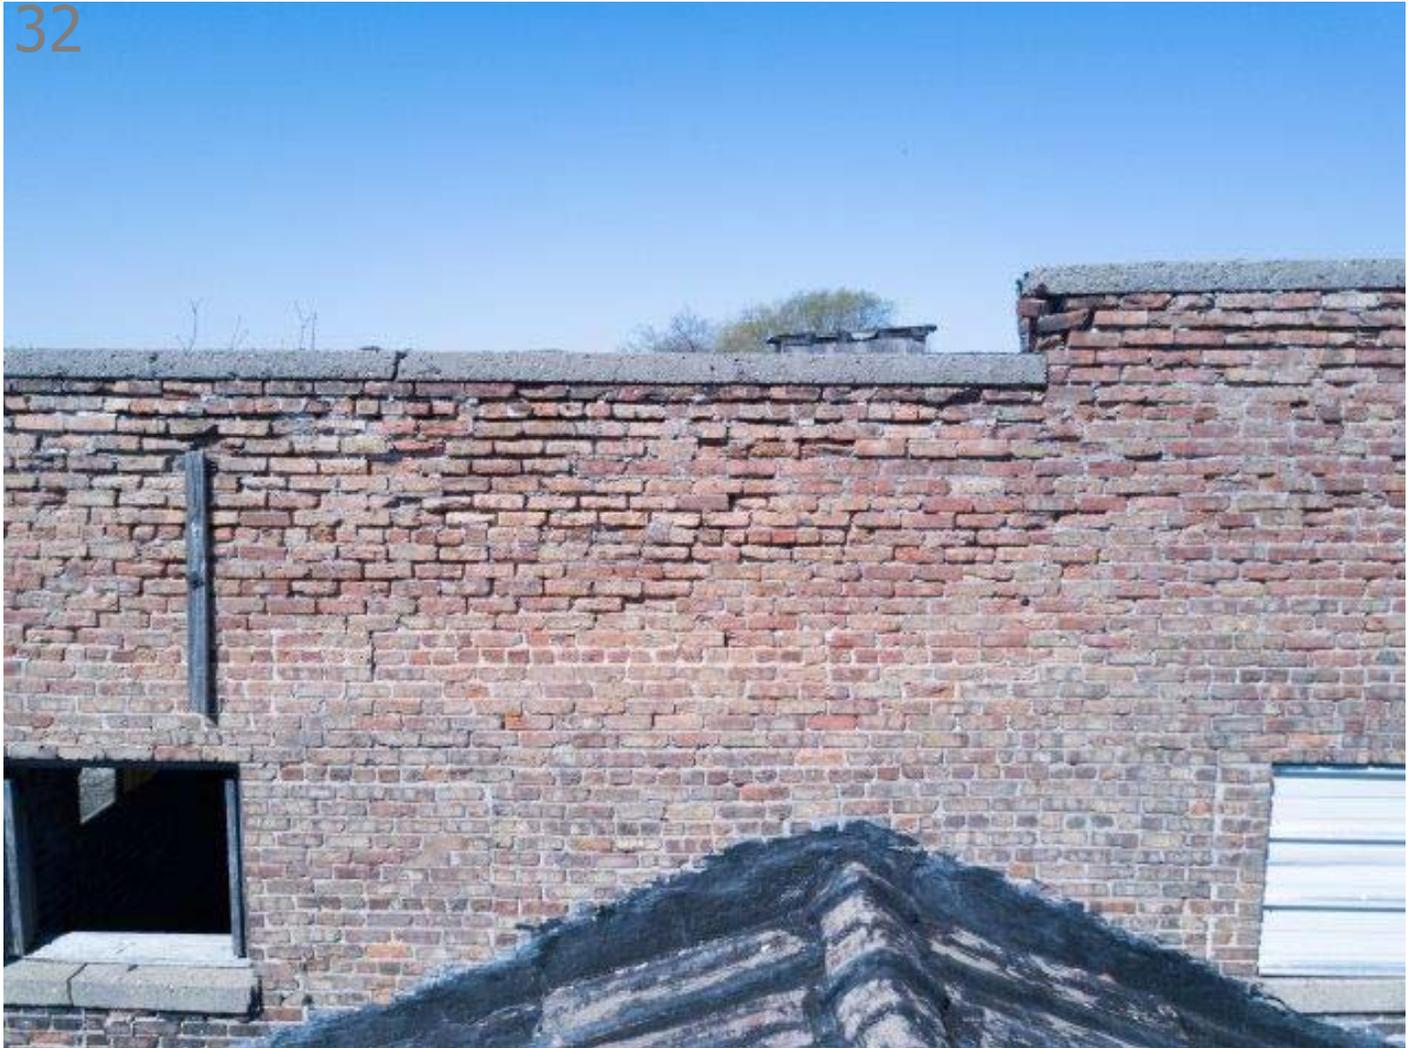
View of deteriorated masonry and mortar - This condition, while it looks severe it is a very restorable condition because the mortar has been "removed" from between the bricks and by the mass of masonry that remains intact.

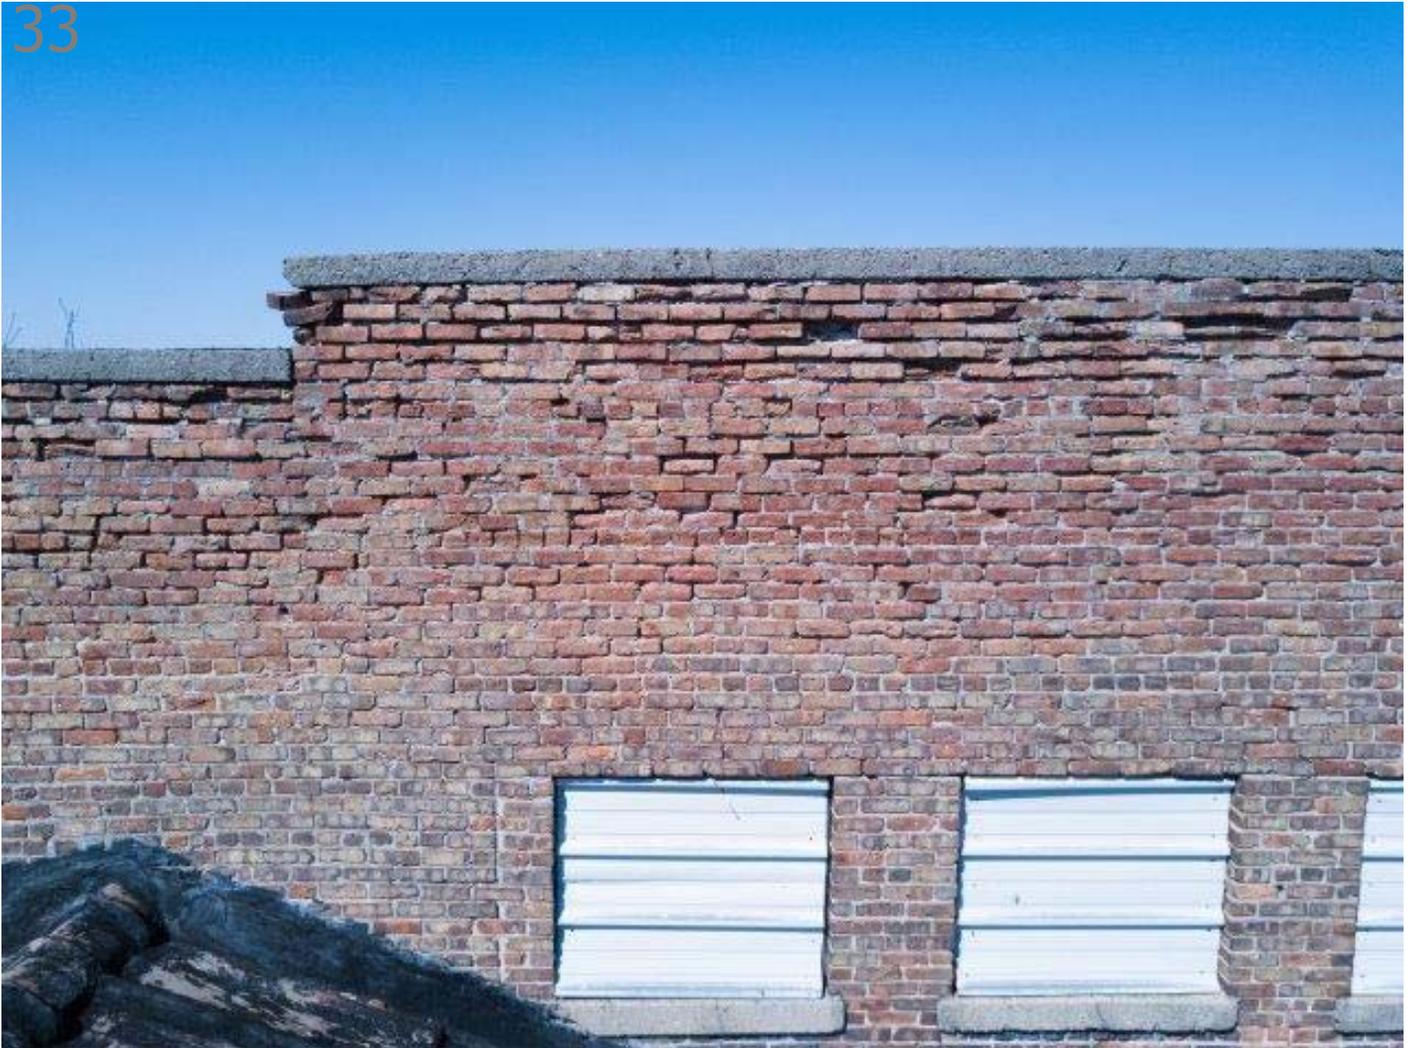
View of deteriorated masonry and mortar.

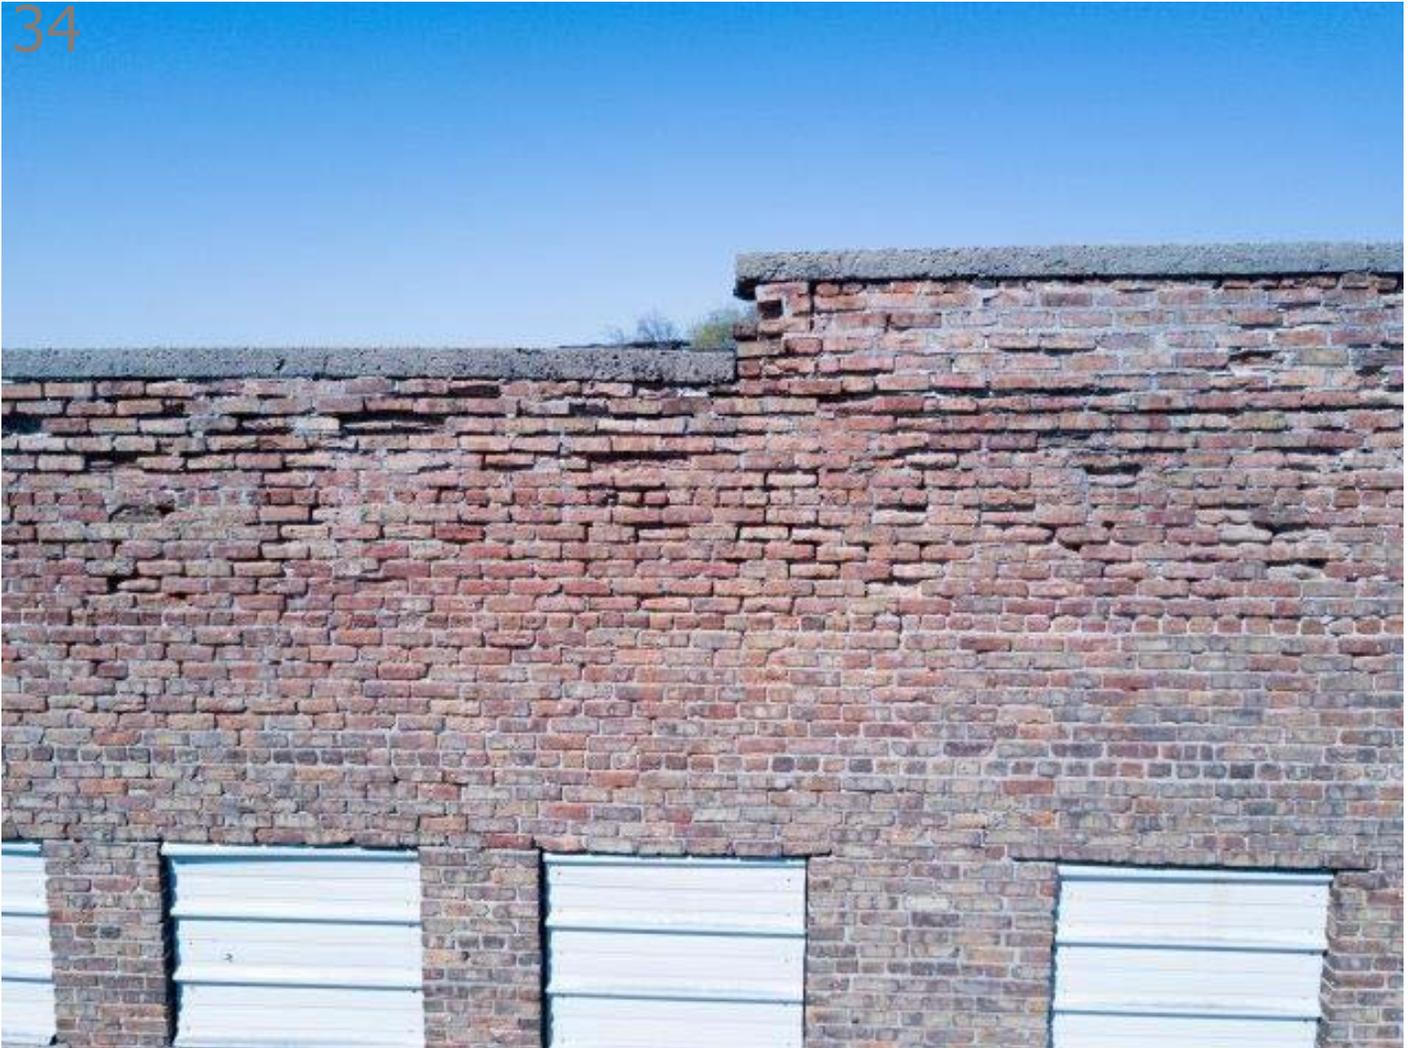
View of deteriorated masonry and mortar - This condition, while it looks severe it is a very restorable condition because the mortar has been "removed" from between the bricks and by the mass of masonry that remains intact.

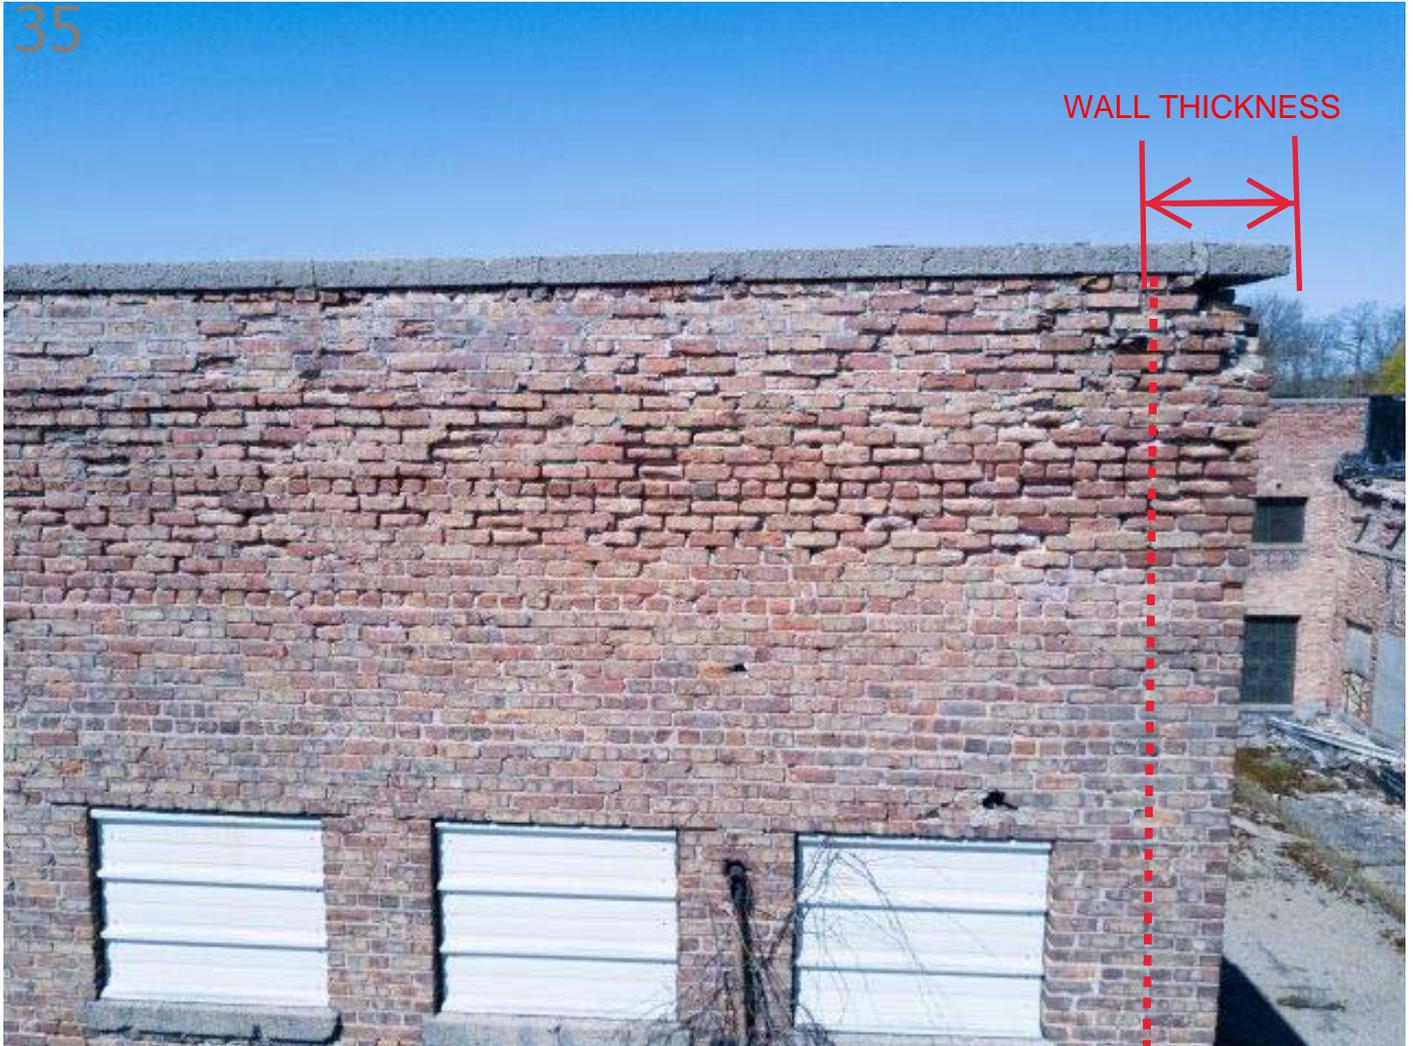
View of deteriorated wall - note the amount of damaged masonry is not significant.

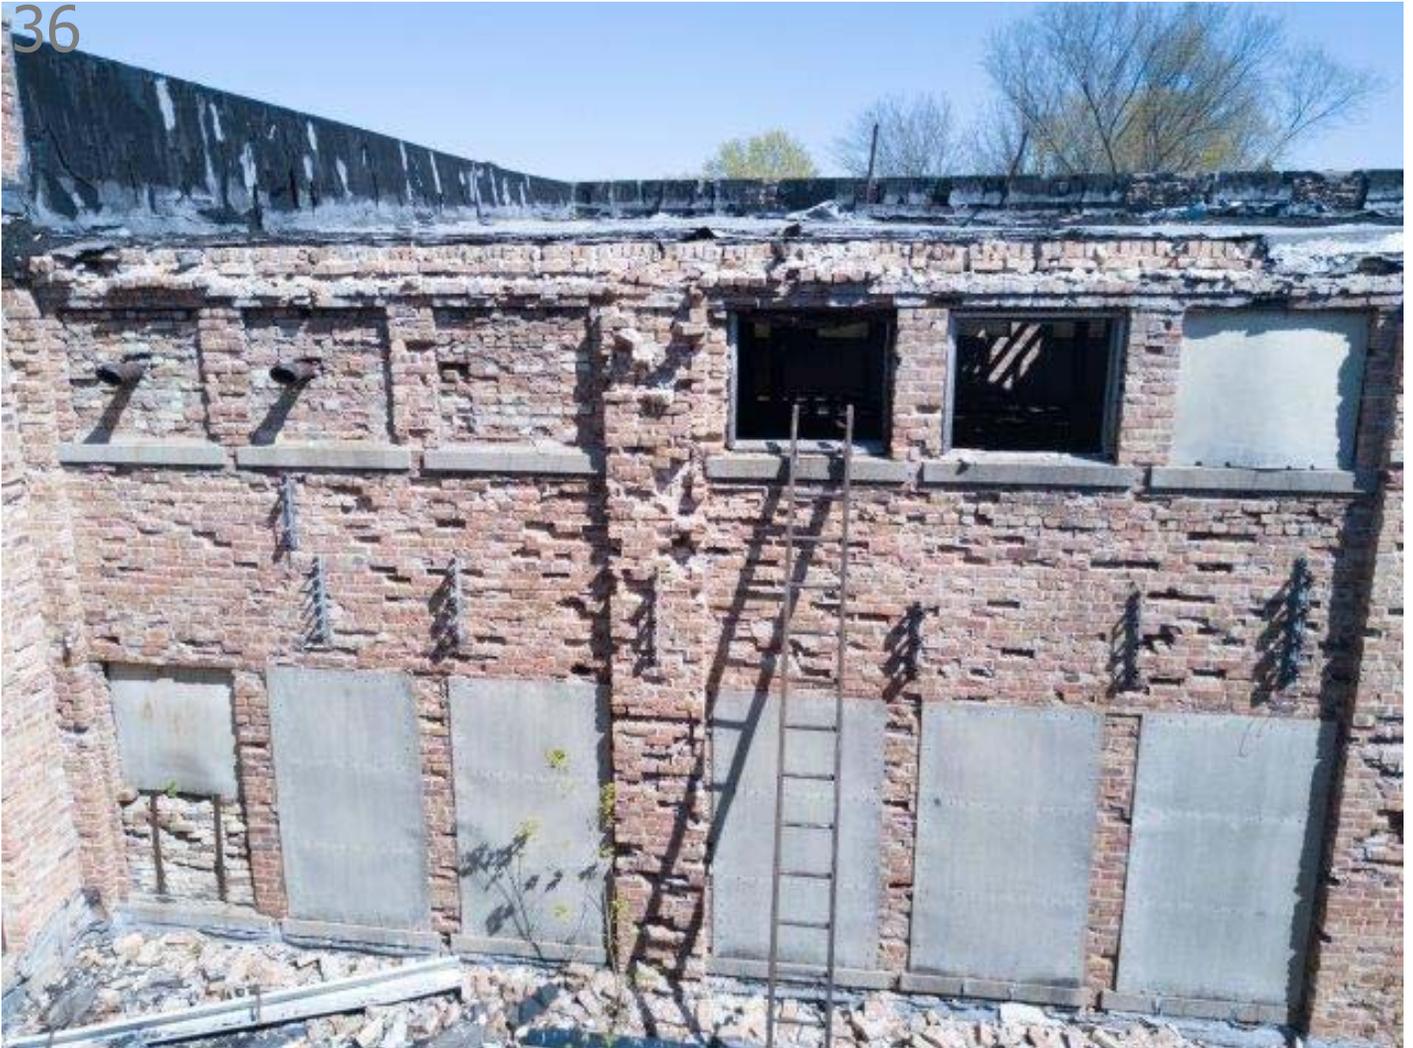
View of extremely deteriorated masonry - even these areas are not challenging to repair because of the mass of remaining masonry.

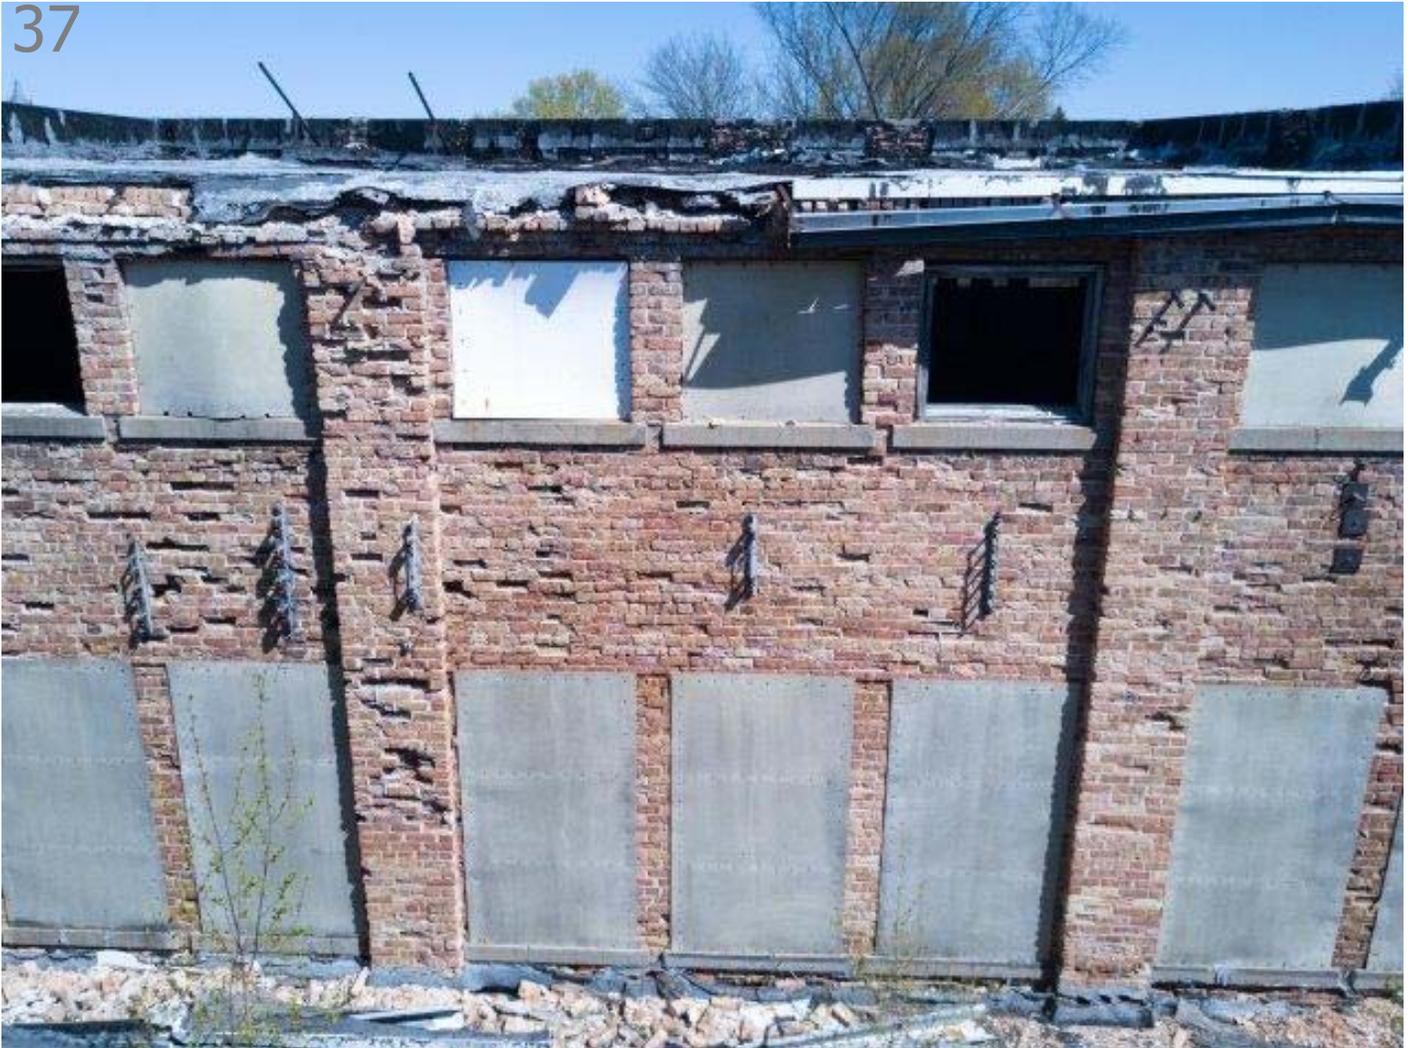
View of extremely deteriorated masonry - even these areas are not challenging to repair because of the mass of remaining masonry.

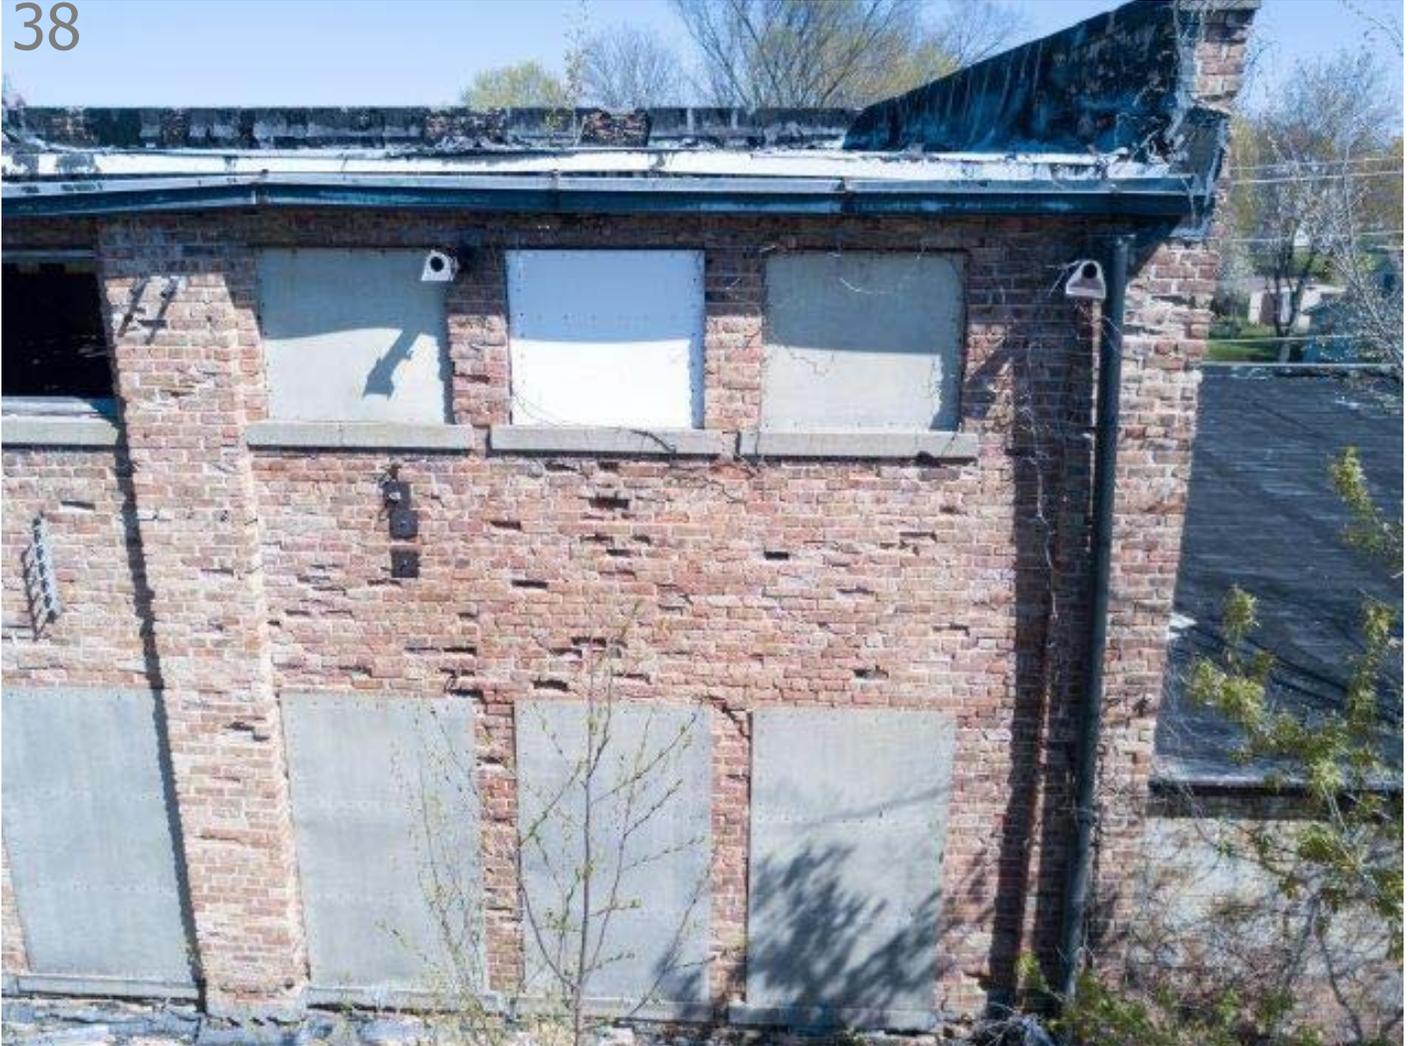
View of extremely deteriorated masonry - even these areas are not challenging to repair because of the mass of remaining masonry.
