**STOUGHTON HIGHWAY TRAILER BUILDING COMPLEX
SURVEY REPORT
STOUGHTON, WISCONSIN**

July 12, 2017

The following is a summary report on our findings of onsite conditions and our recommendations for the treatment of the Highway Trailer Building Complex. We have based this report on a facility inspection conducted on May 18, 2017. This inspection was preceded by a drone survey to provide a safe close-up inspection of the exterior materials. Focus of inspection was to assess and make recommendations related to safety issues associated with potential structural collapse along E. South St., and to assess and make recommendations regarding existing structural masonry shell salvage and reuse throughout the facility. Partial and full deconstruction of connected structural systems considered for demolition is also addressed in our record of observations and opinions.

Stoughton Highway Trailer Building Complex Survey Image Report

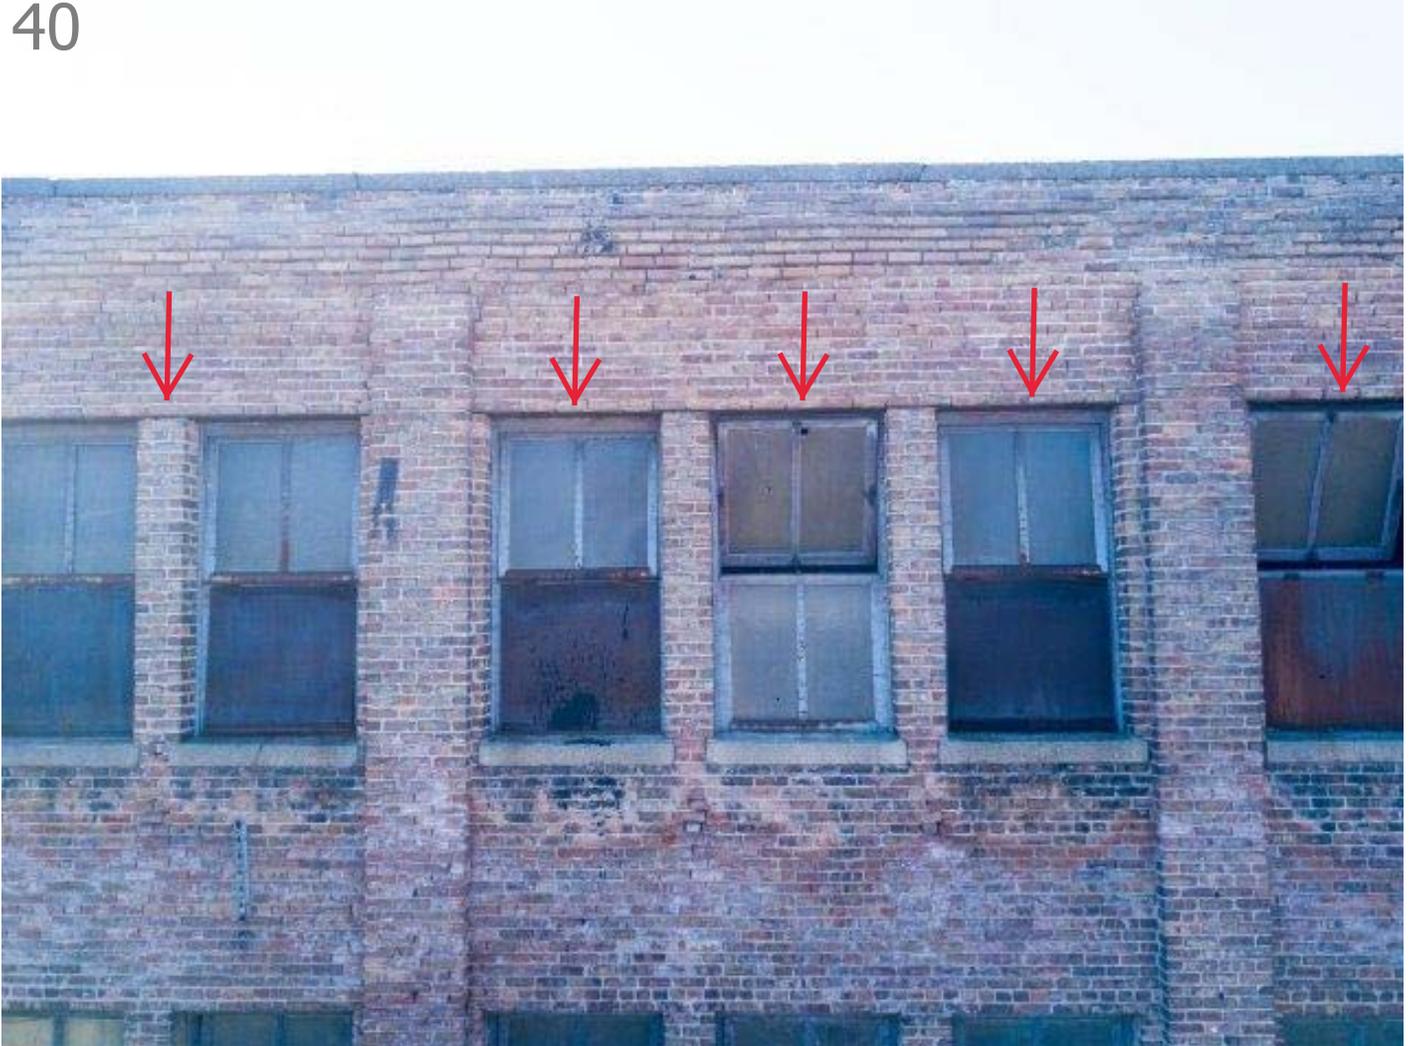
View of lineal conditions - The masonry is relatively stable and will require minimal restoration. All lintels are in excellent condition.

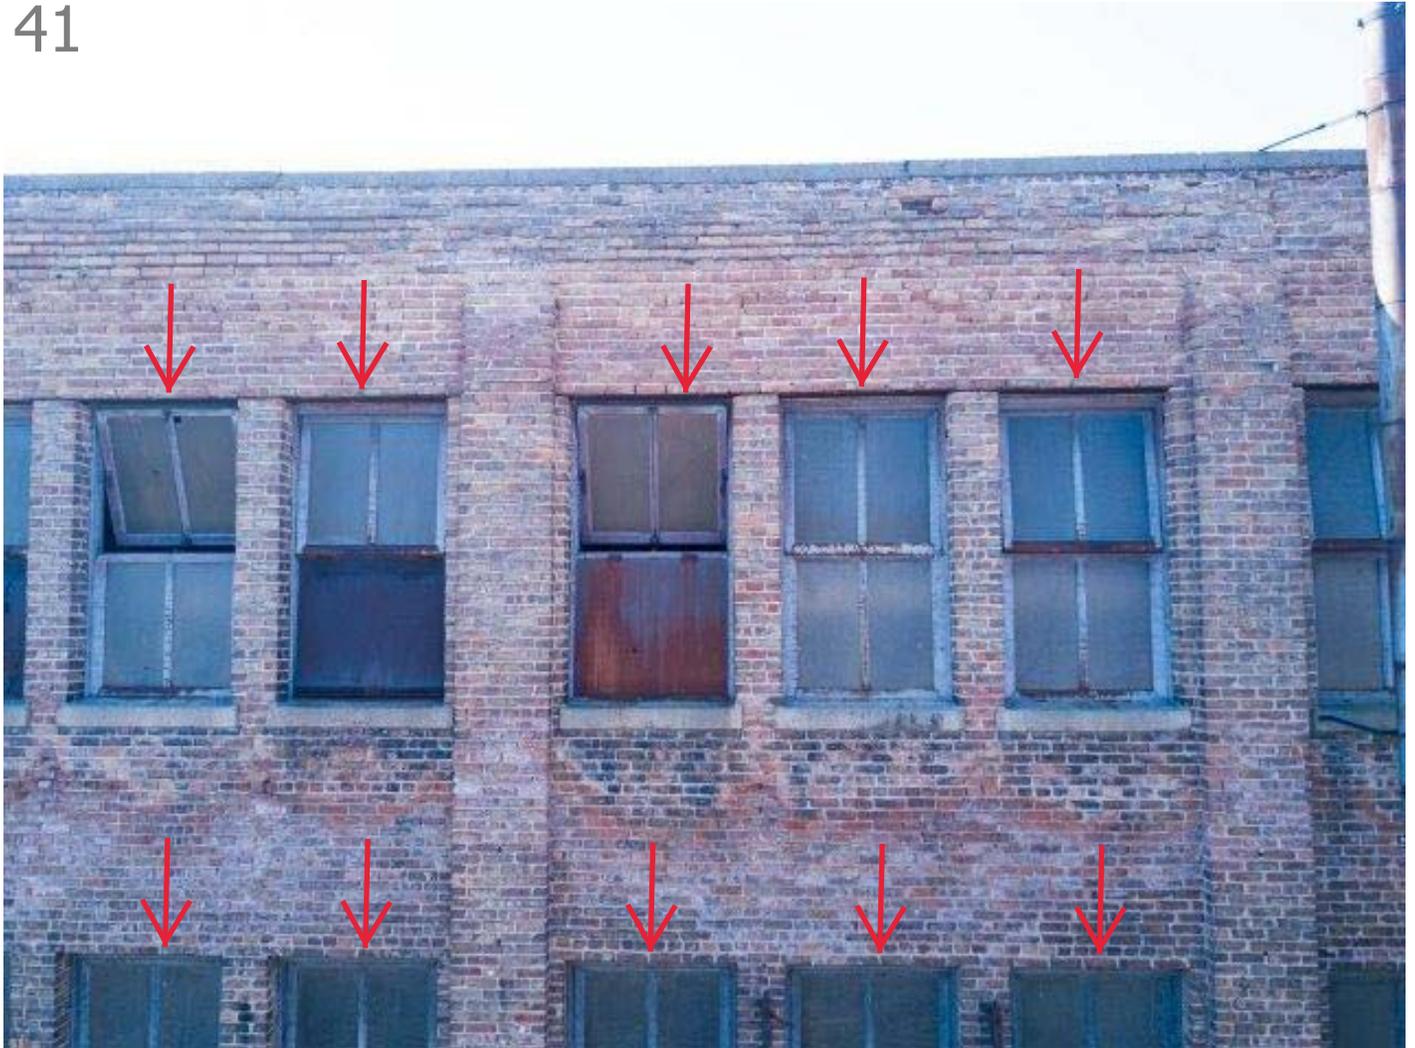
View of lineal conditions - The masonry is relatively stable and will require minimal restoration. All lintels are in excellent condition.

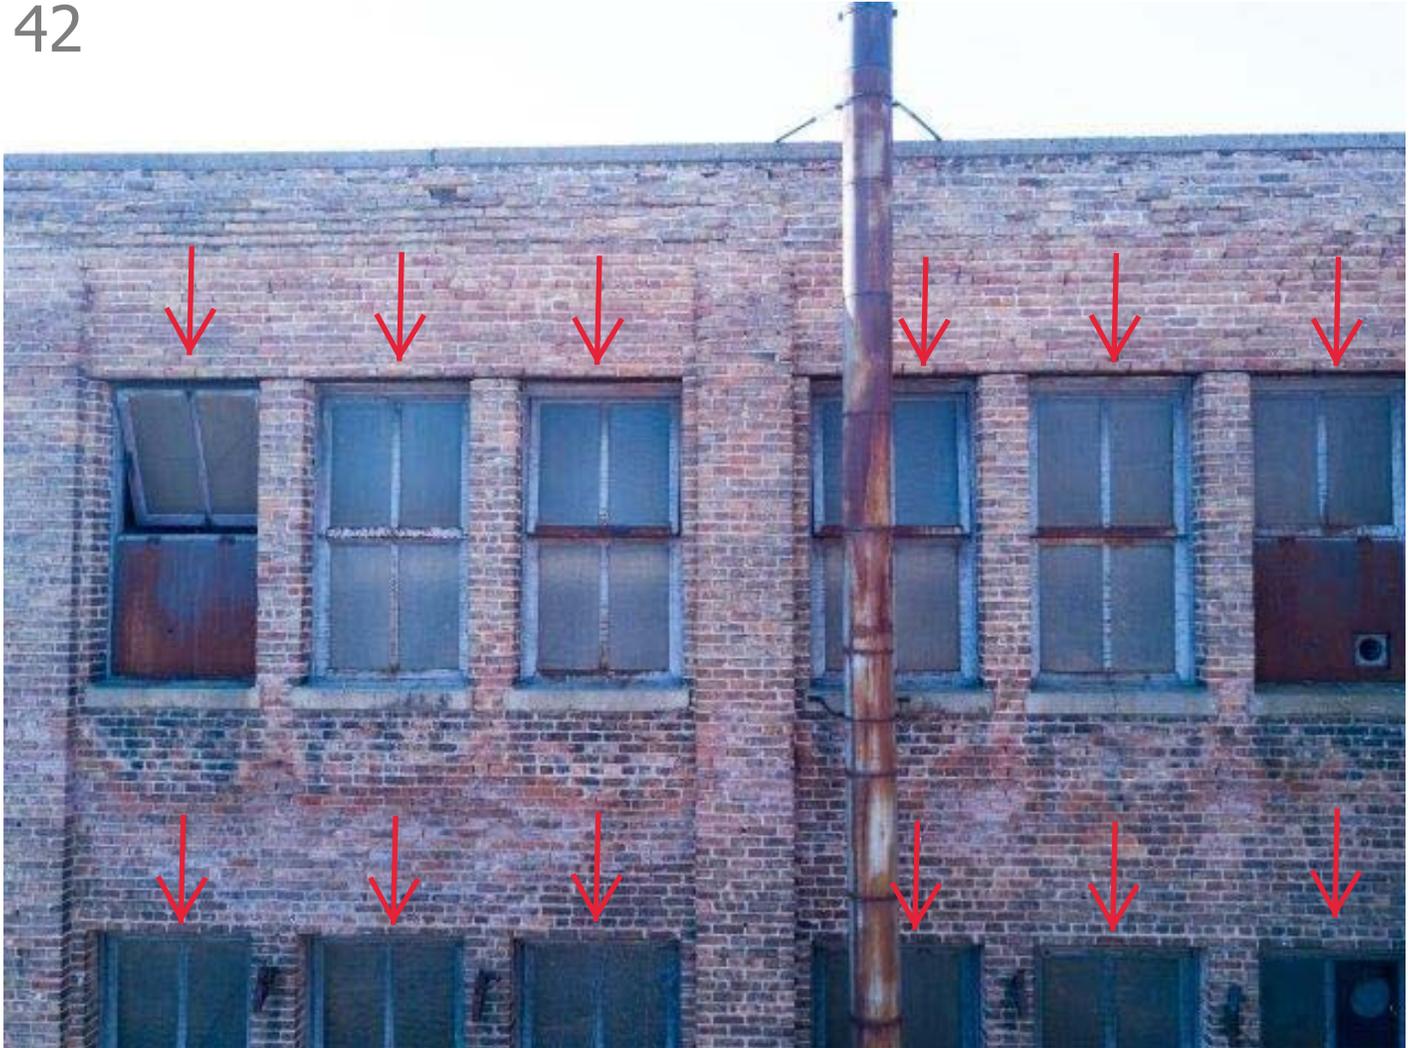
View of lineal conditions - The masonry is relatively stable and will require minimal restoration. All lintels are in excellent condition.

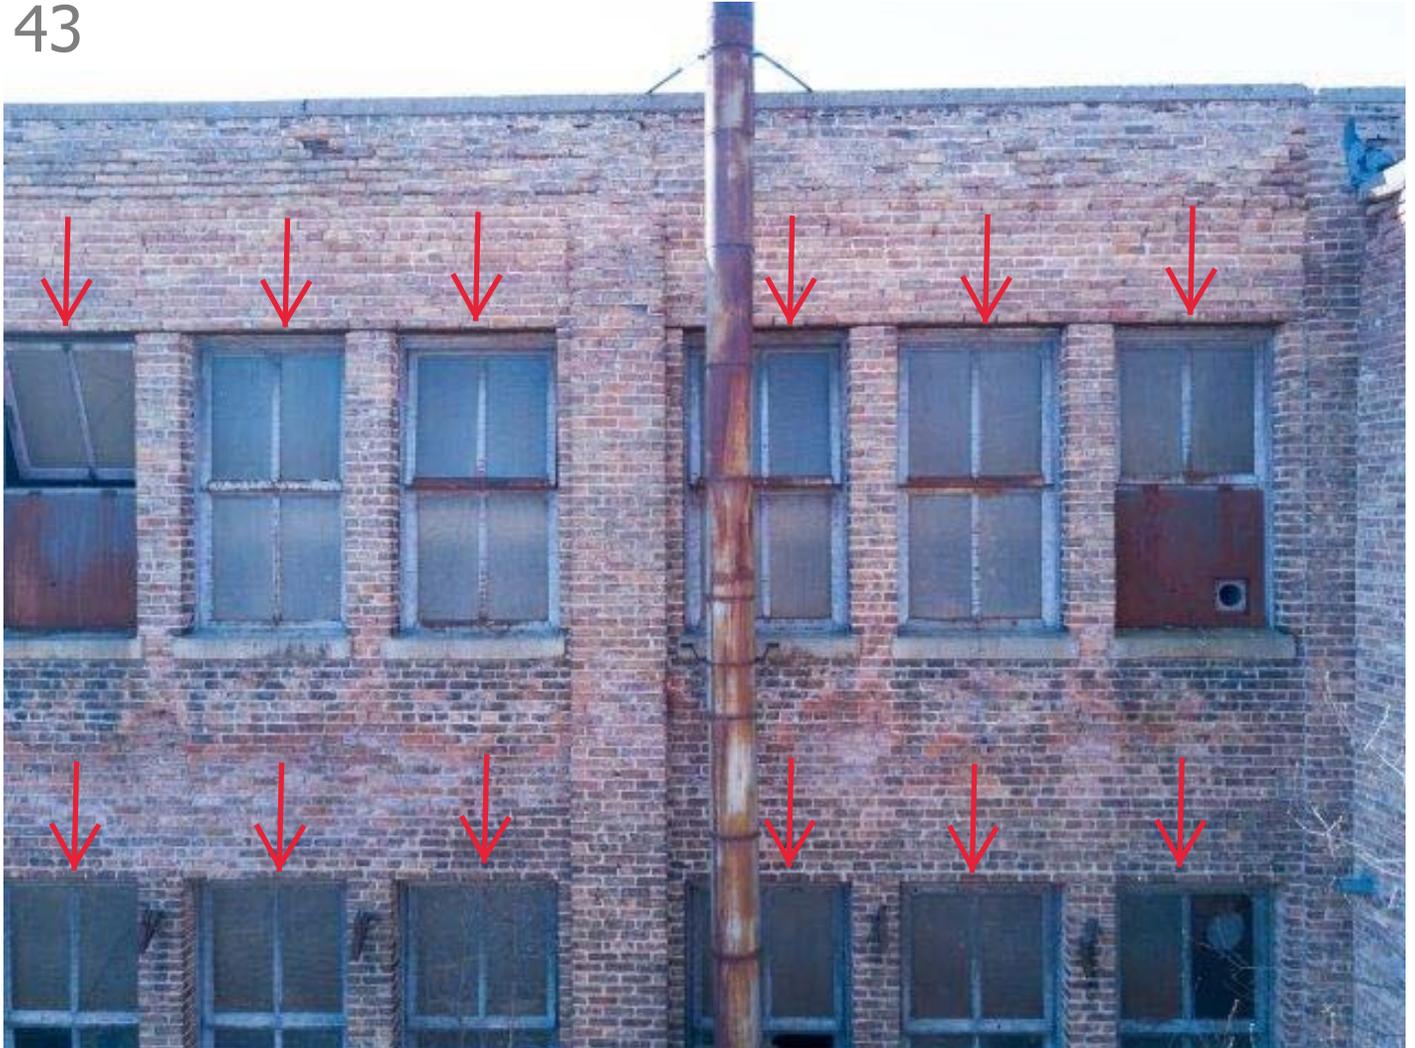
View of lineal conditions - The masonry is relatively stable and will require minimal restoration. All lintels are in excellent condition.

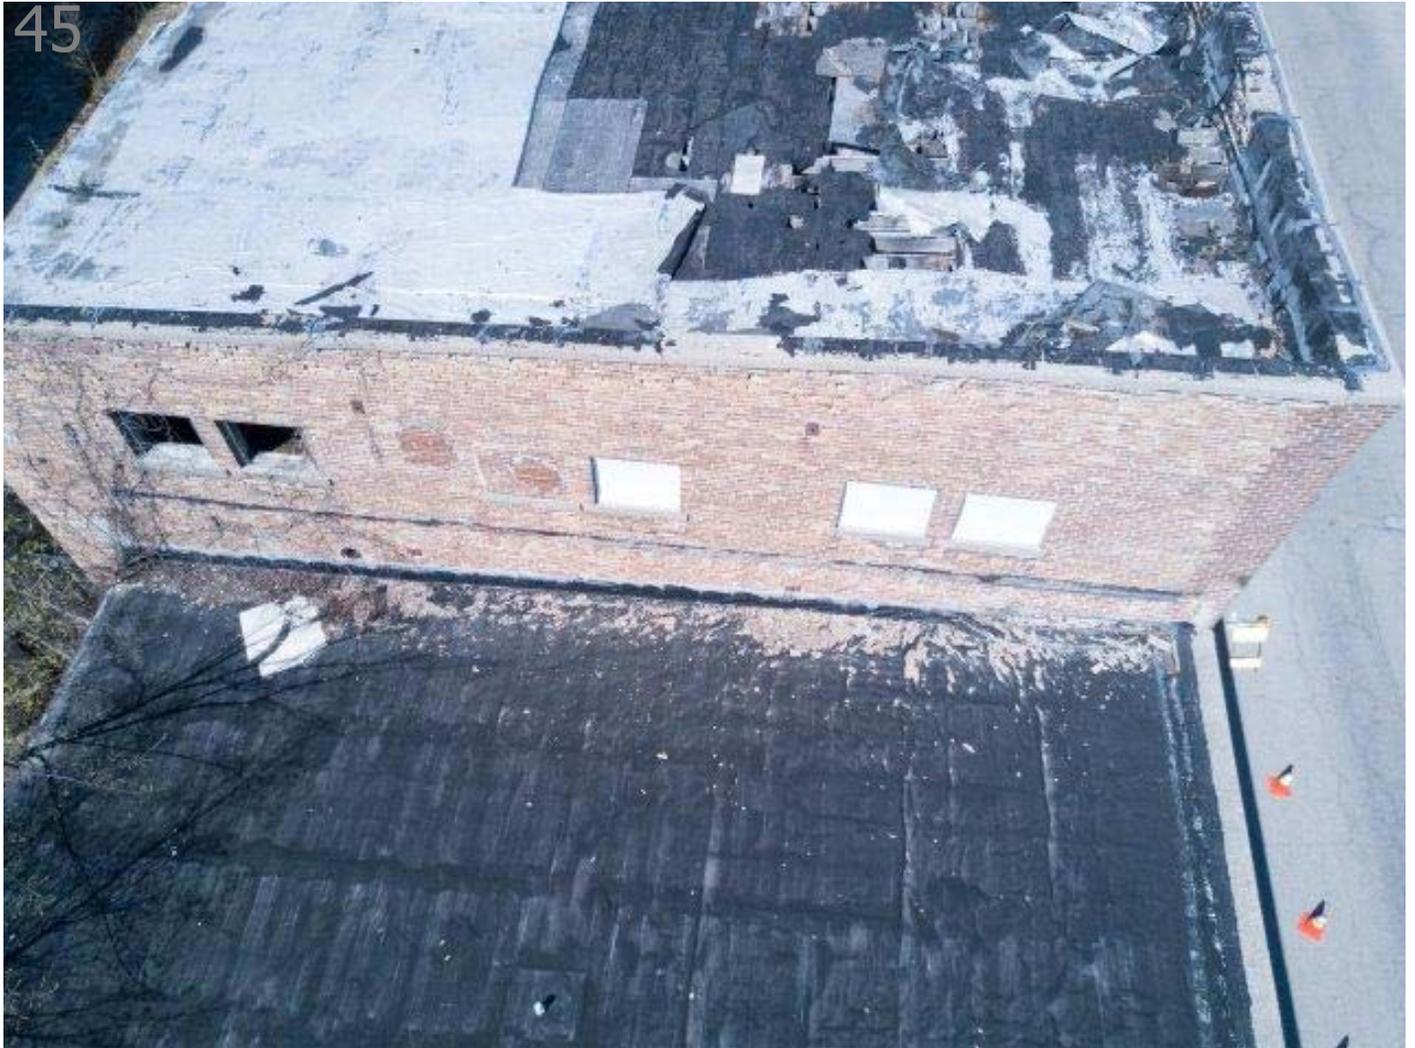
Note poor condition of roof - this has been open for many years - note the brick & mortar debris on the lower roof.

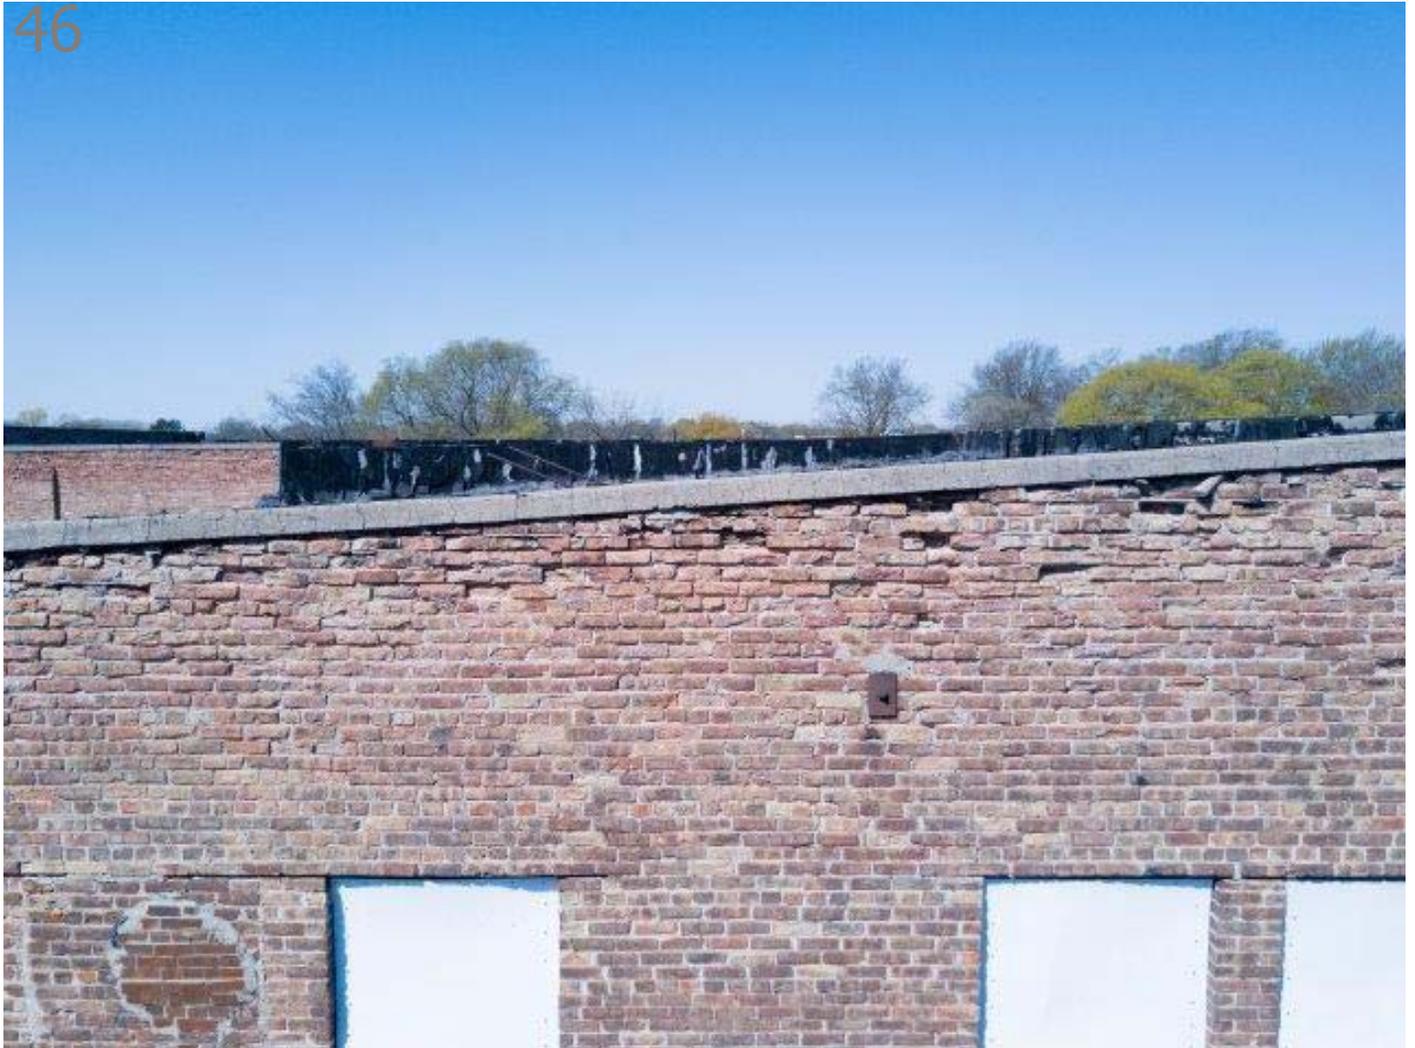
View of damage at parapet - these conditions are very repairable.

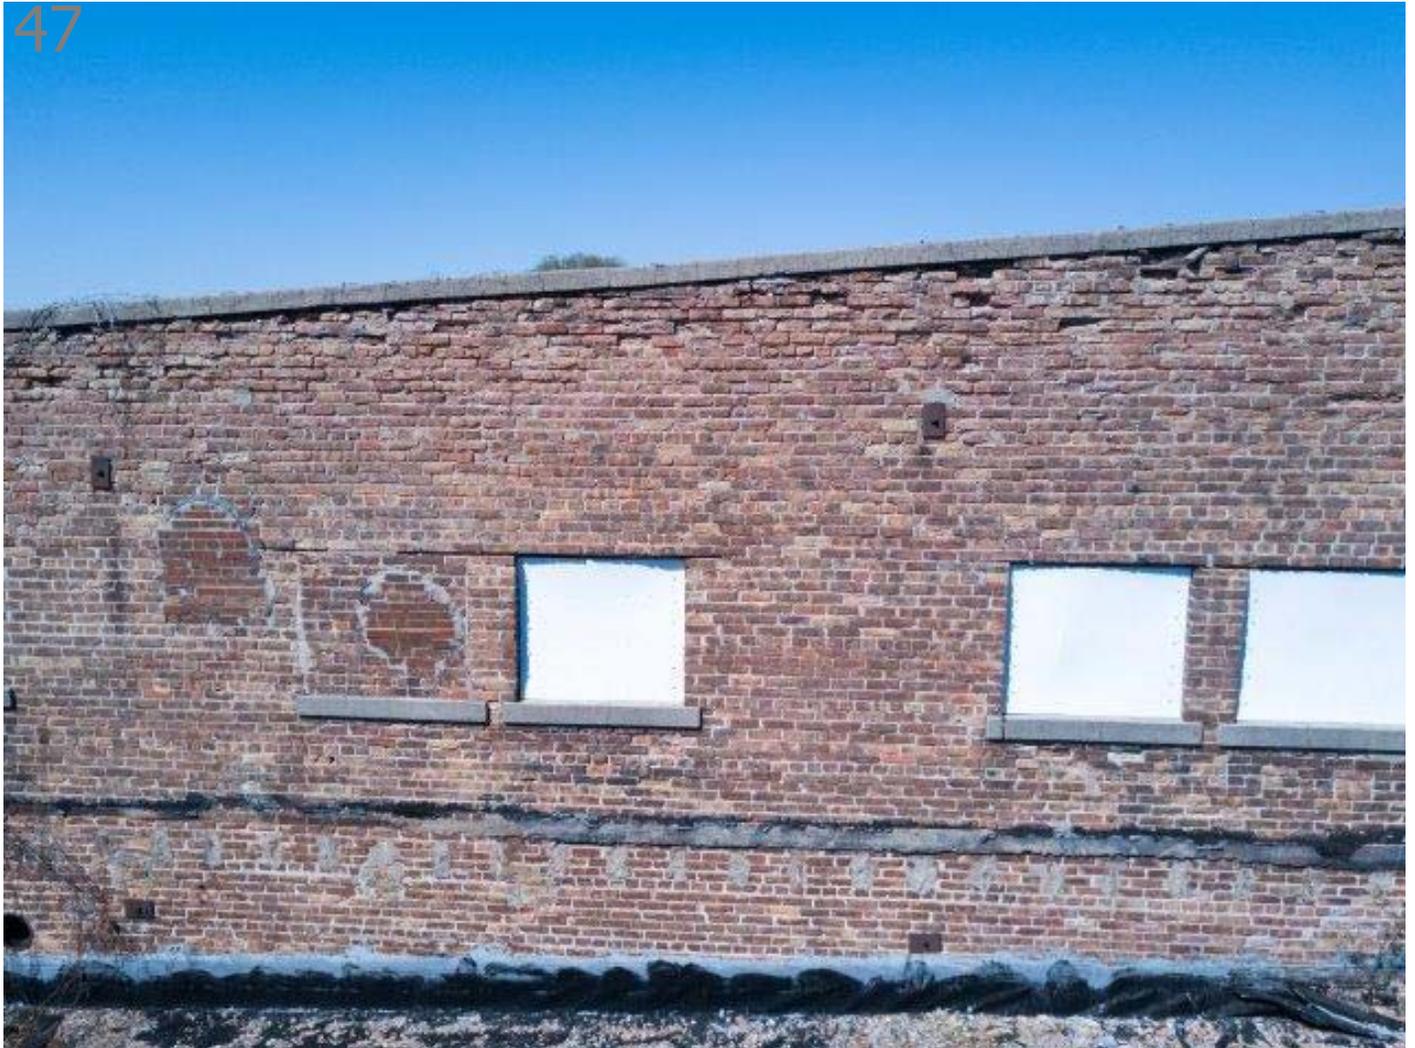
View of damage at parapet - these conditions are very repairable.

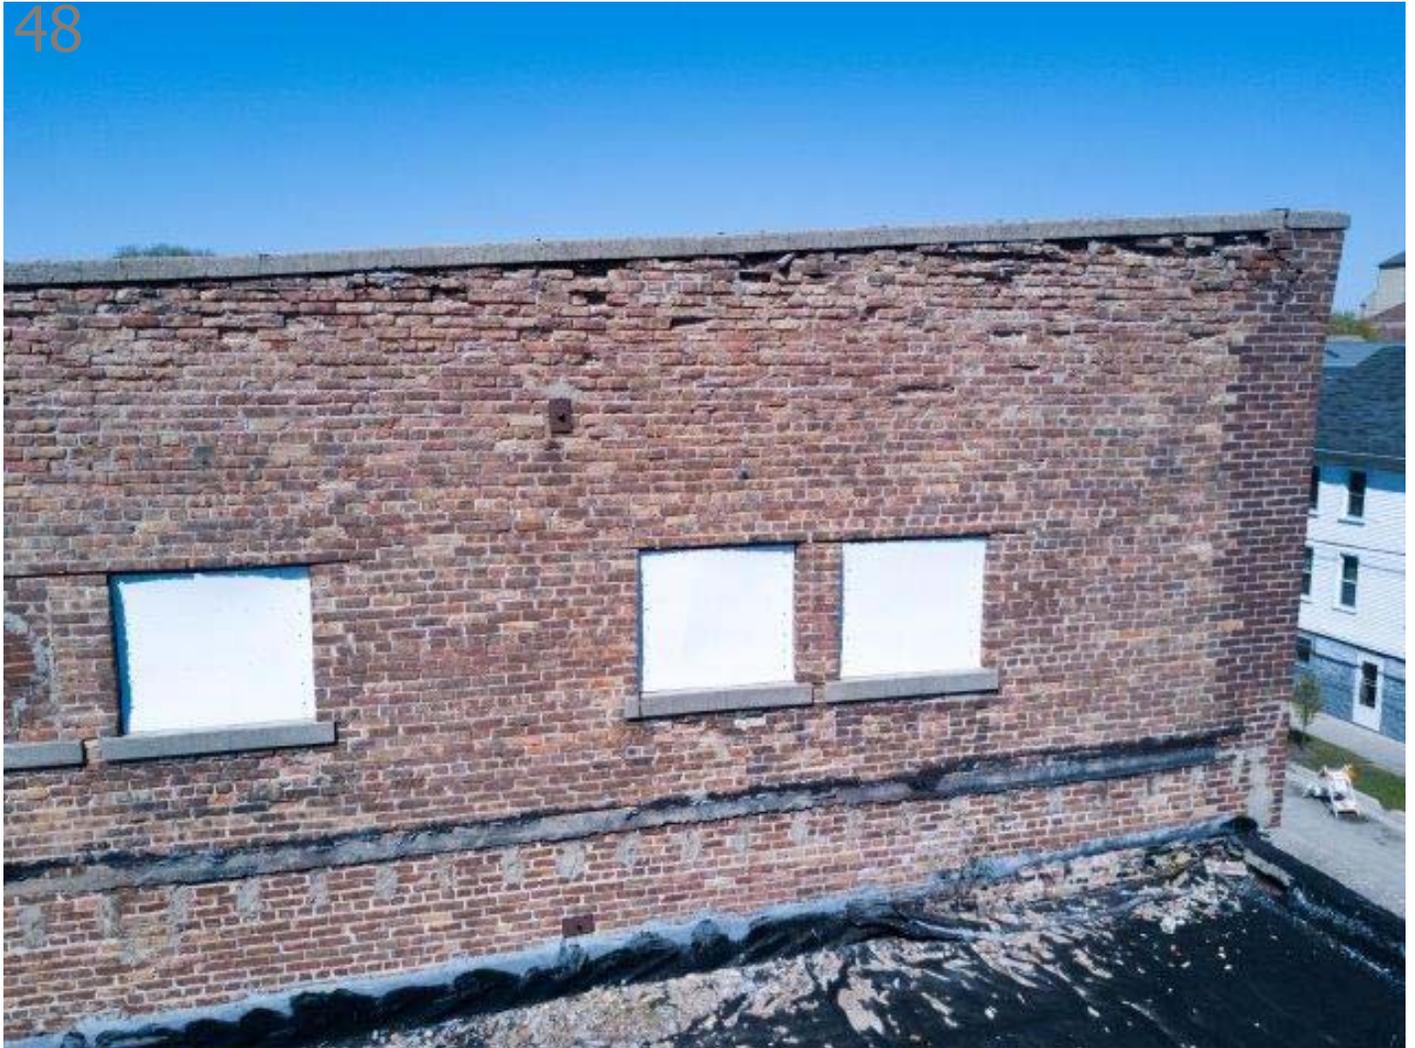
View of damage at parapet - these conditions are very repairable.

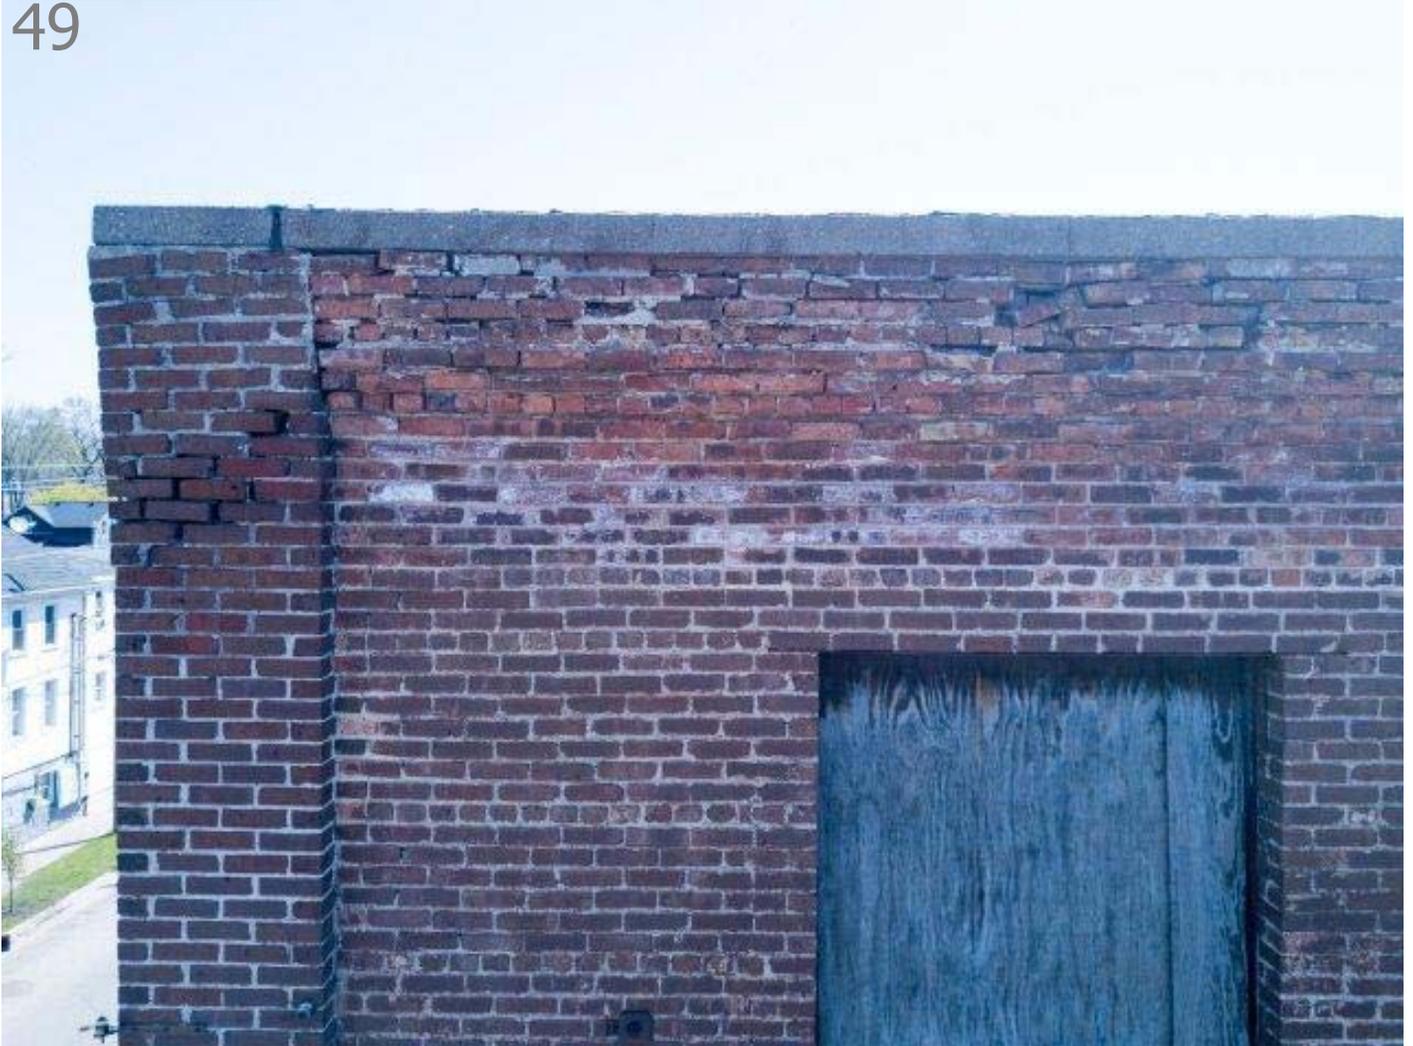
View of damage at parapet - these conditions are very repairable.

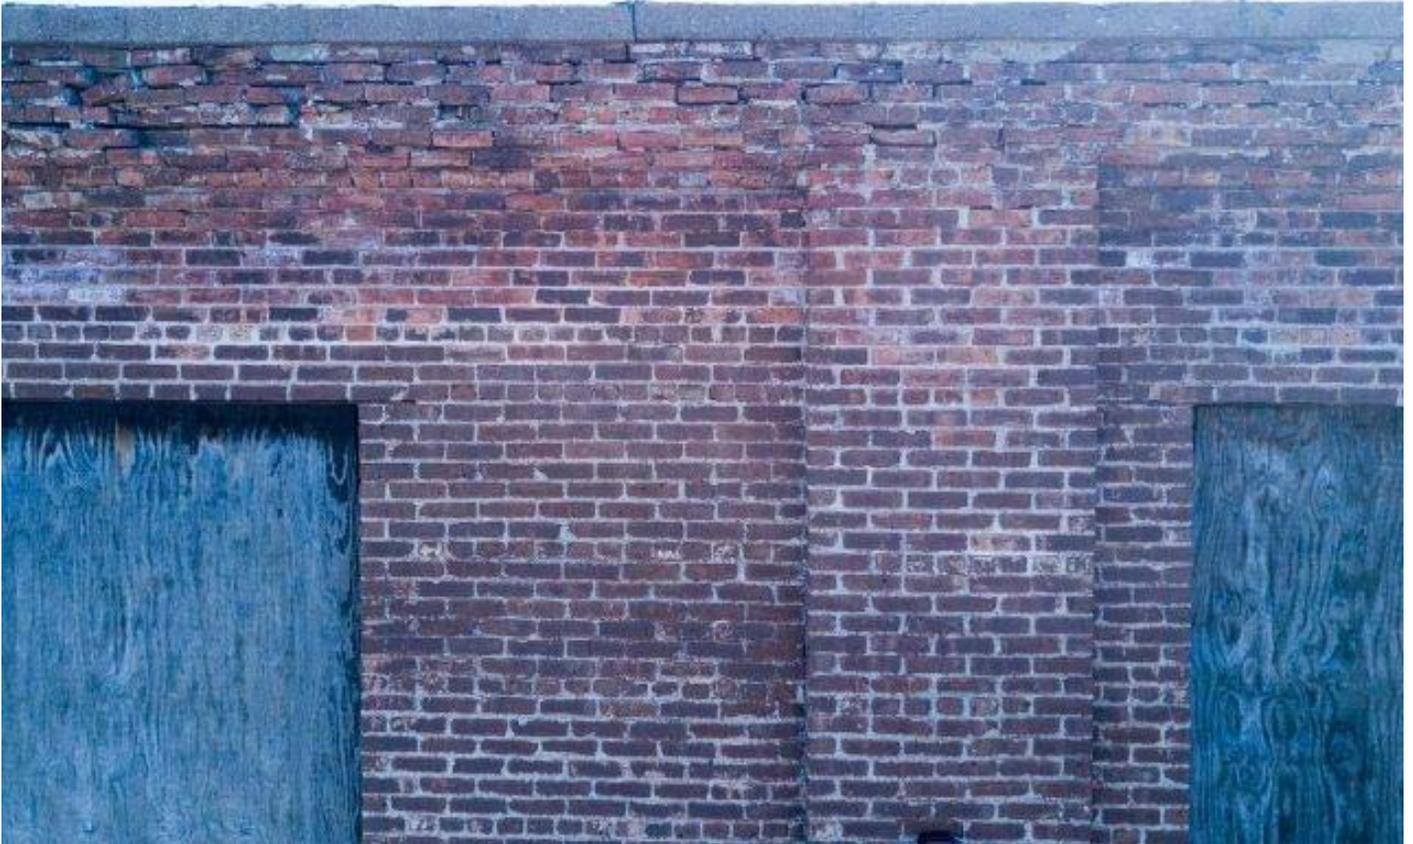
View of damage at parapet - these conditions are very repairable.

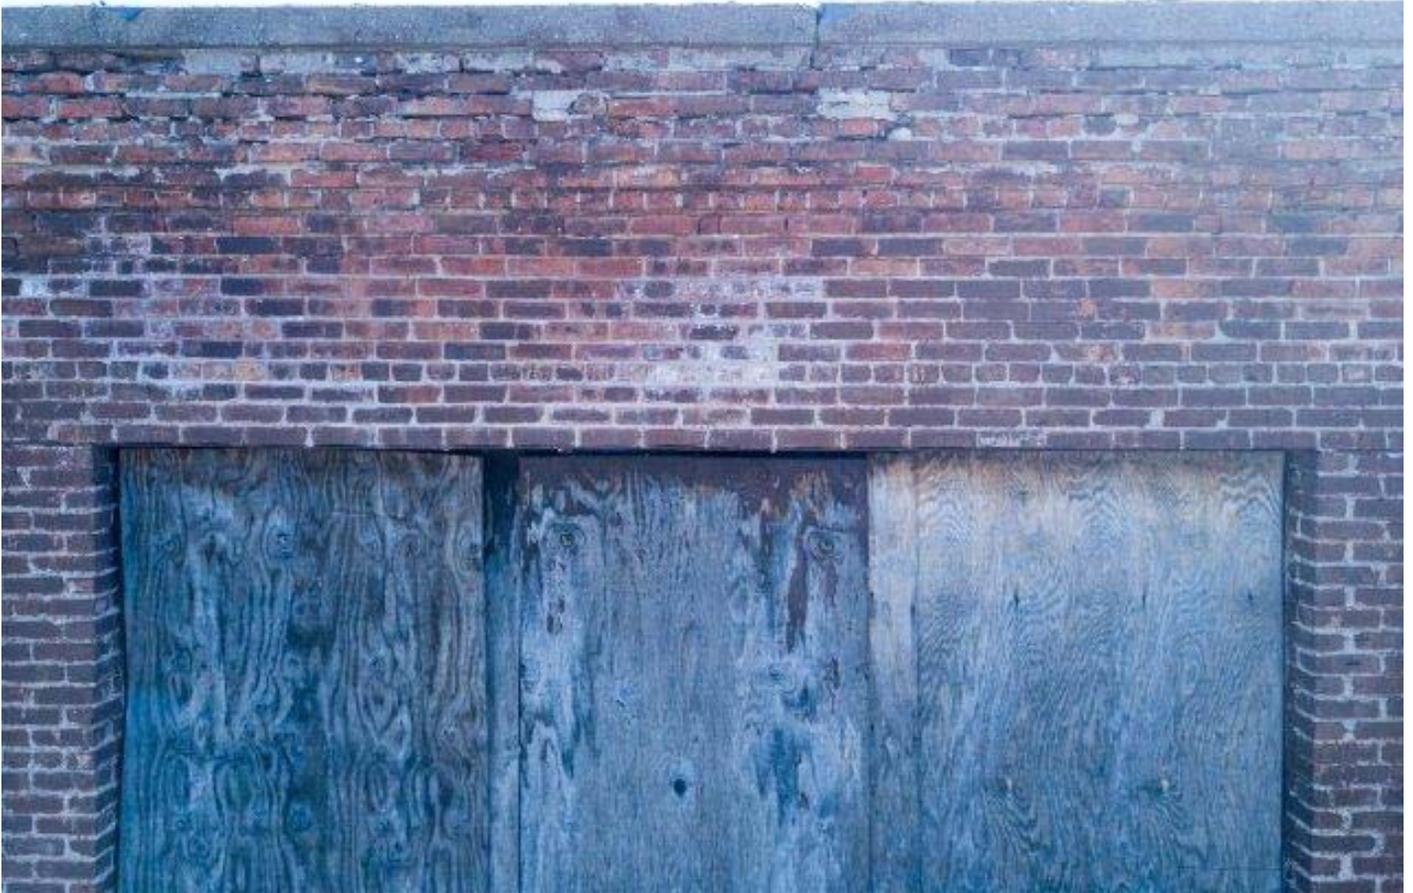
View of damage at parapet - these conditions are very repairable.

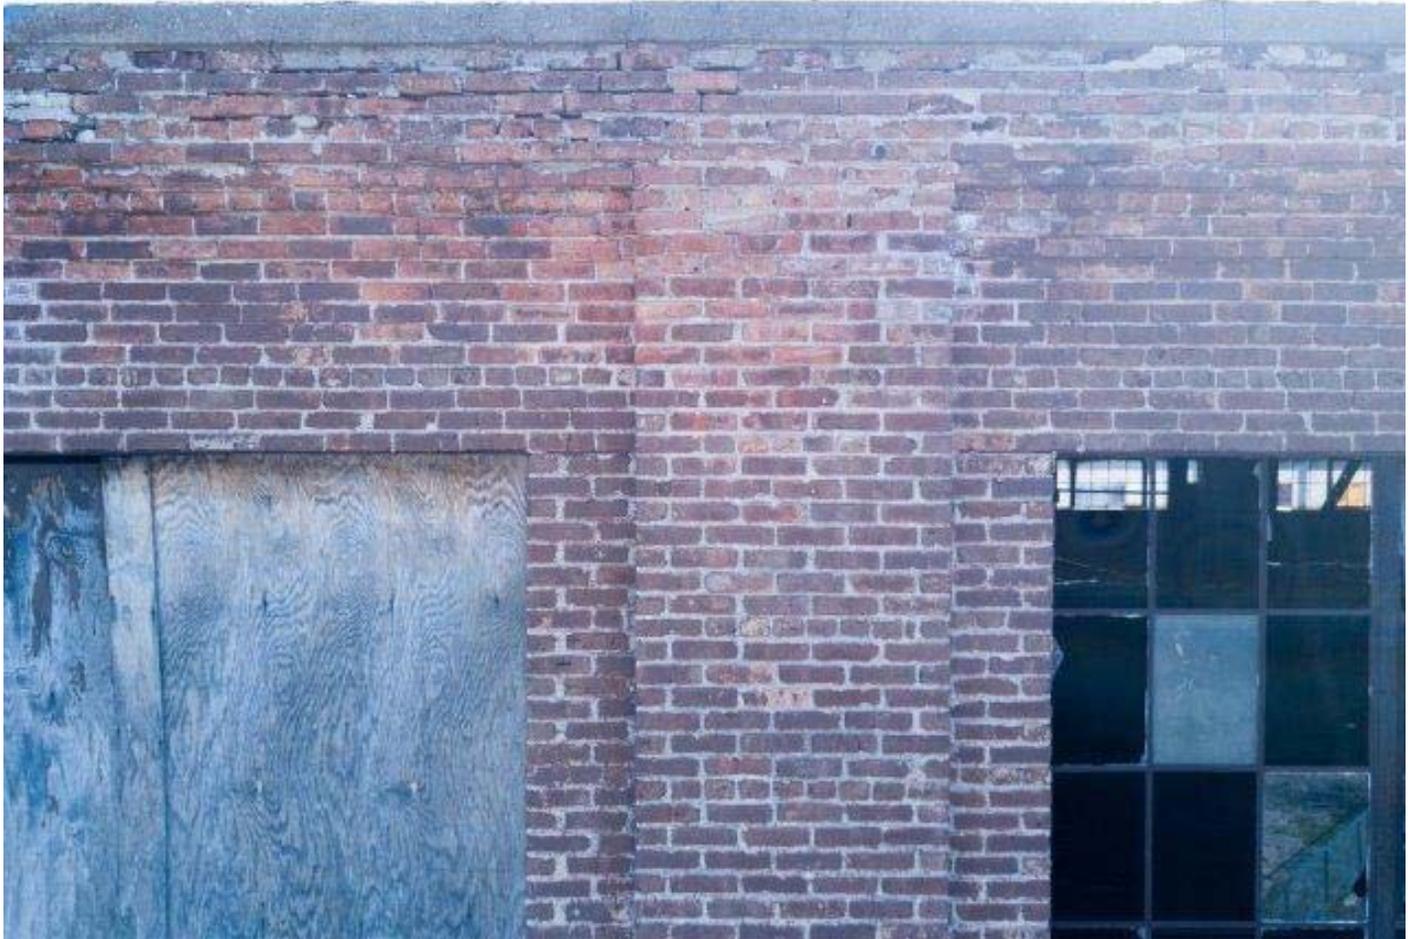
View of damage at parapet - these conditions are very repairable.

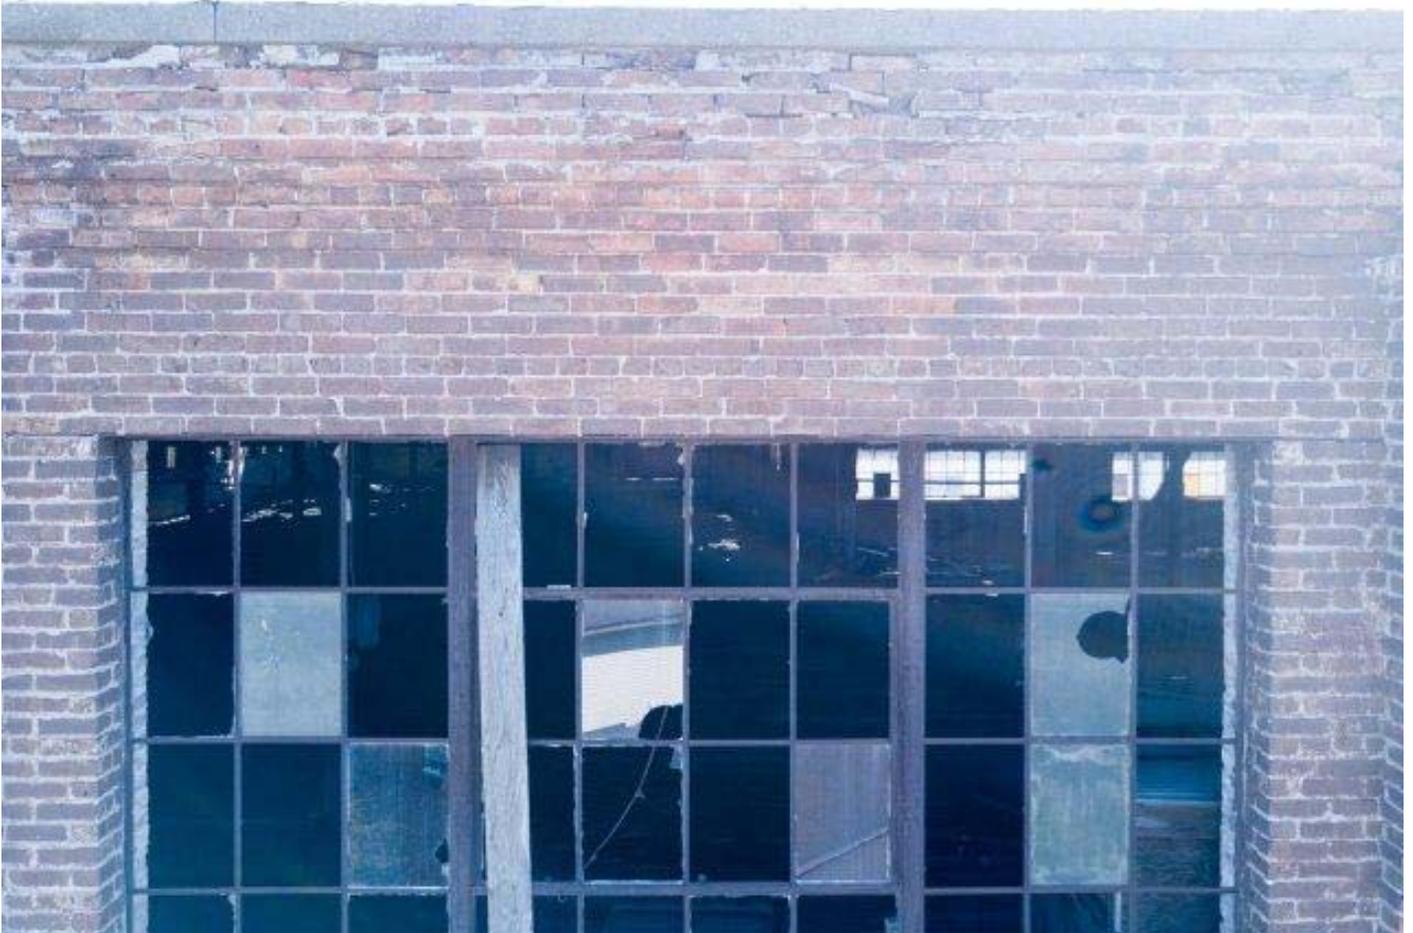
View of damage at parapet - these conditions are very repairable.

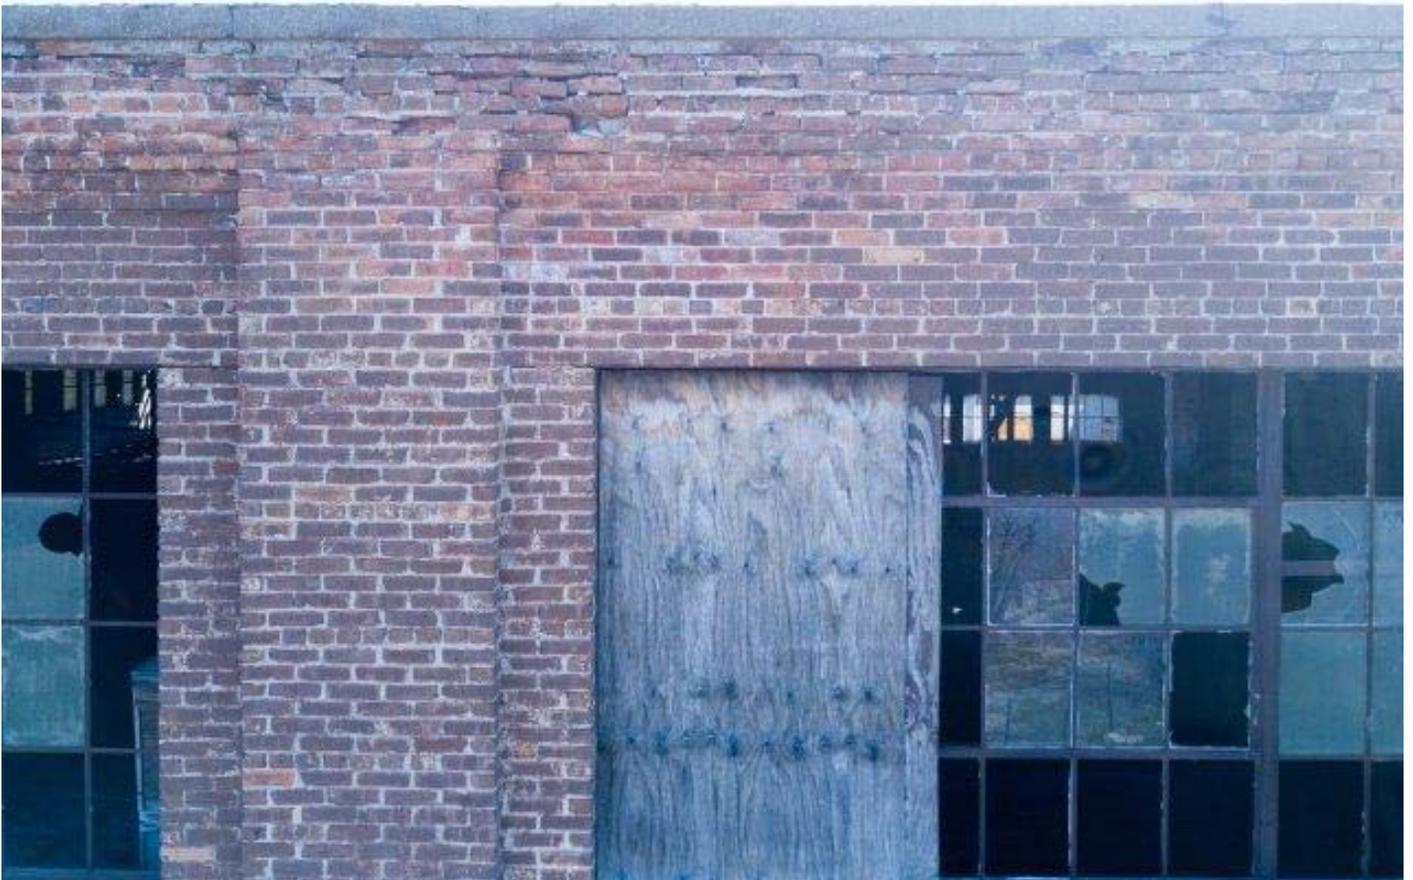
View of damage at parapet - these conditions are very repairable.

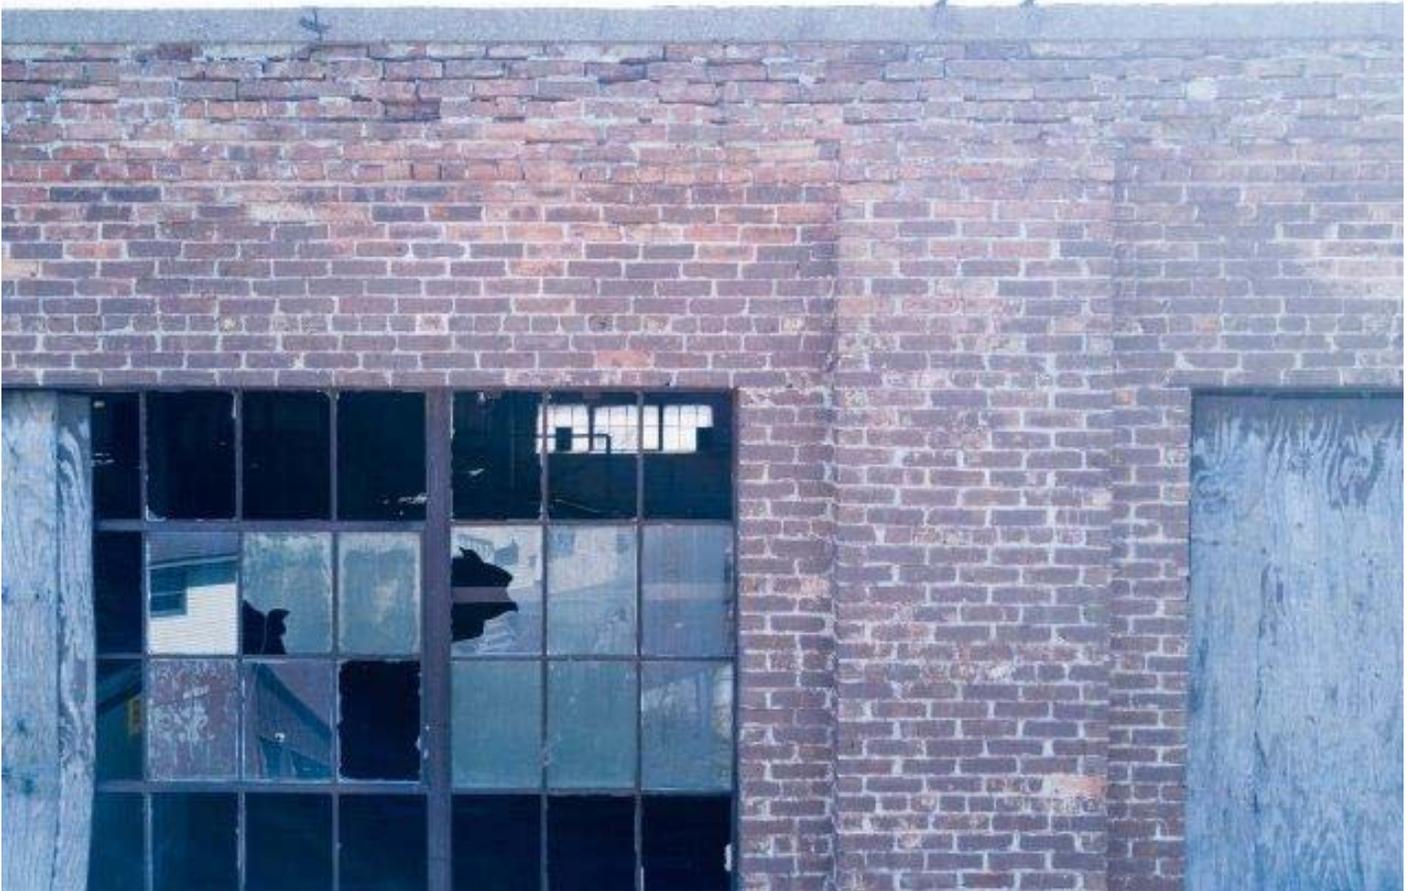
View of damage at parapet - these conditions are very repairable.

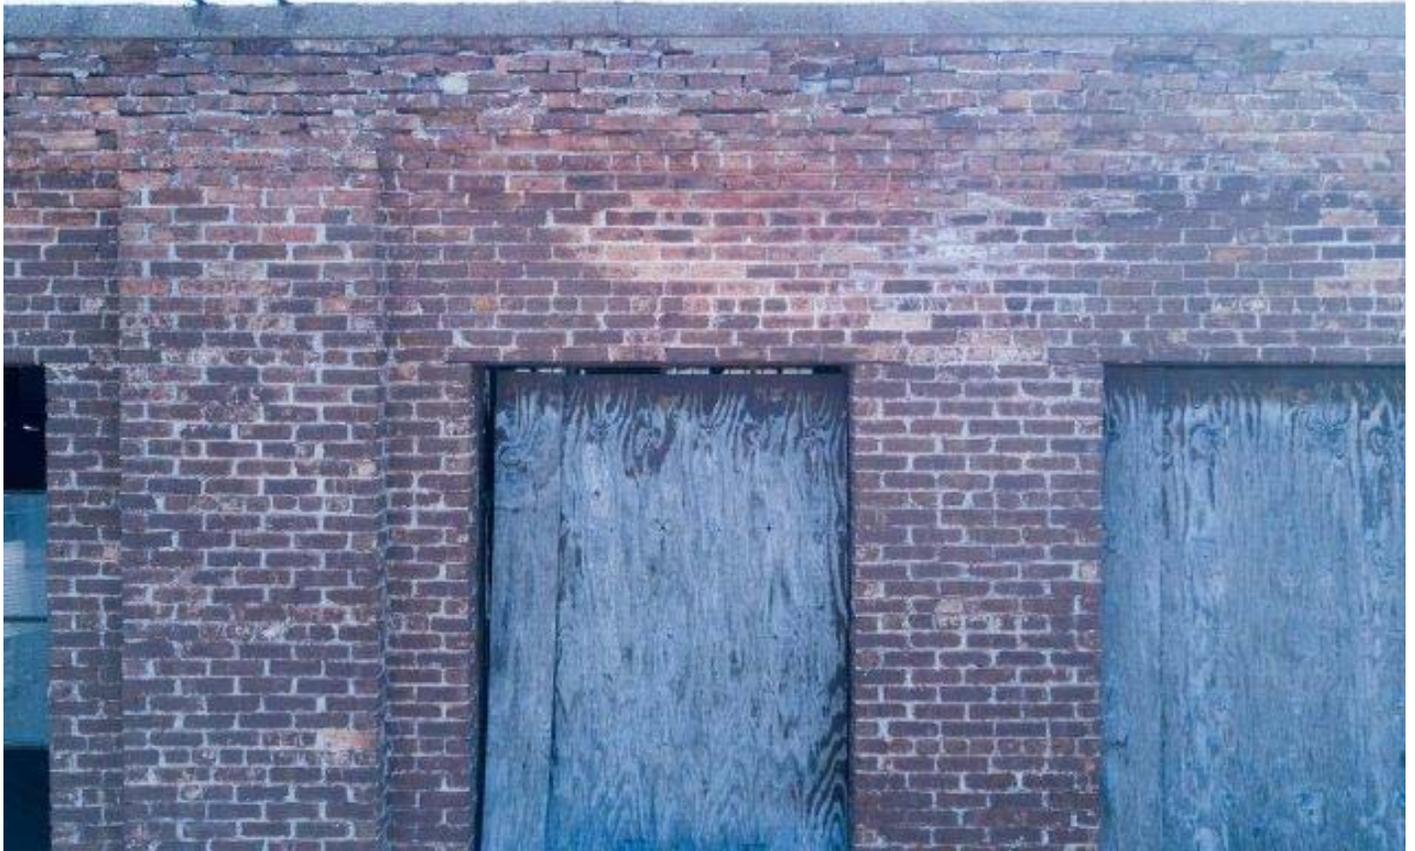
View of damage at parapet - these conditions are very repairable.
