**STOUGHTON HIGHWAY TRAILER BUILDING COMPLEX
SURVEY REPORT
STOUGHTON, WISCONSIN**

July 12, 2017

The following is a summary report on our findings of onsite conditions and our recommendations for the treatment of the Highway Trailer Building Complex. We have based this report on a facility inspection conducted on May 18, 2017. This inspection was preceded by a drone survey to provide a safe close-up inspection of the exterior materials. Focus of inspection was to assess and make recommendations related to safety issues associated with potential structural collapse along E. South St., and to assess and make recommendations regarding existing structural masonry shell salvage and reuse throughout the facility. Partial and full deconstruction of connected structural systems considered for demolition is also addressed in our record of observations and opinions.

Stoughton Highway Trailer Building Complex Survey Image Report

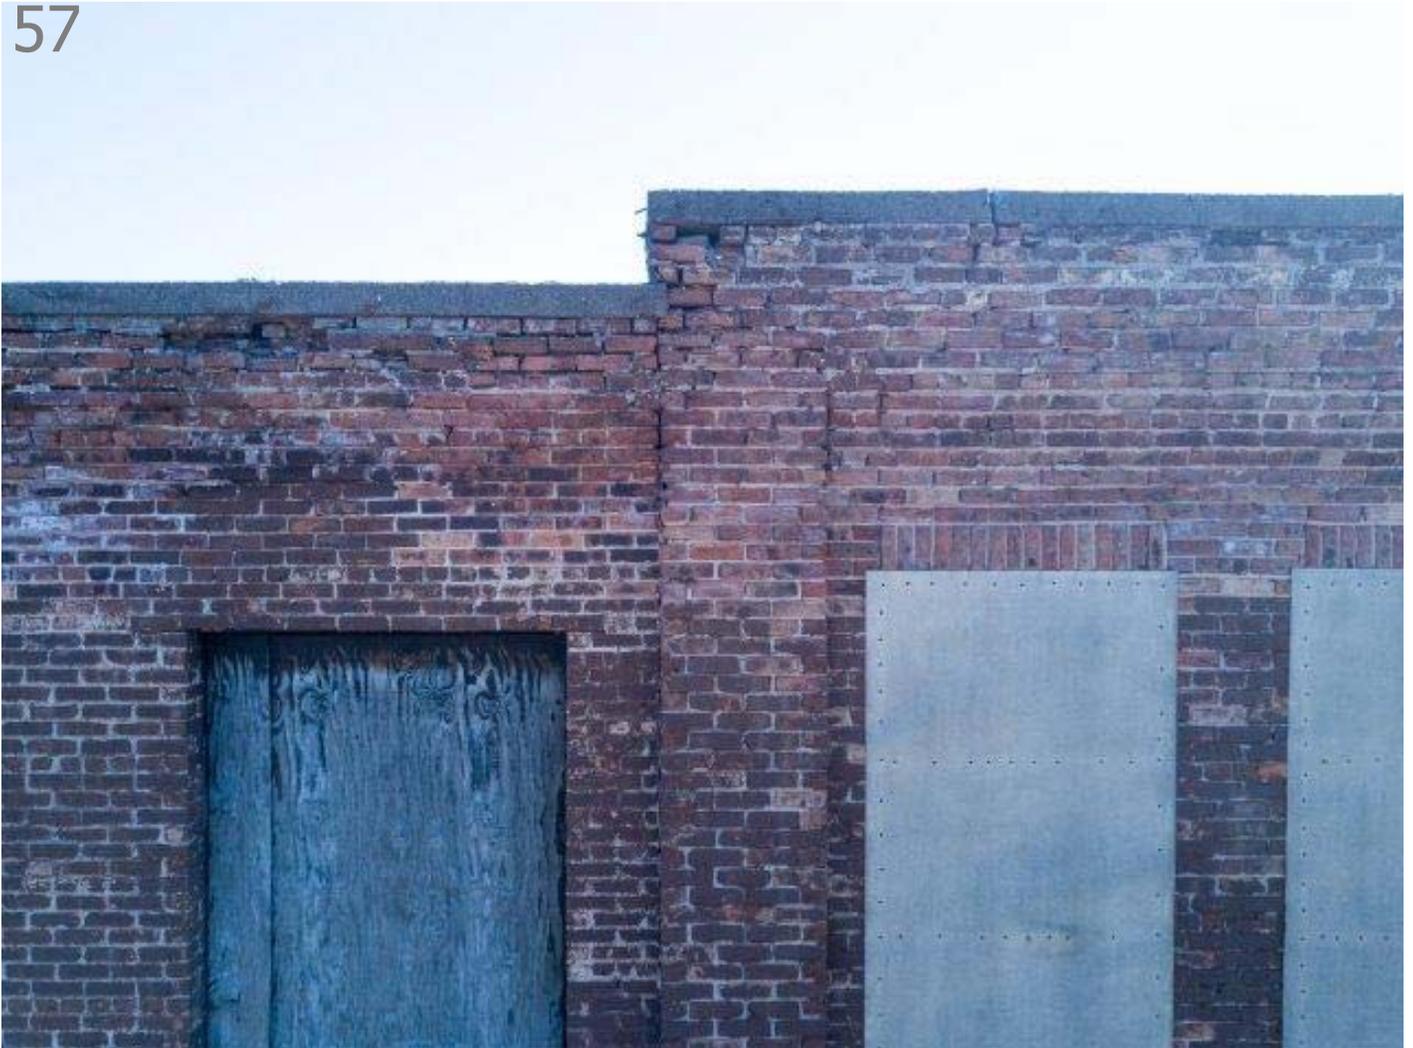
View of damage at parapet - these conditions are very repairable.

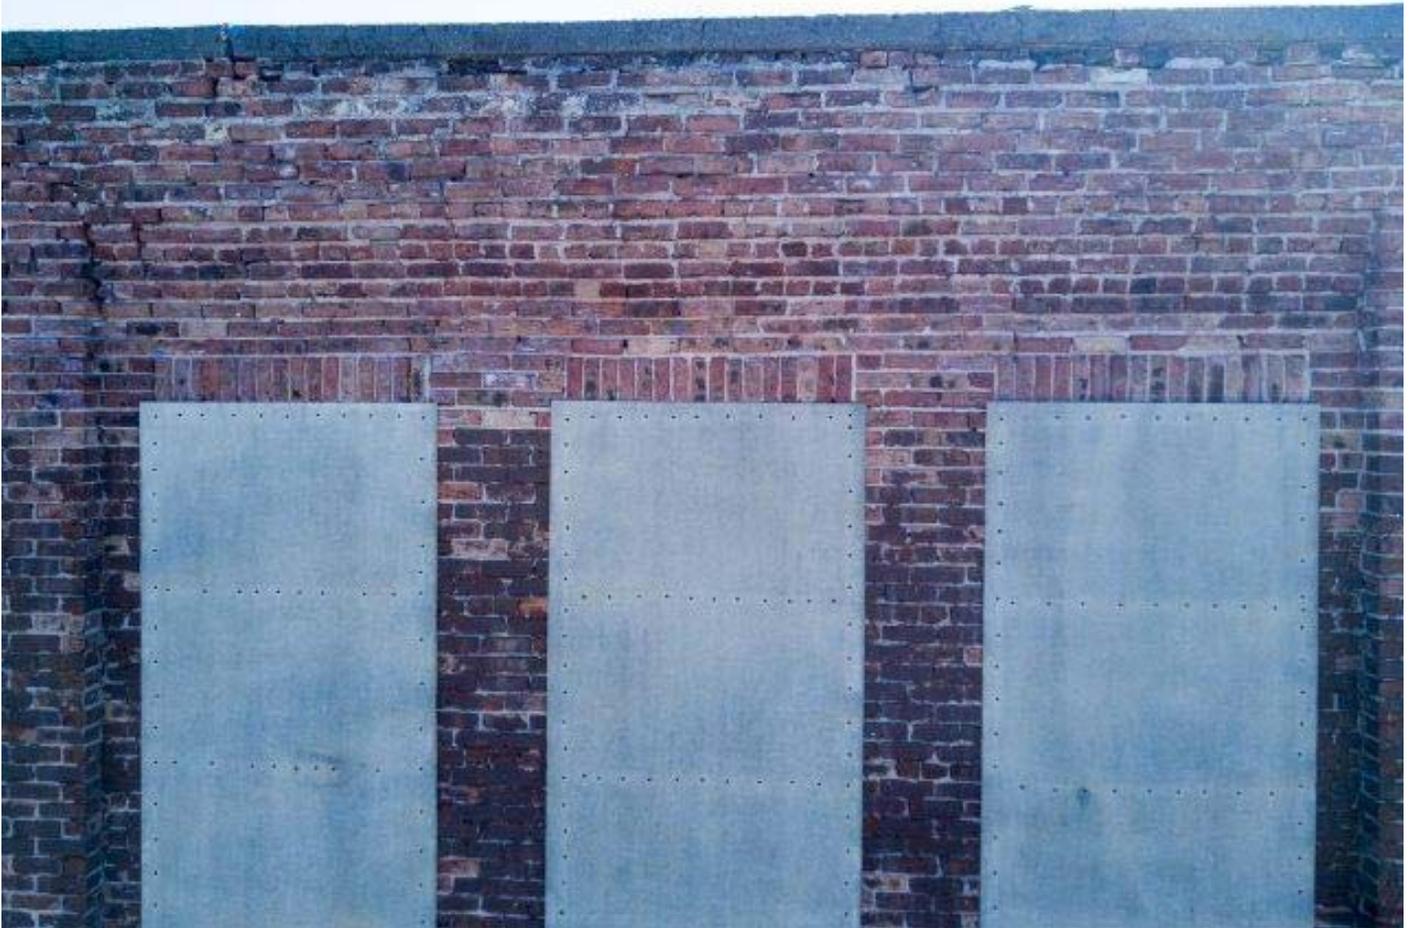
View of damage at parapet - these conditions are very repairable.

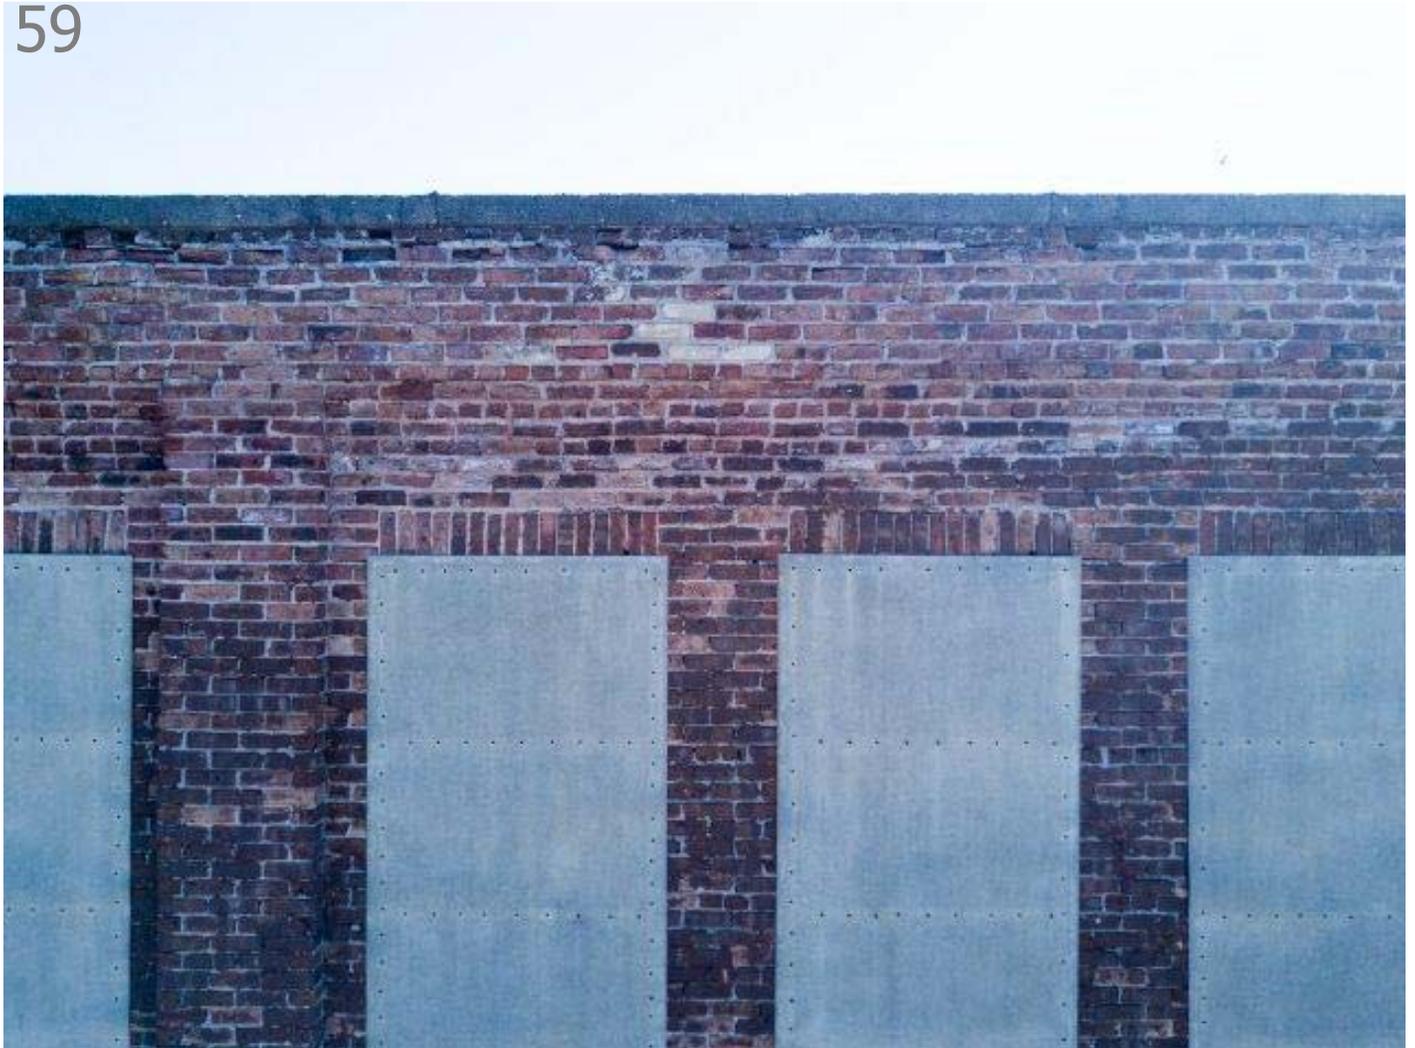
View of damage at parapet - these conditions are very repairable.

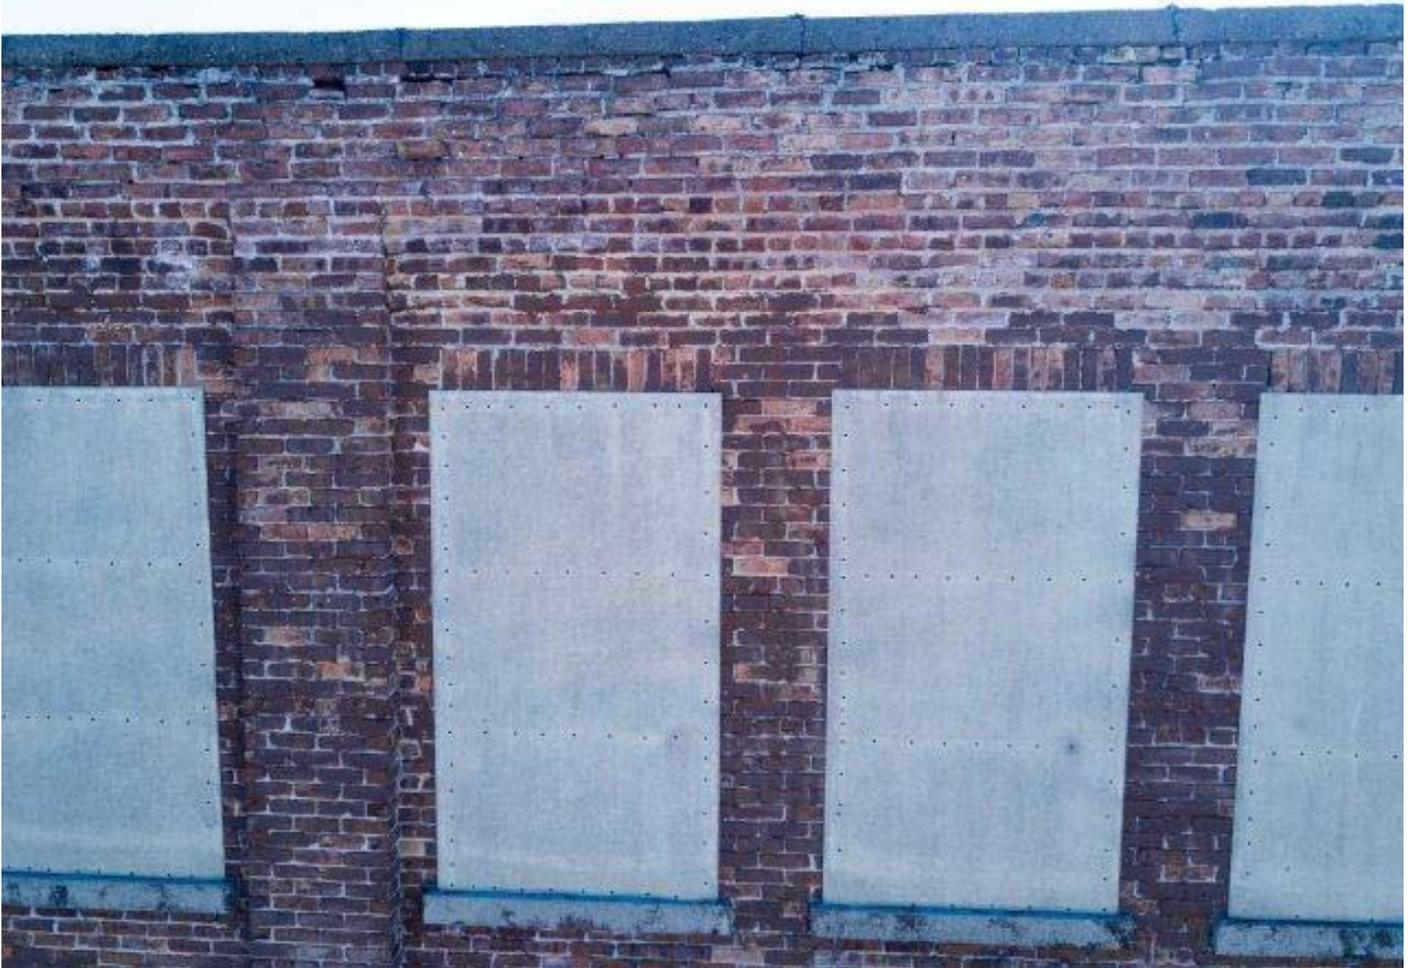
View of damage at parapet - these conditions are very repairable.

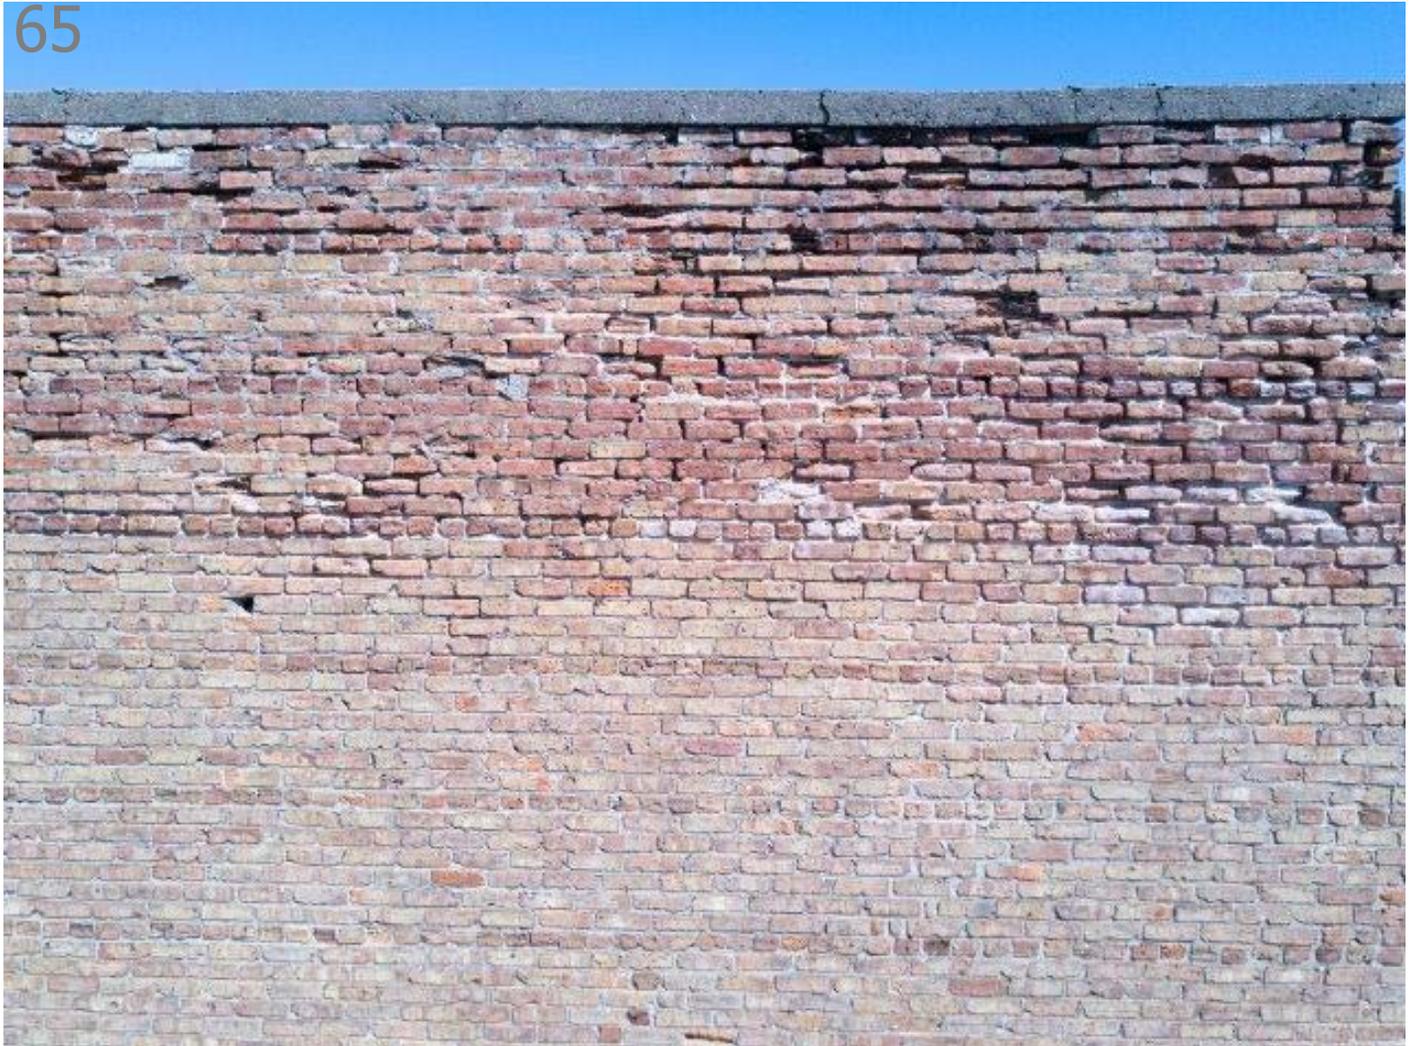
View of damage at parapet - these conditions are very repairable.

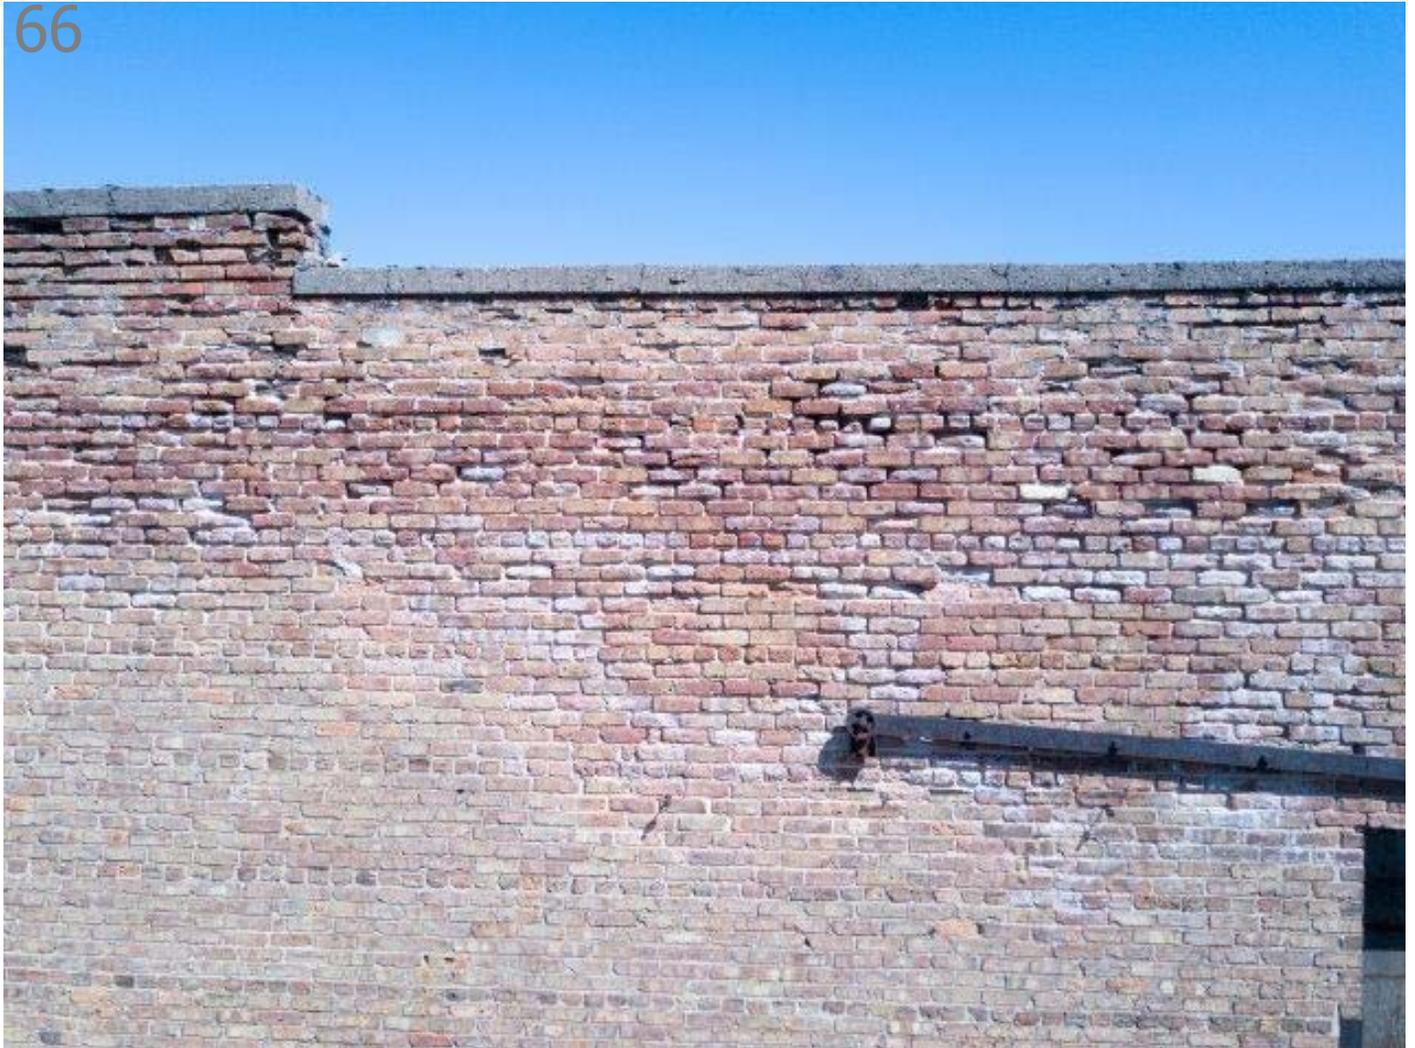
View of damage at parapet - these conditions are very repairable.

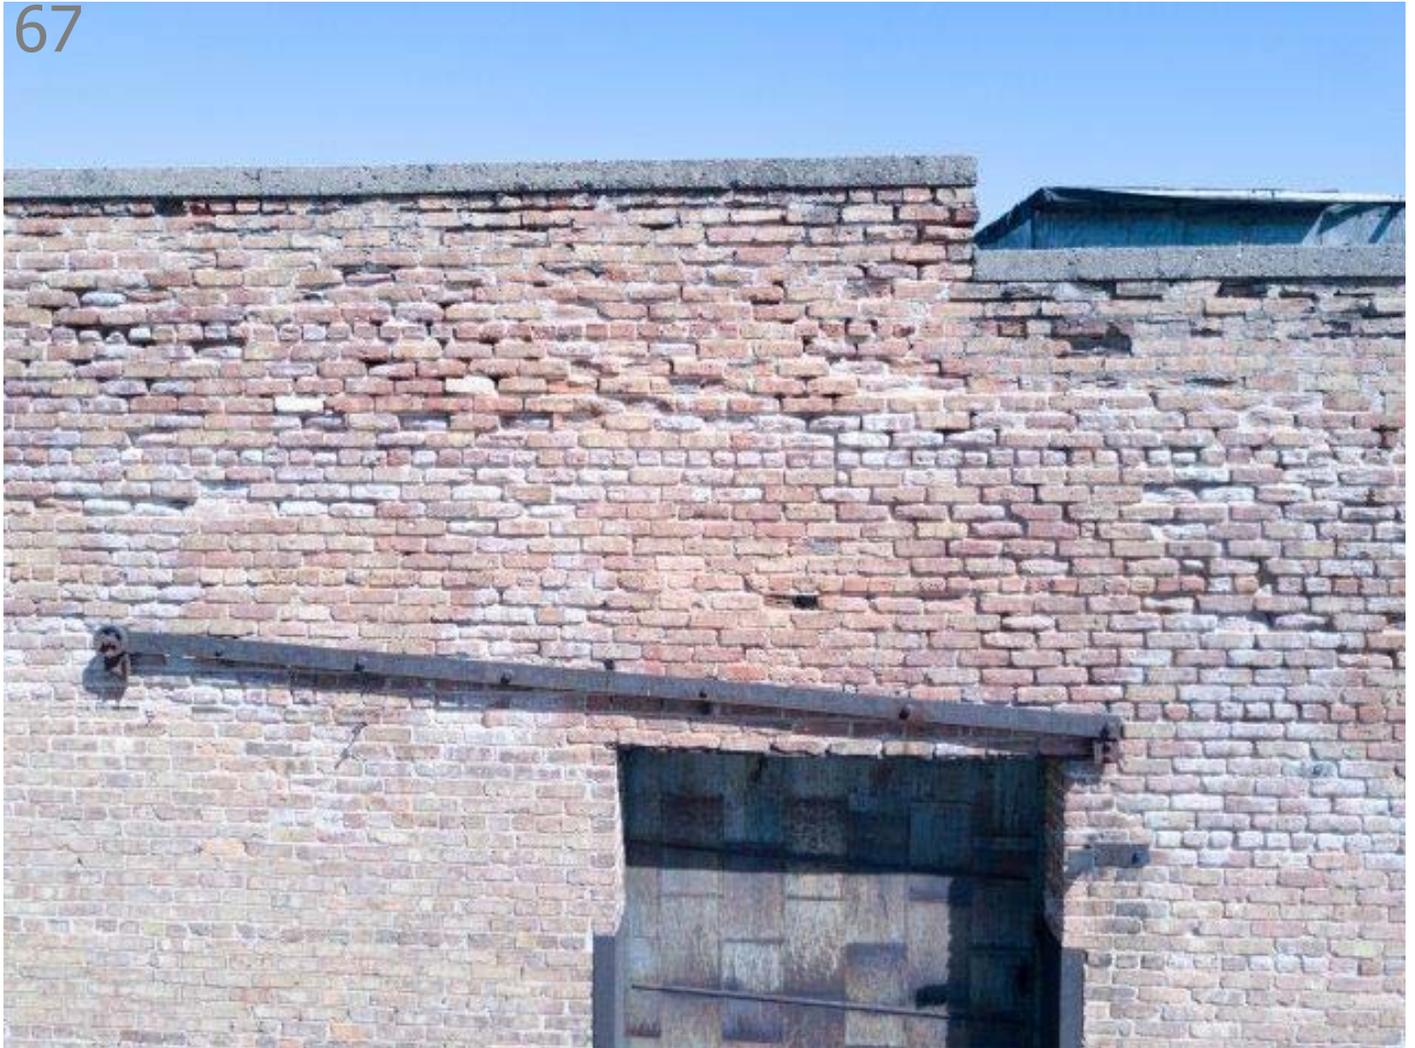
View of damage at parapet - these conditions are very repairable.

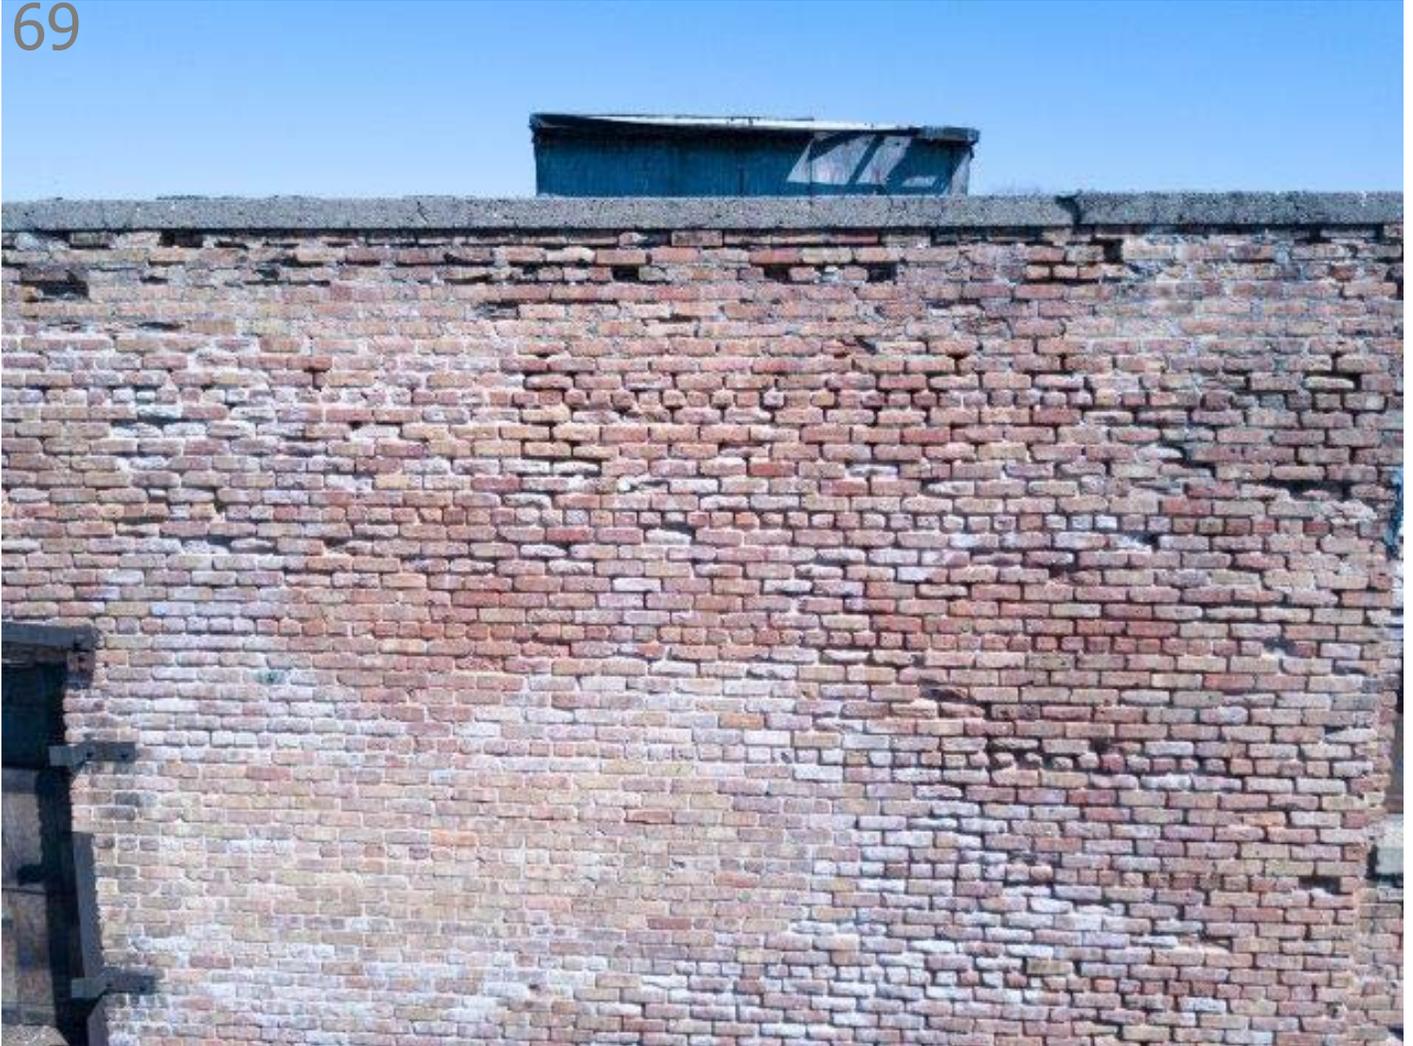
View of damage at parapet - these conditions are very repairable.

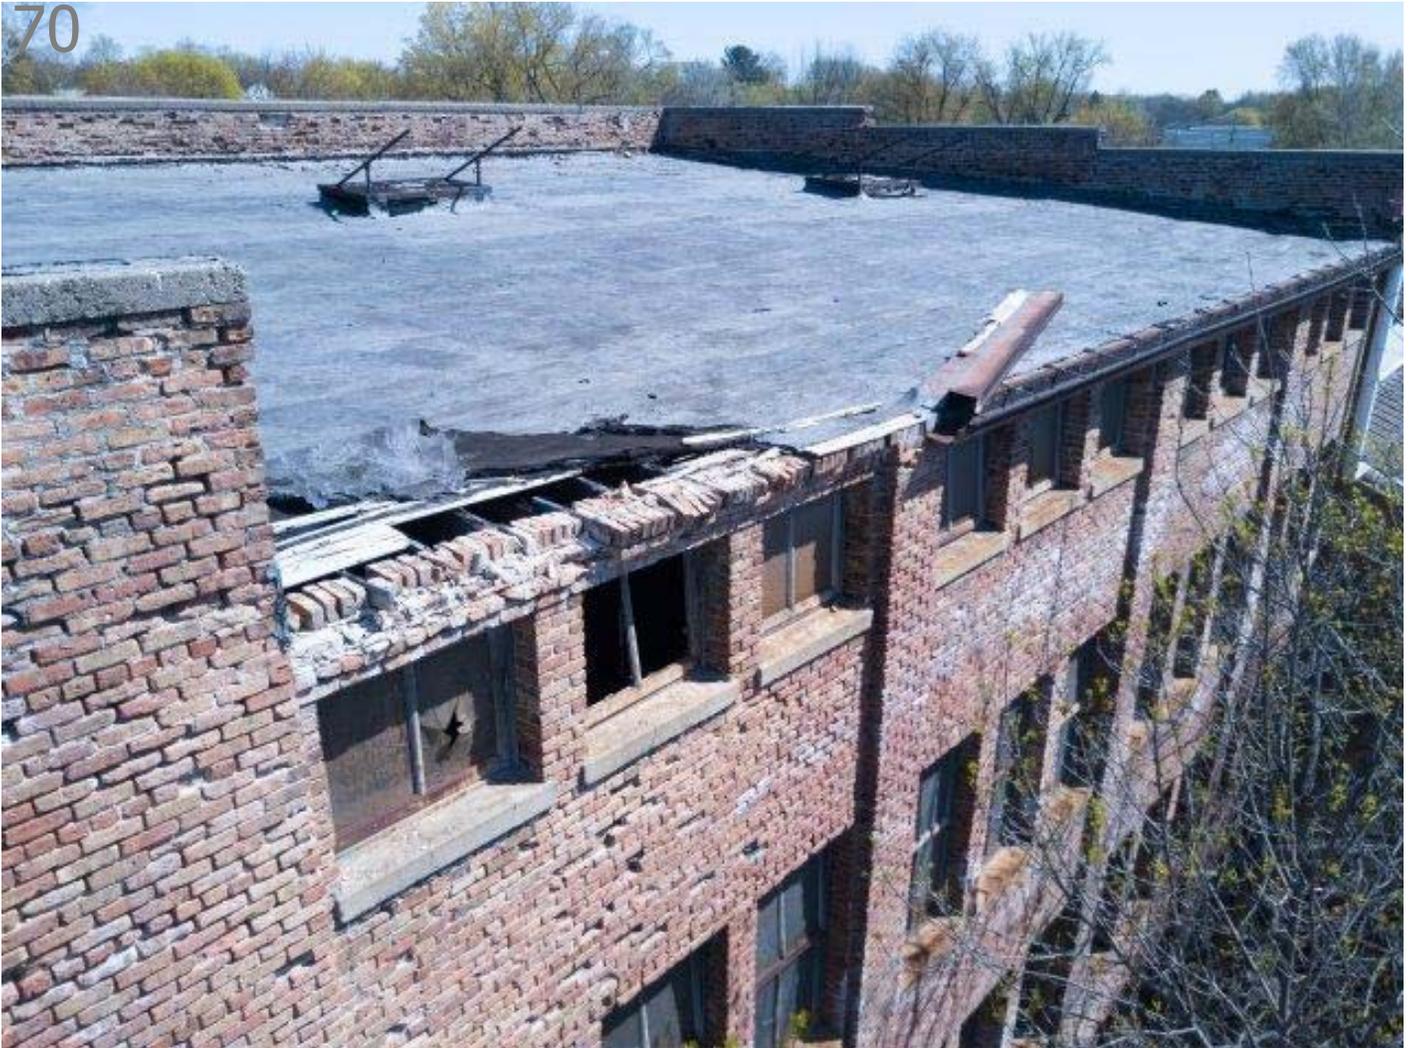
Note condition at parapet - even though this area is severely deteriorated the overall (mass thickness) of the wall remains relatively unchanged.

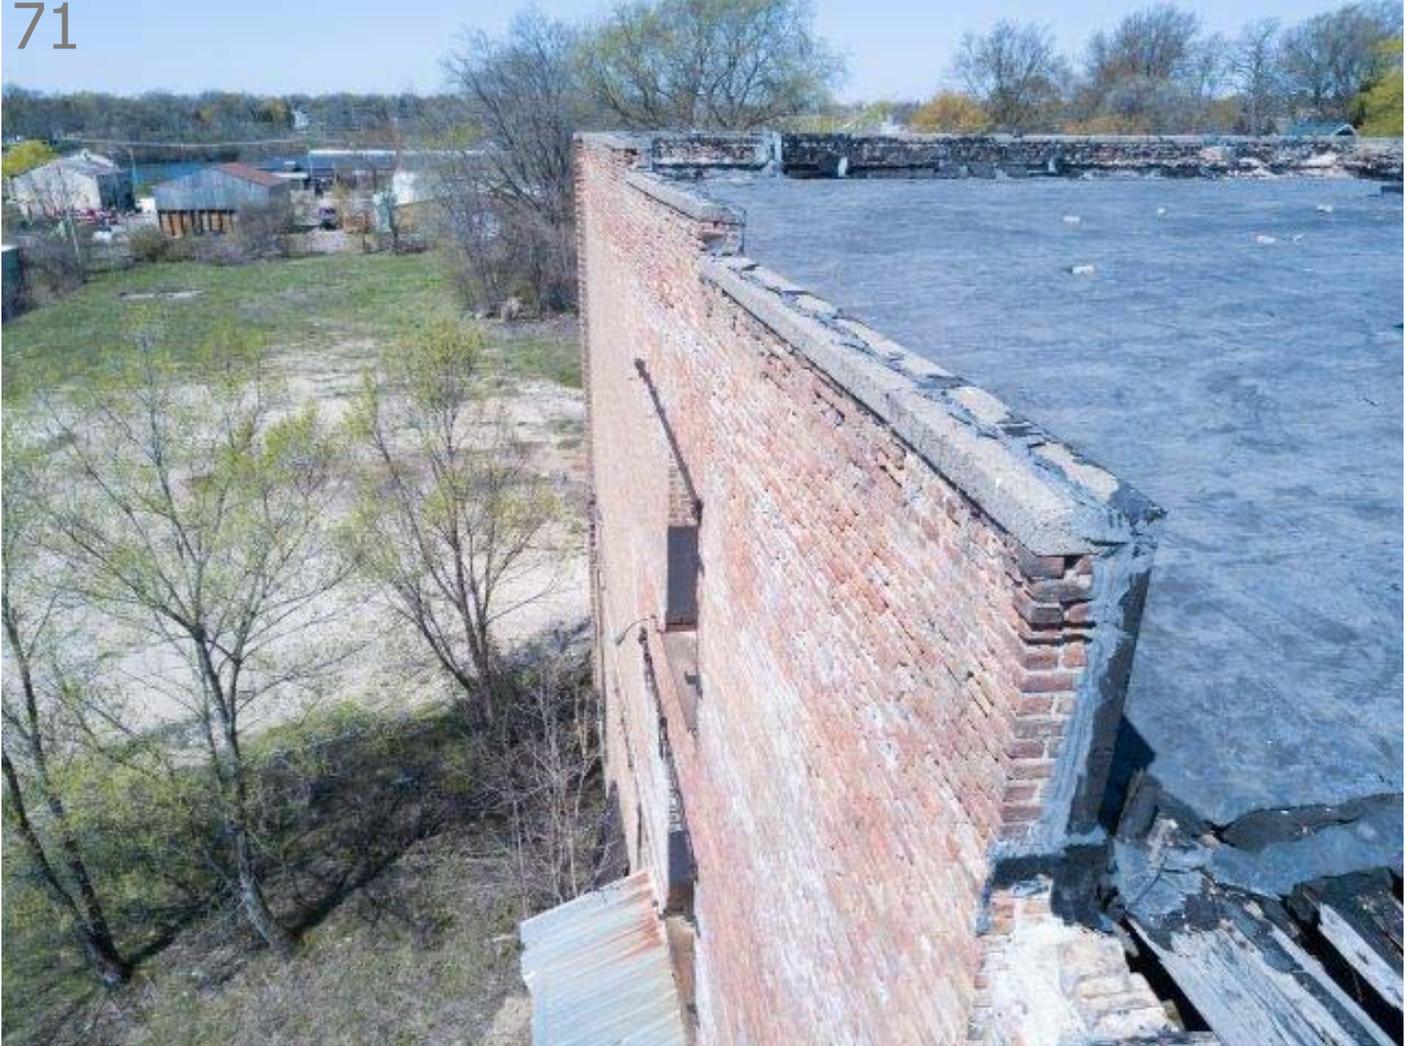
View of parapet. View of relatively stable parapet despite the exceptionally deteriorated roof deck.

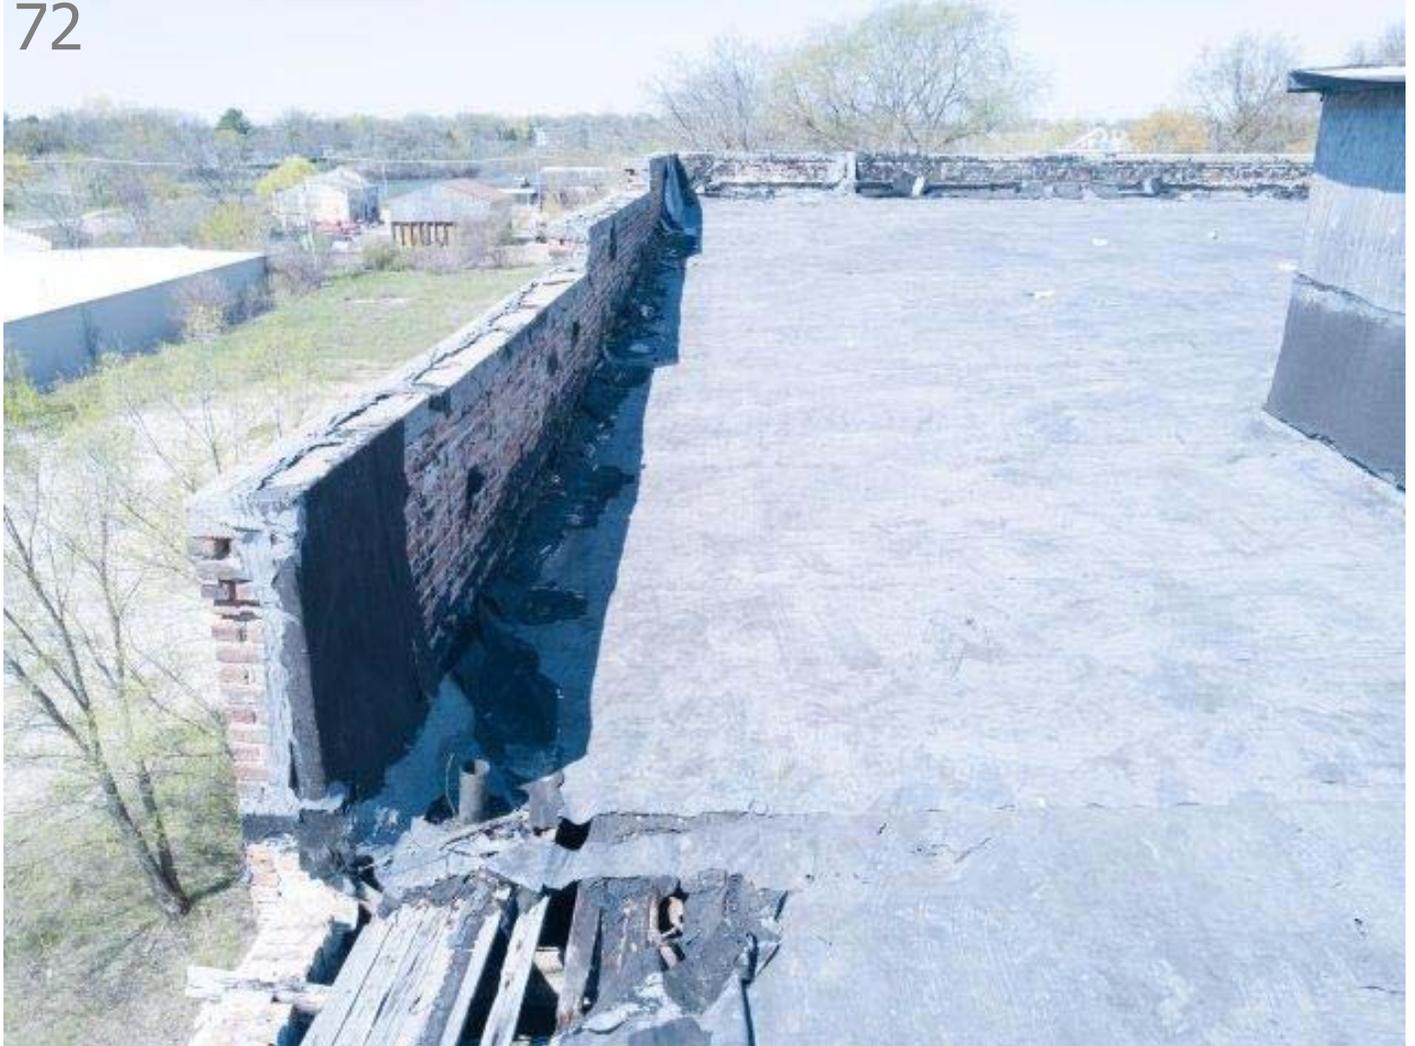
View of parapet. View of relatively stable parapet despite the exceptionally deteriorated roof deck.

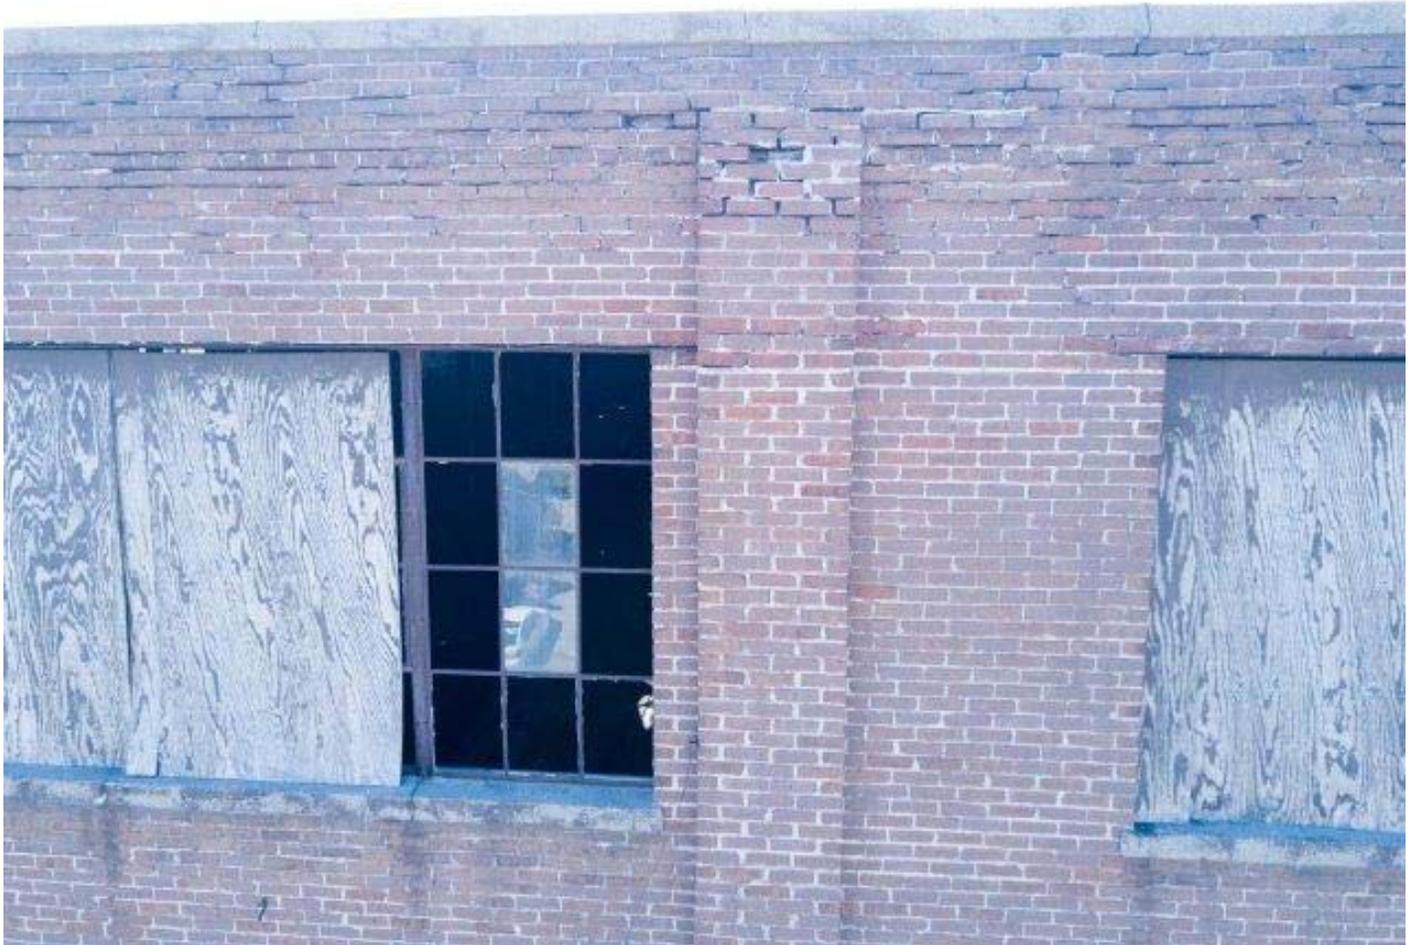
View of open mortar - a condition that is very repairable with this type of building.

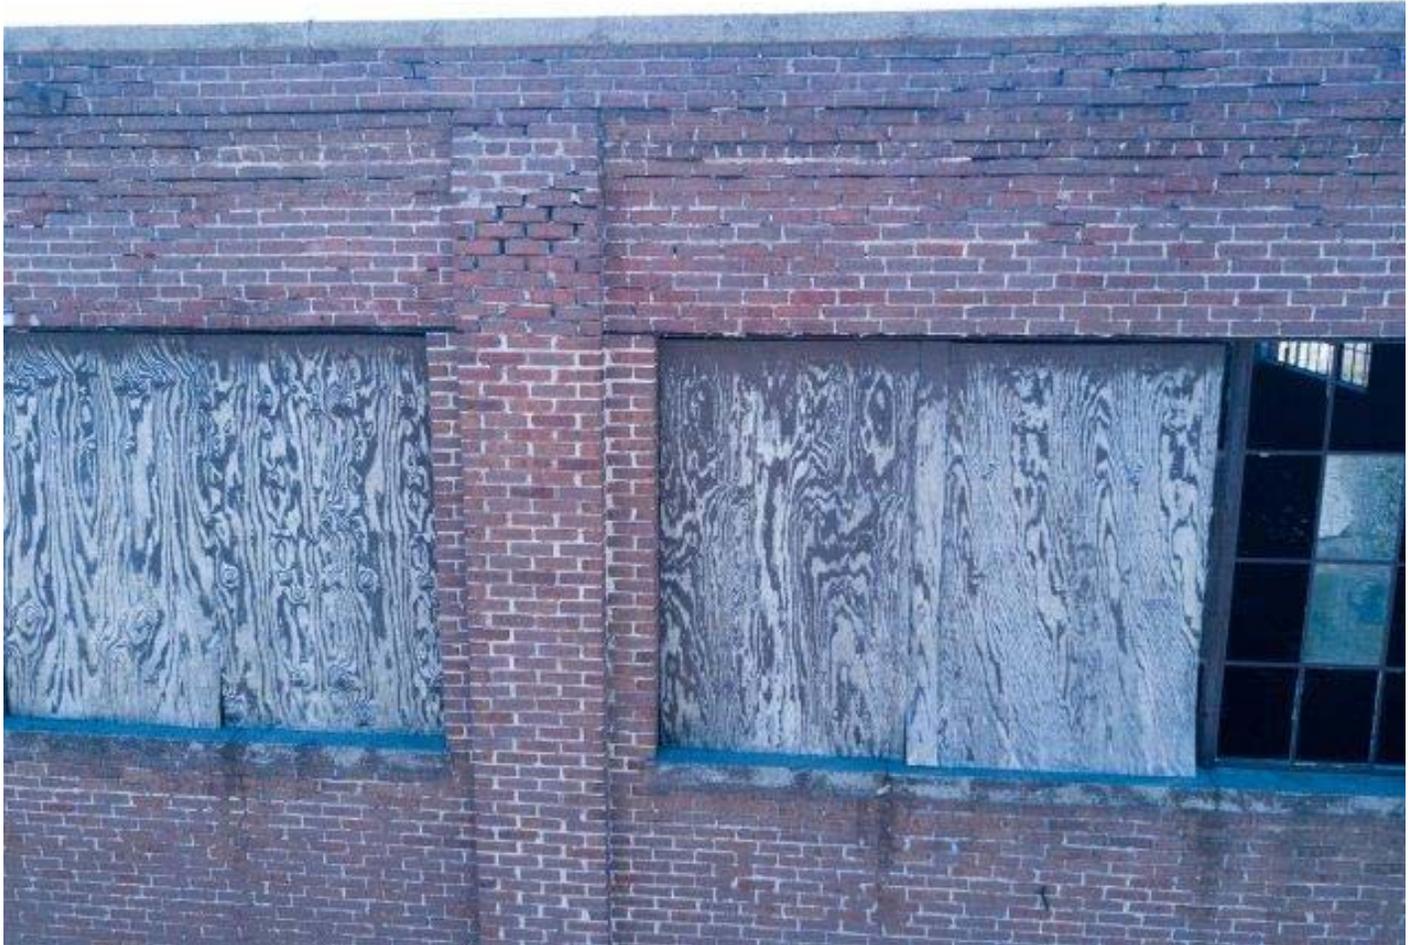
View of open mortar - a condition that is very repairable with this type of building.

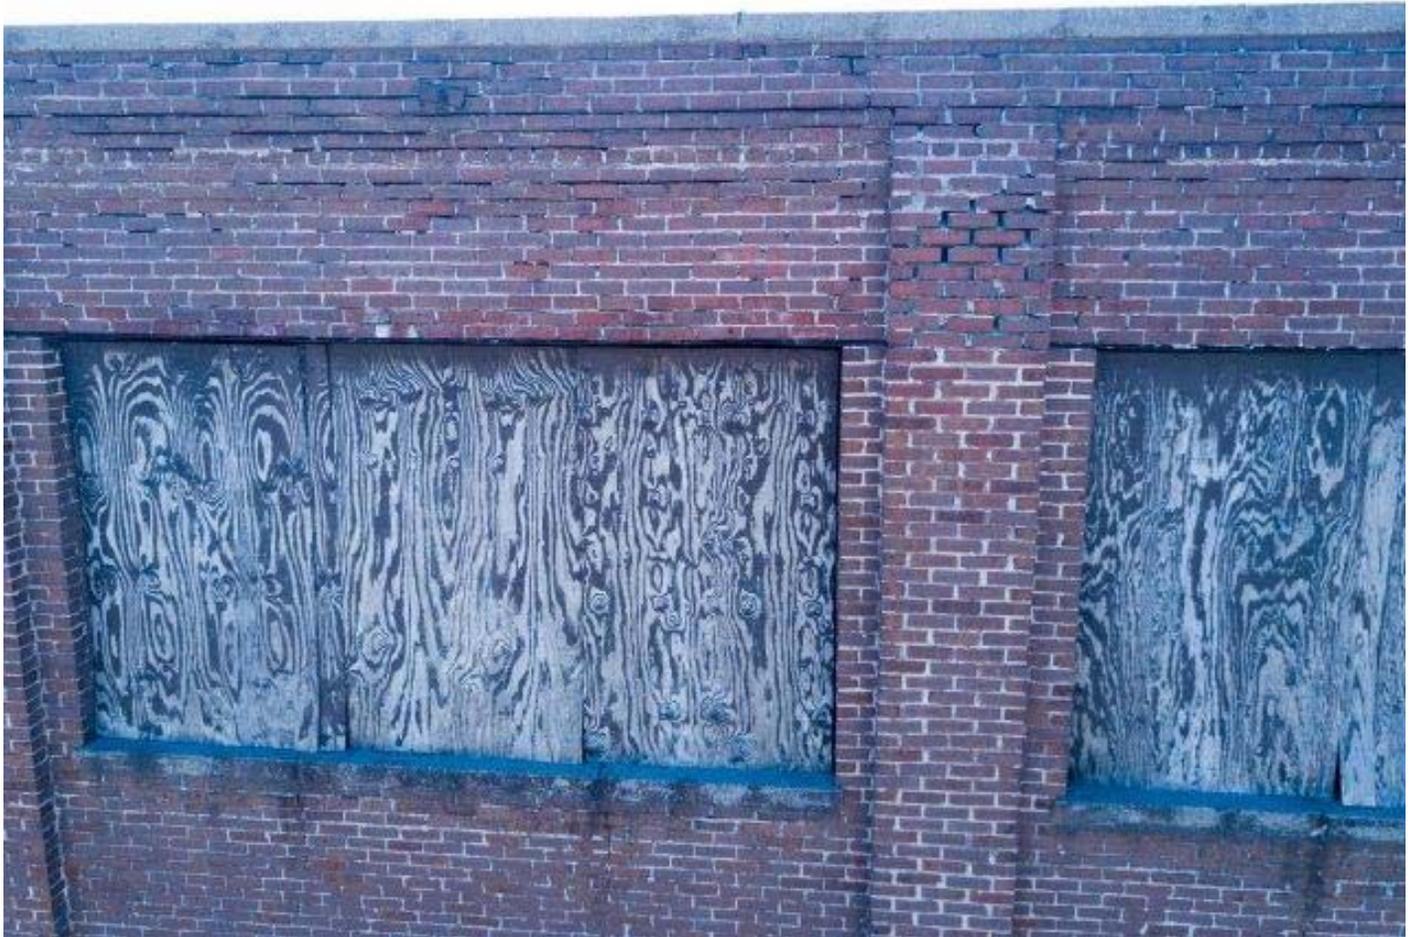
View of open mortar - a condition that is very repairable with this type of building.

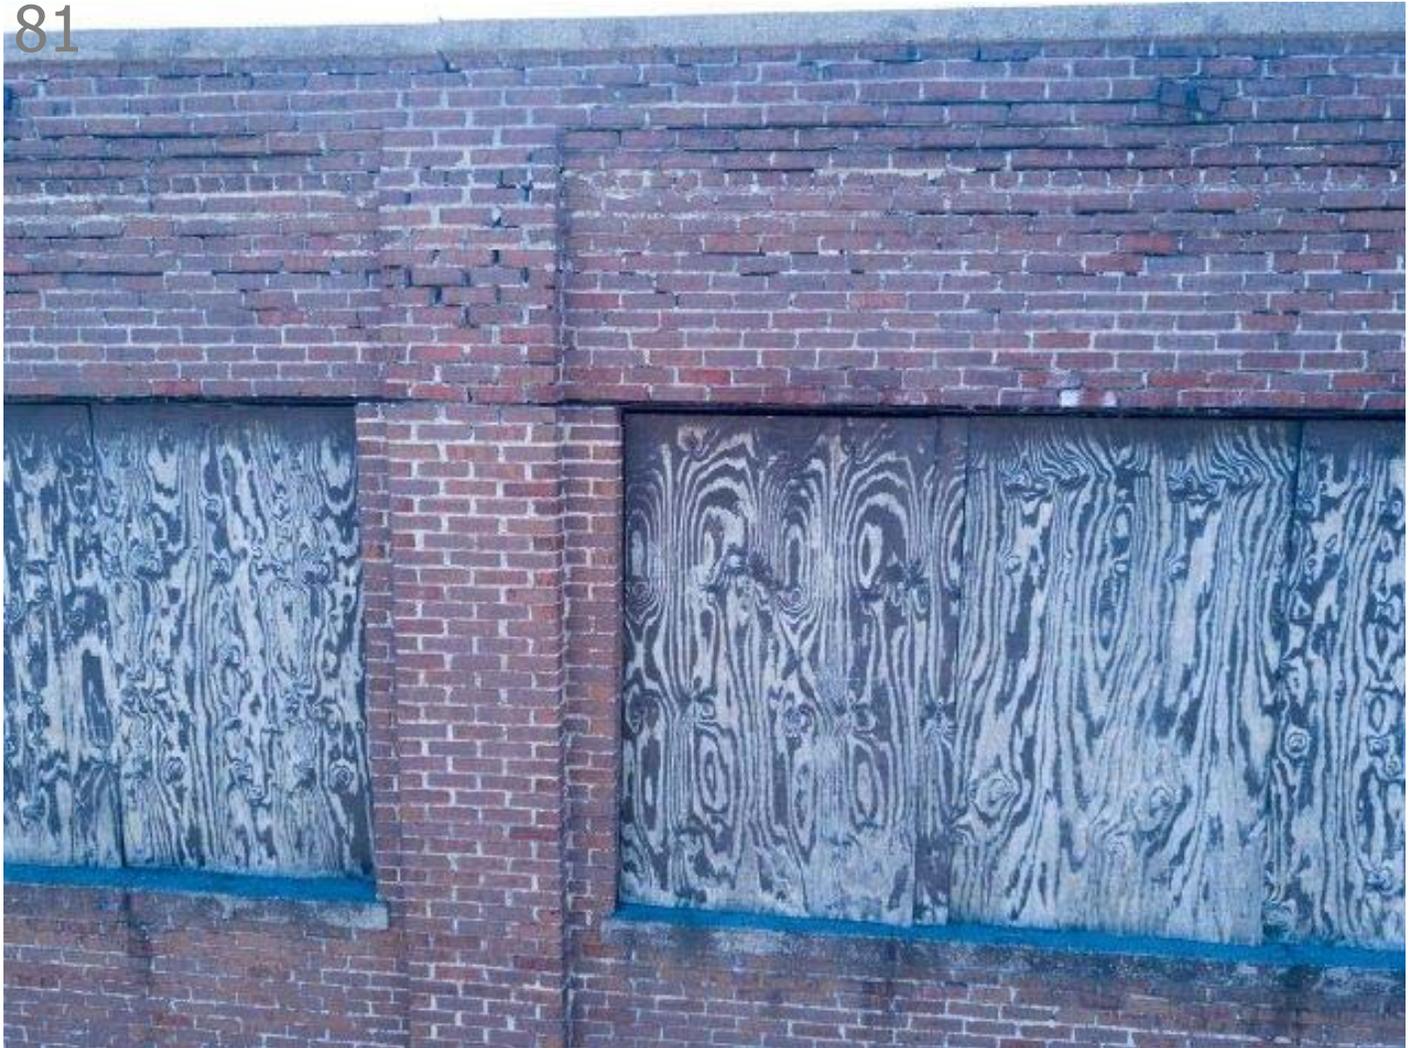
View of open mortar - a condition that is very repairable with this type of building.
