**STOUGHTON HIGHWAY TRAILER BUILDING COMPLEX
SURVEY REPORT
STOUGHTON, WISCONSIN**

July 12, 2017

The following is a summary report on our findings of onsite conditions and our recommendations for the treatment of the Highway Trailer Building Complex. We have based this report on a facility inspection conducted on May 18, 2017. This inspection was preceded by a drone survey to provide a safe close-up inspection of the exterior materials. Focus of inspection was to assess and make recommendations related to safety issues associated with potential structural collapse along E. South St., and to assess and make recommendations regarding existing structural masonry shell salvage and reuse throughout the facility. Partial and full deconstruction of connected structural systems considered for demolition is also addressed in our record of observations and opinions.

Stoughton Highway Trailer Building Complex Survey Image Report

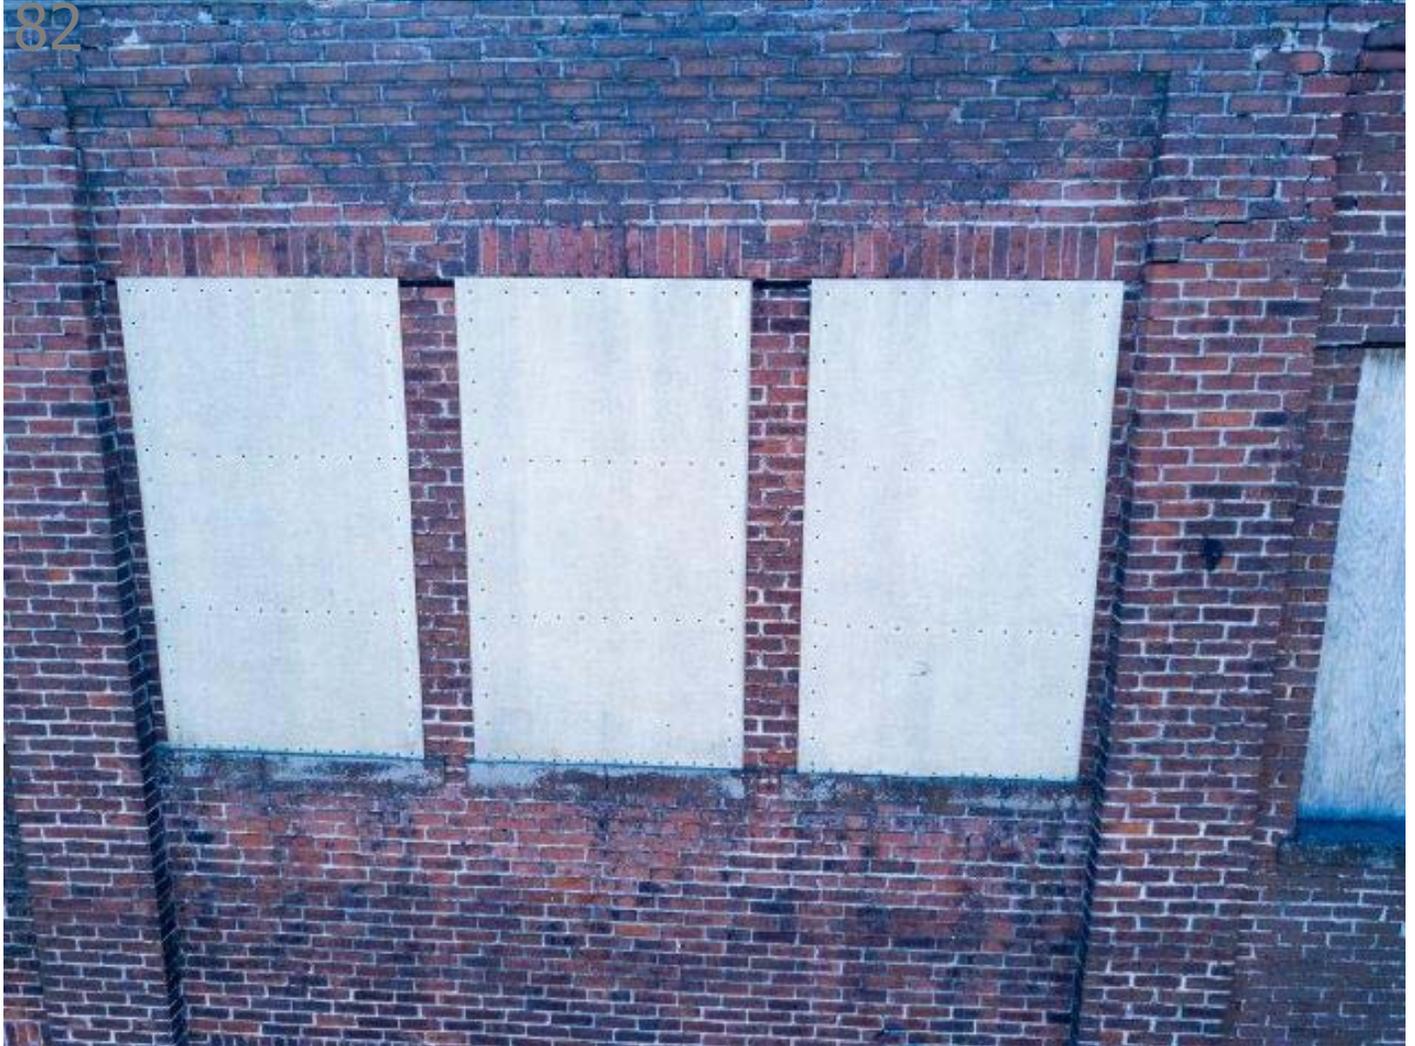
View of openings in very good condition.

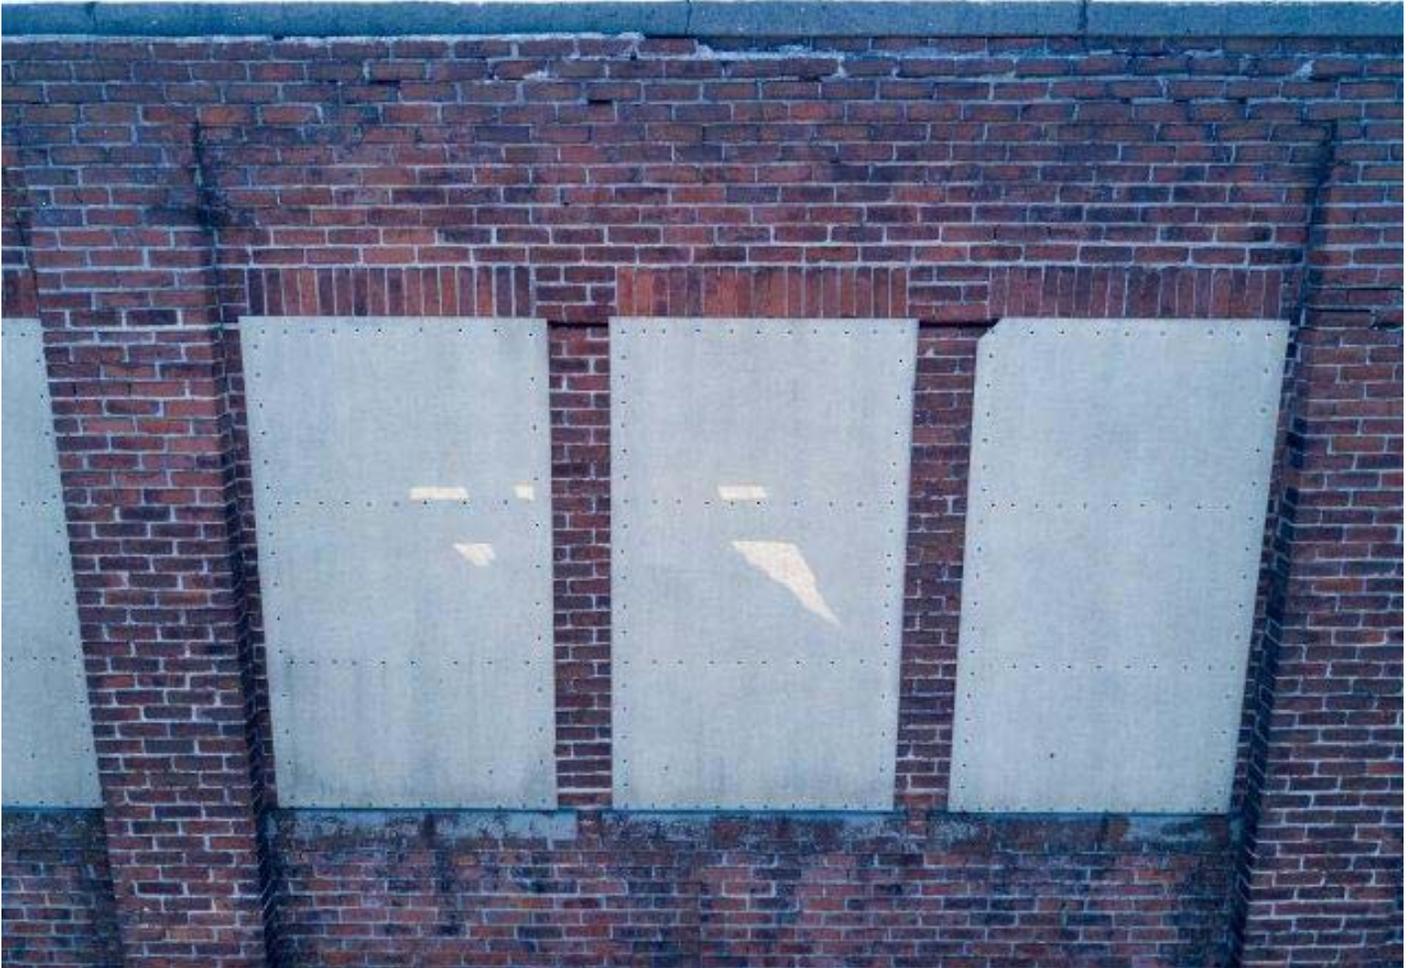
View of openings in very good condition.

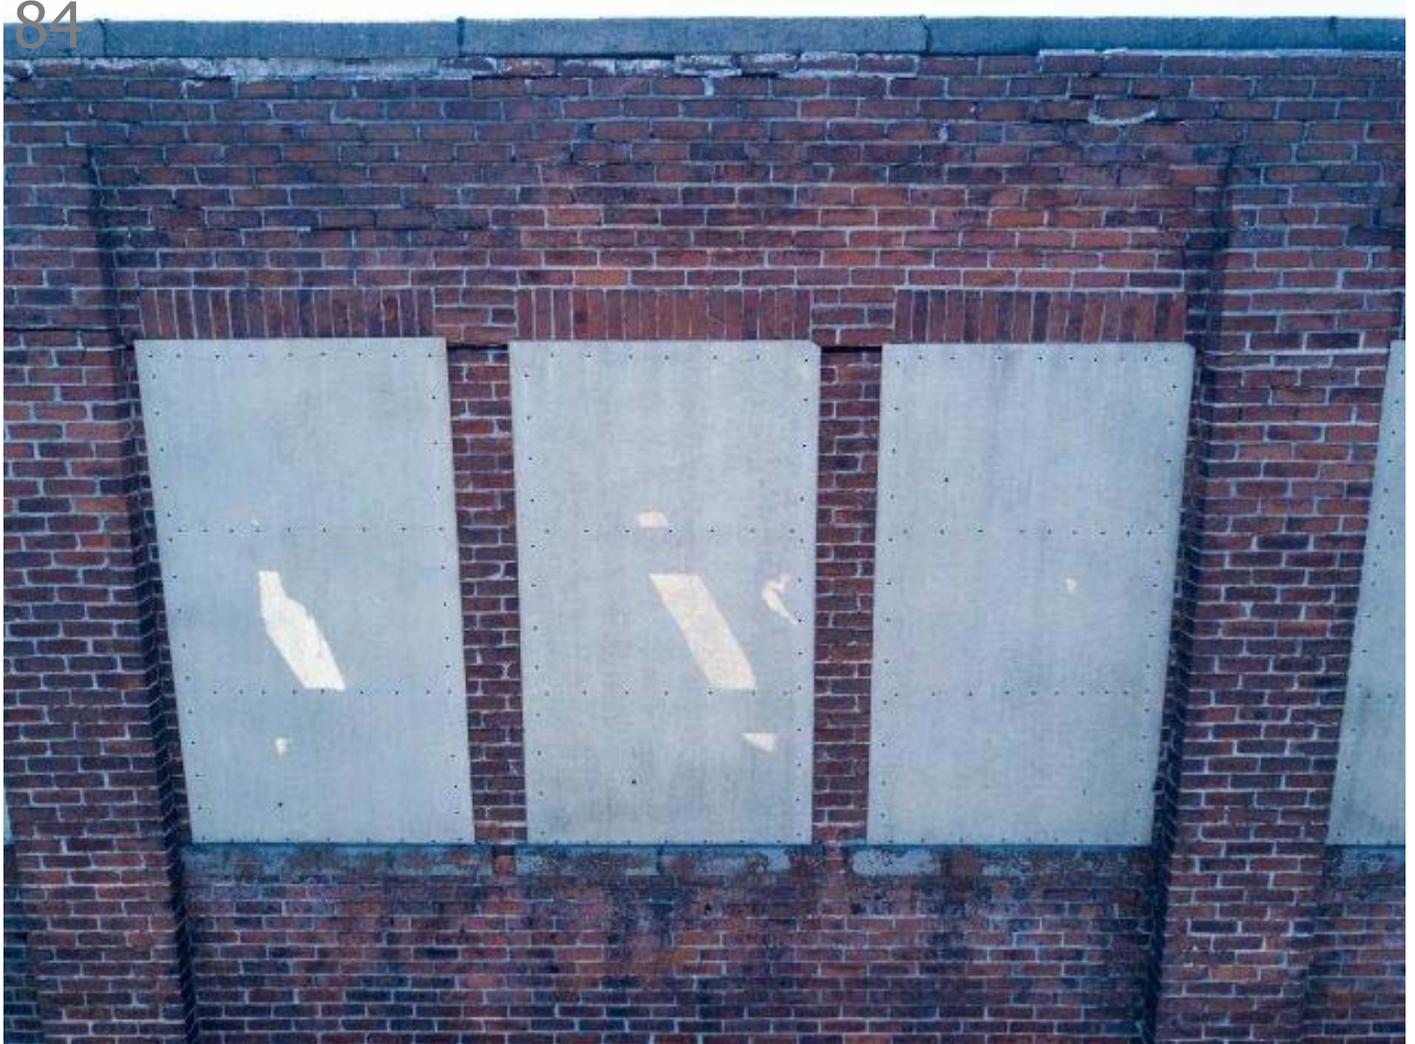
View of openings in very good condition.

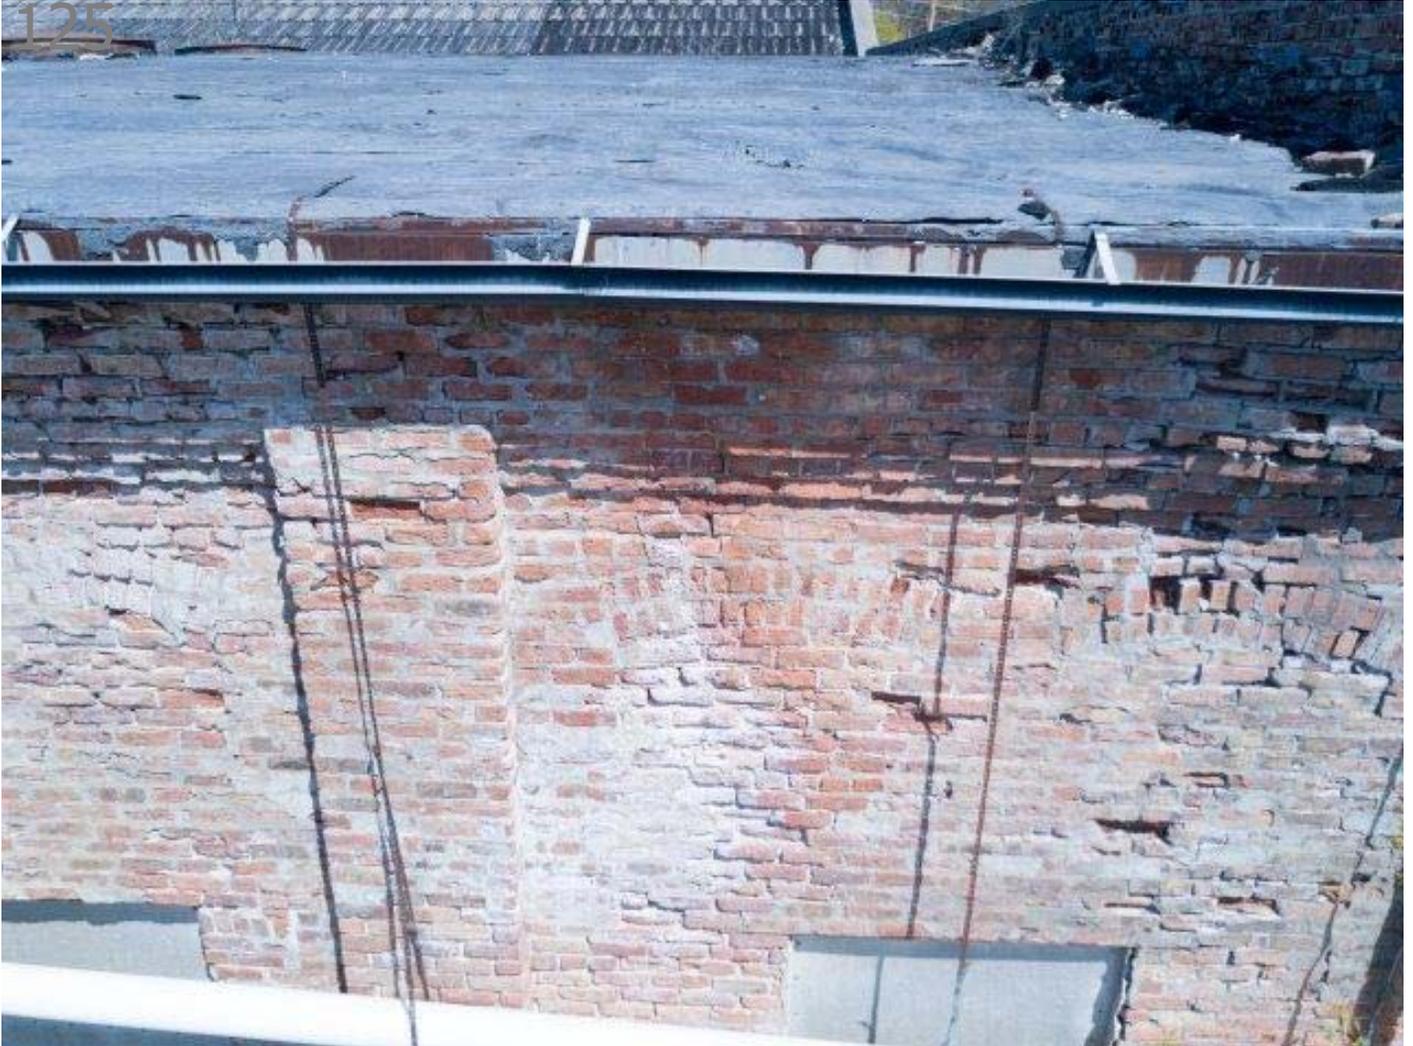
View of deterioration.

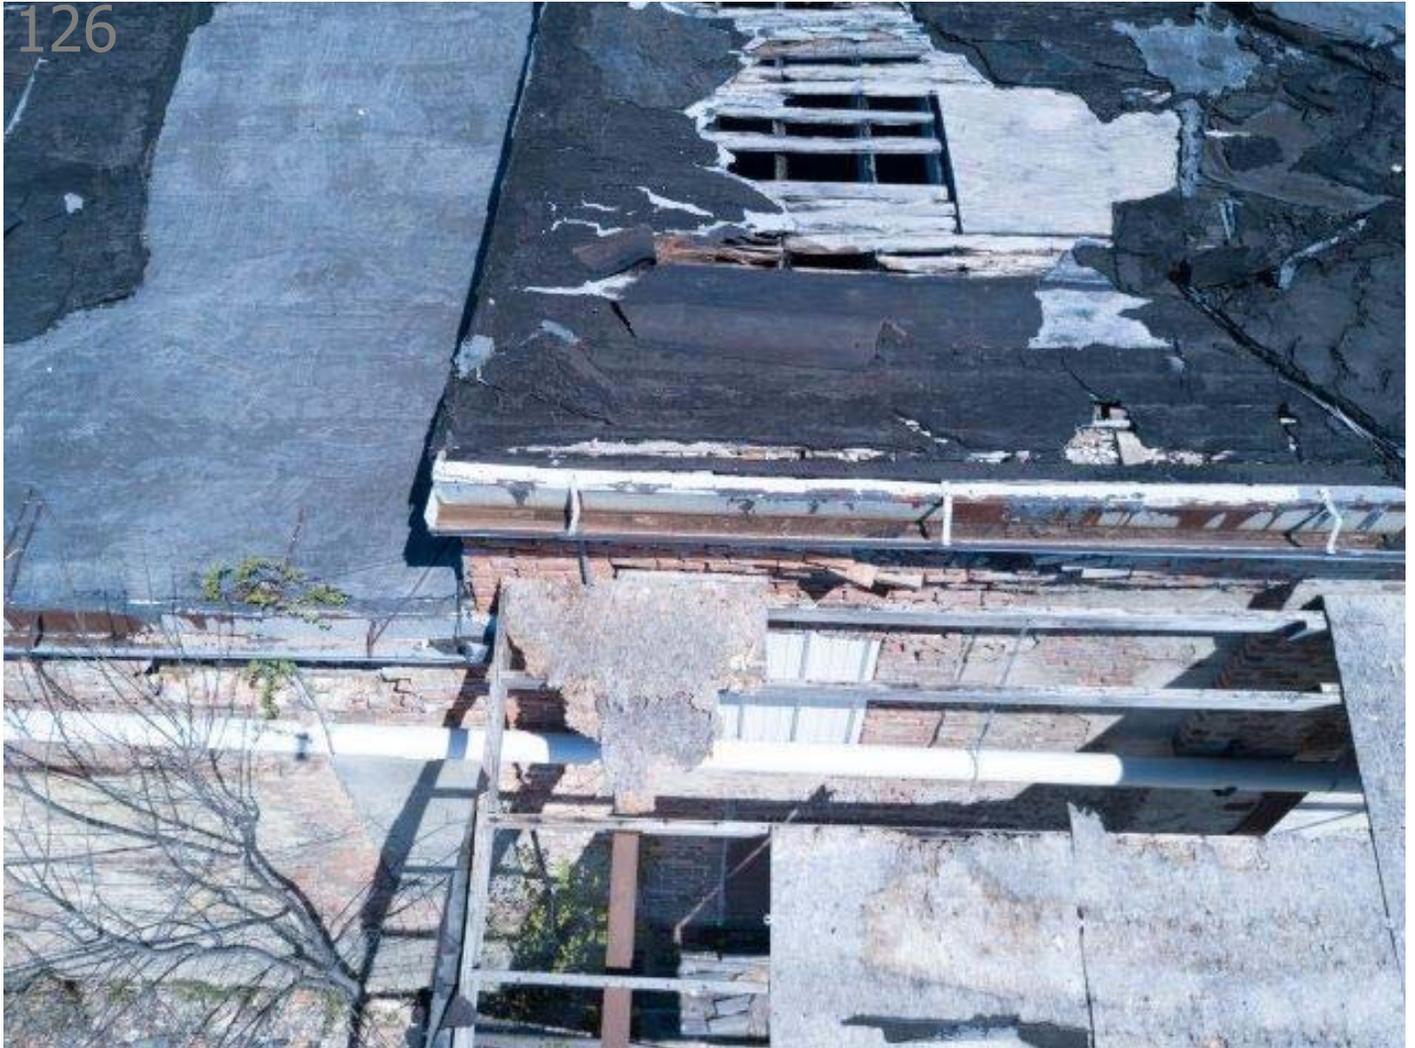
View of deterioration.

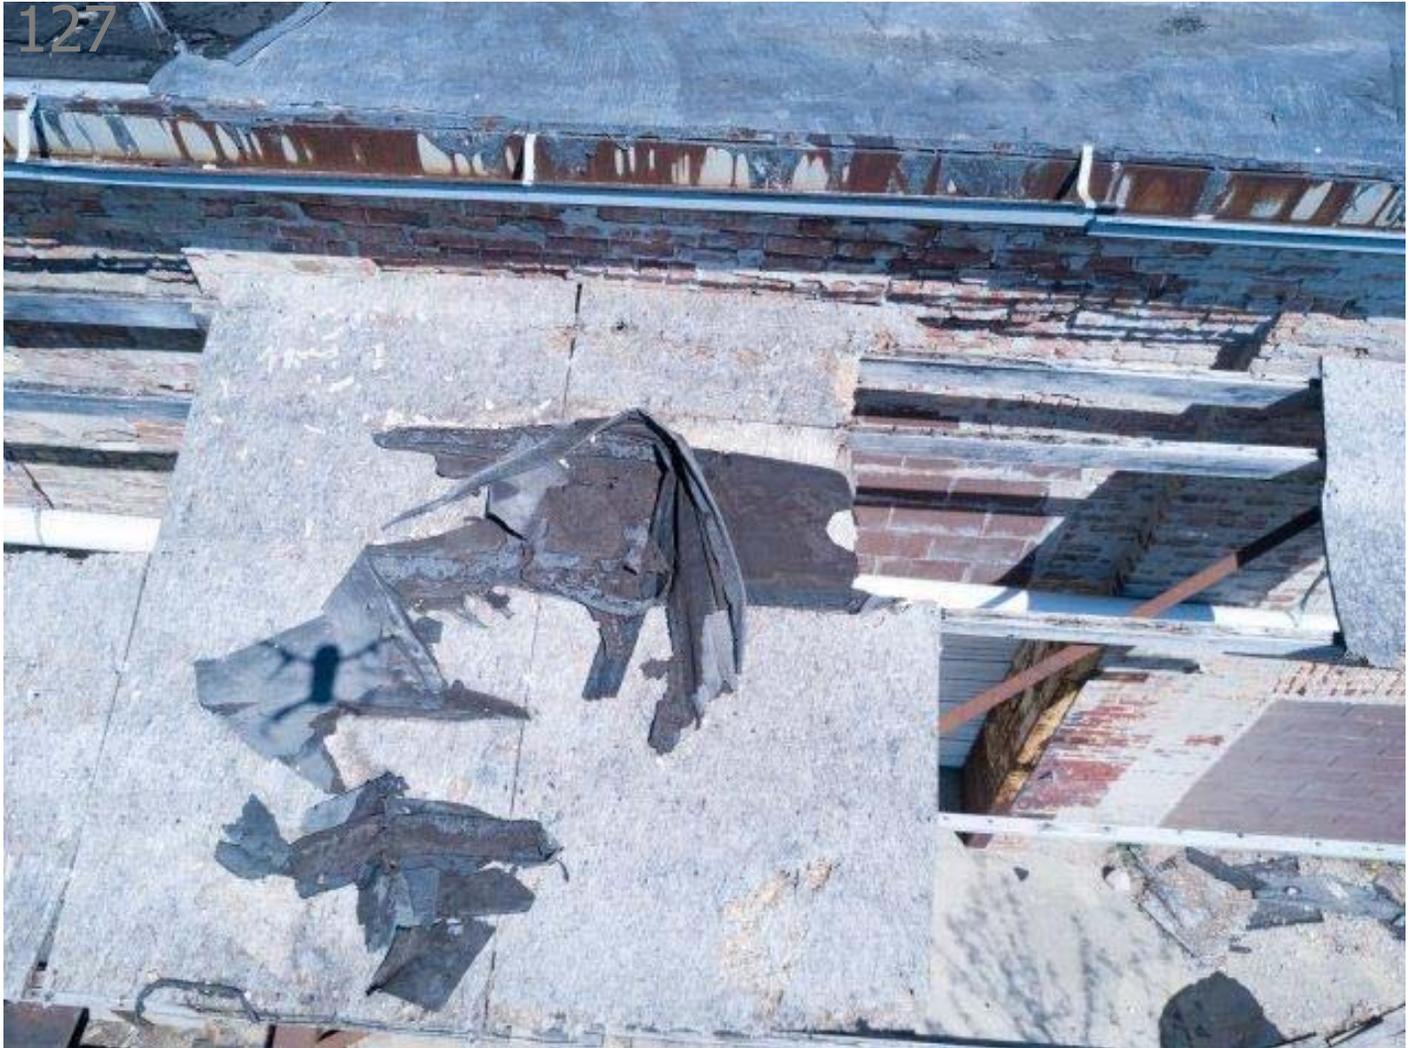
View of deterioration.

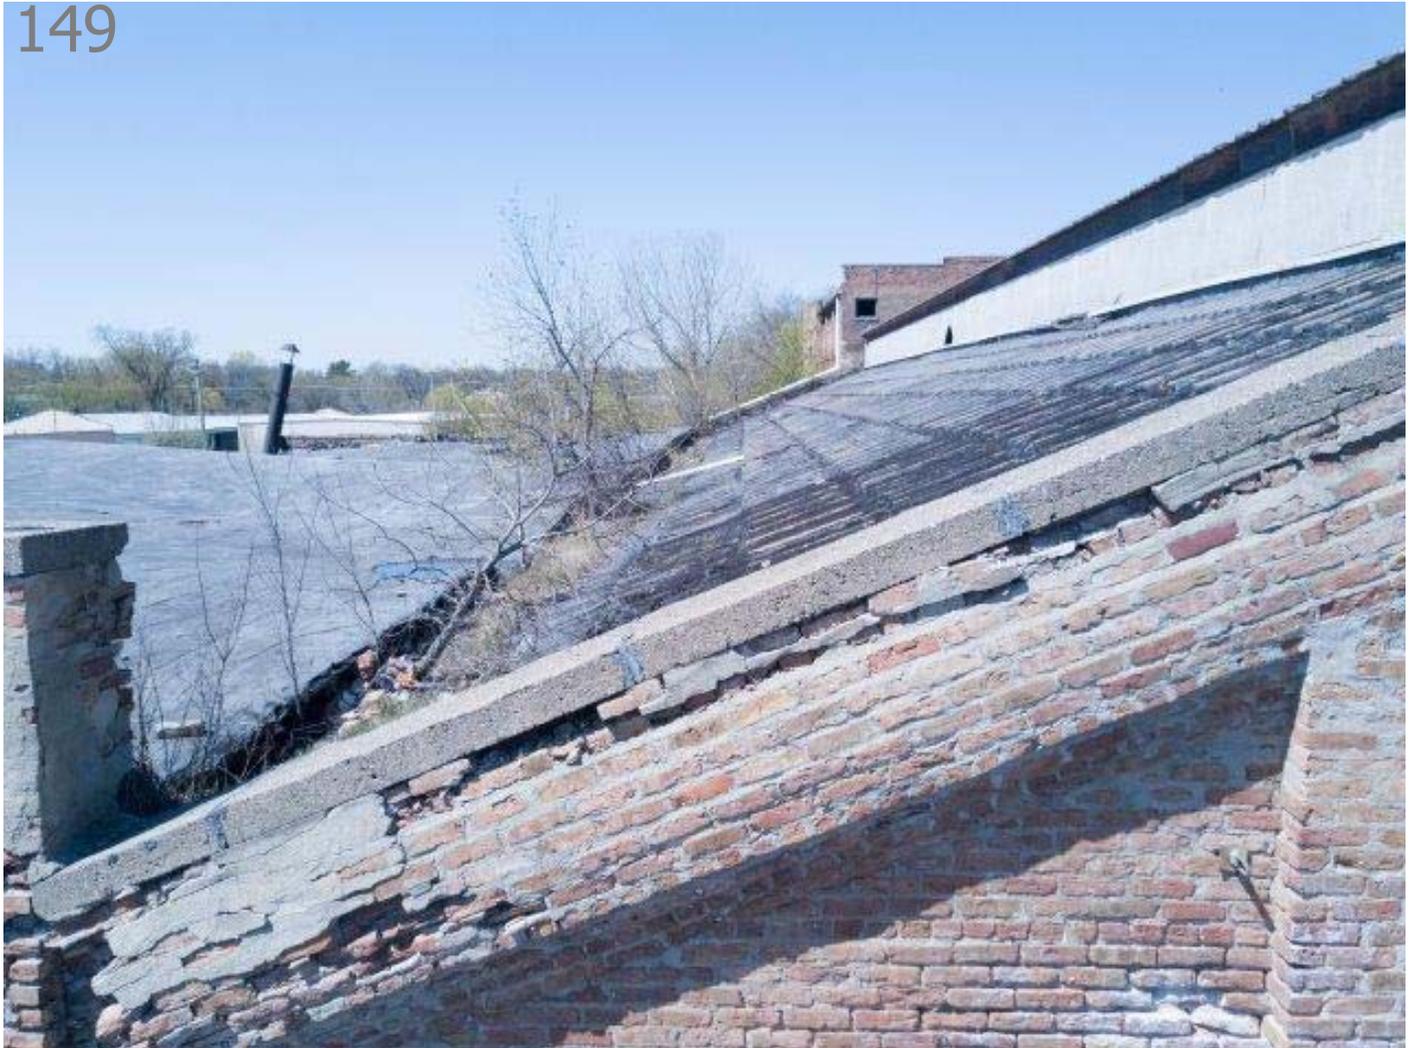
View of severe damage at South gable of Blacksmith Shop.

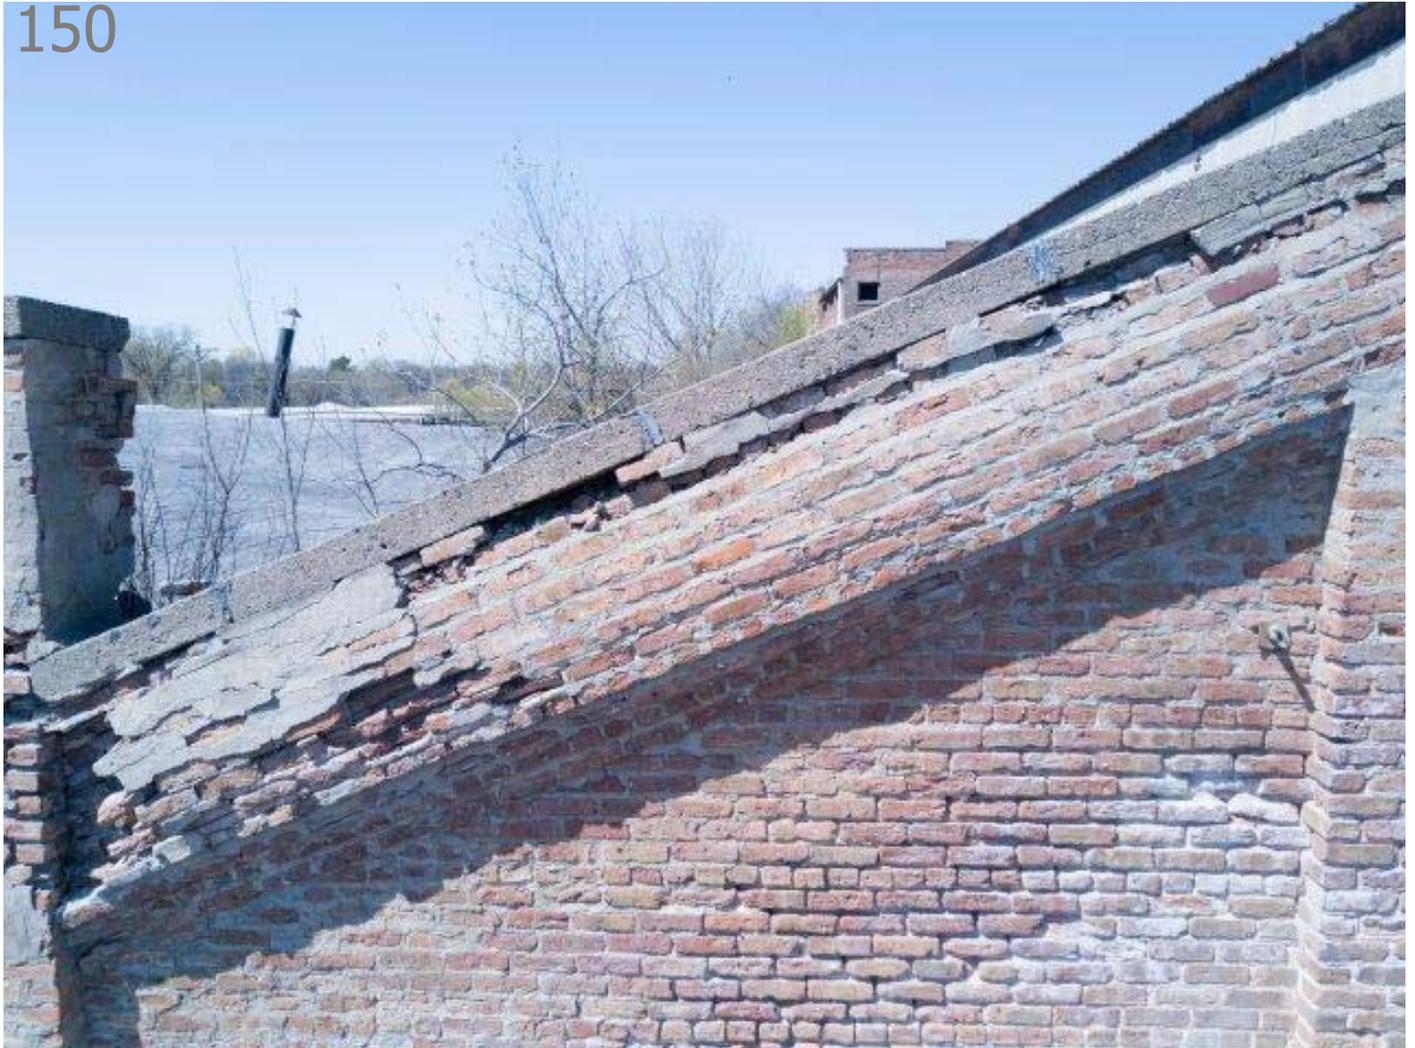
View of severe damage at South gable of Blacksmith Shop.

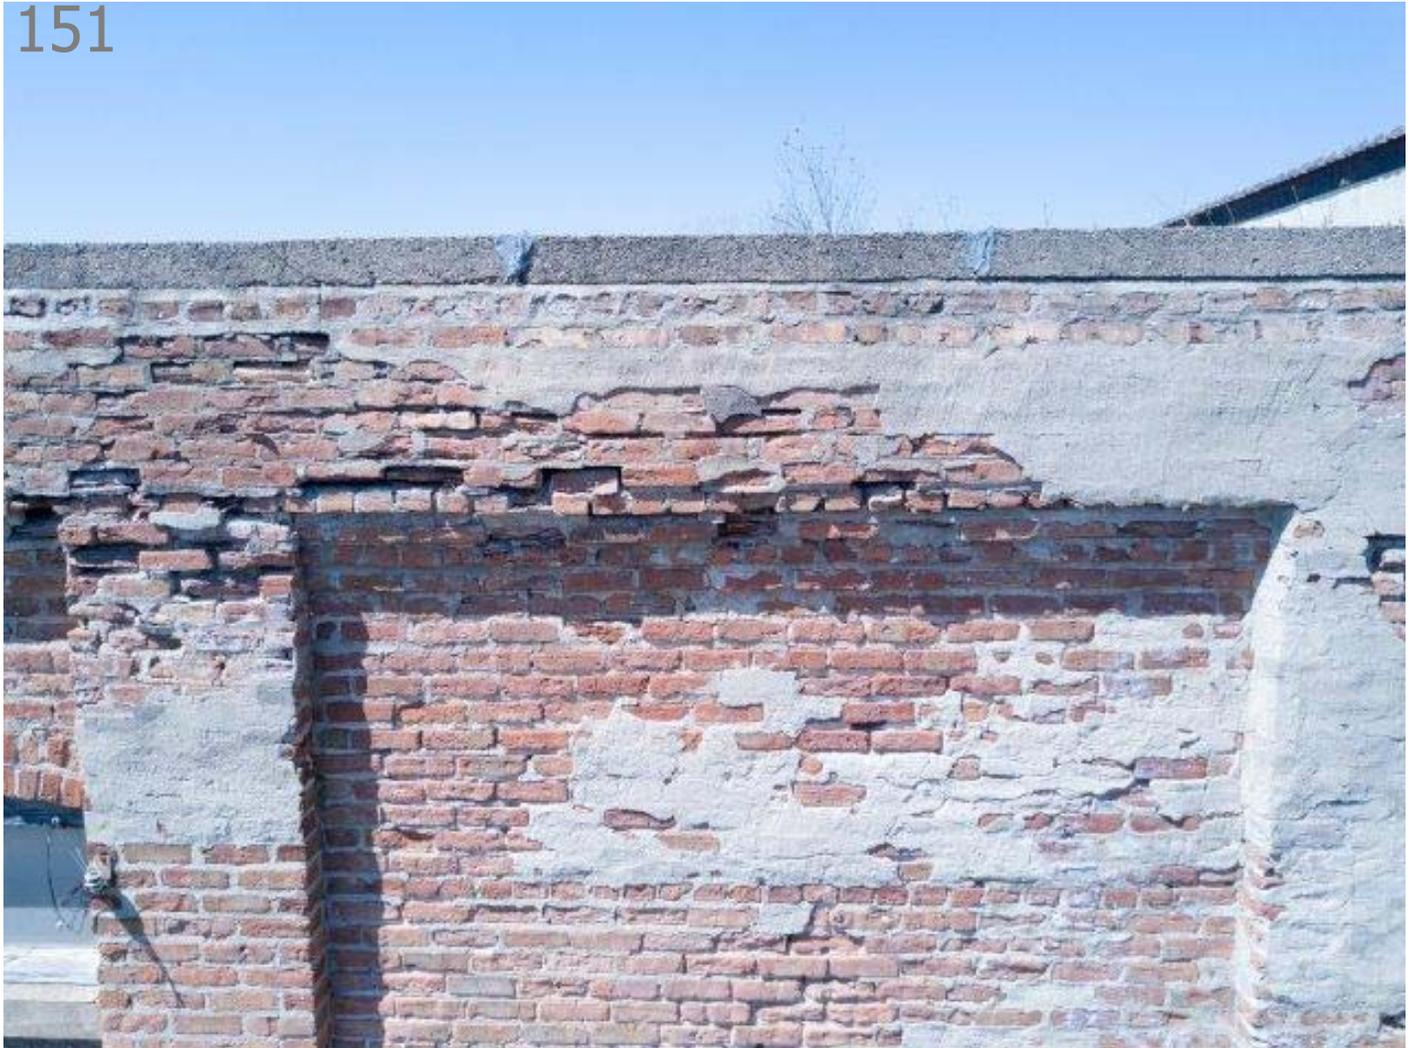
View of severe masonry deterioration.

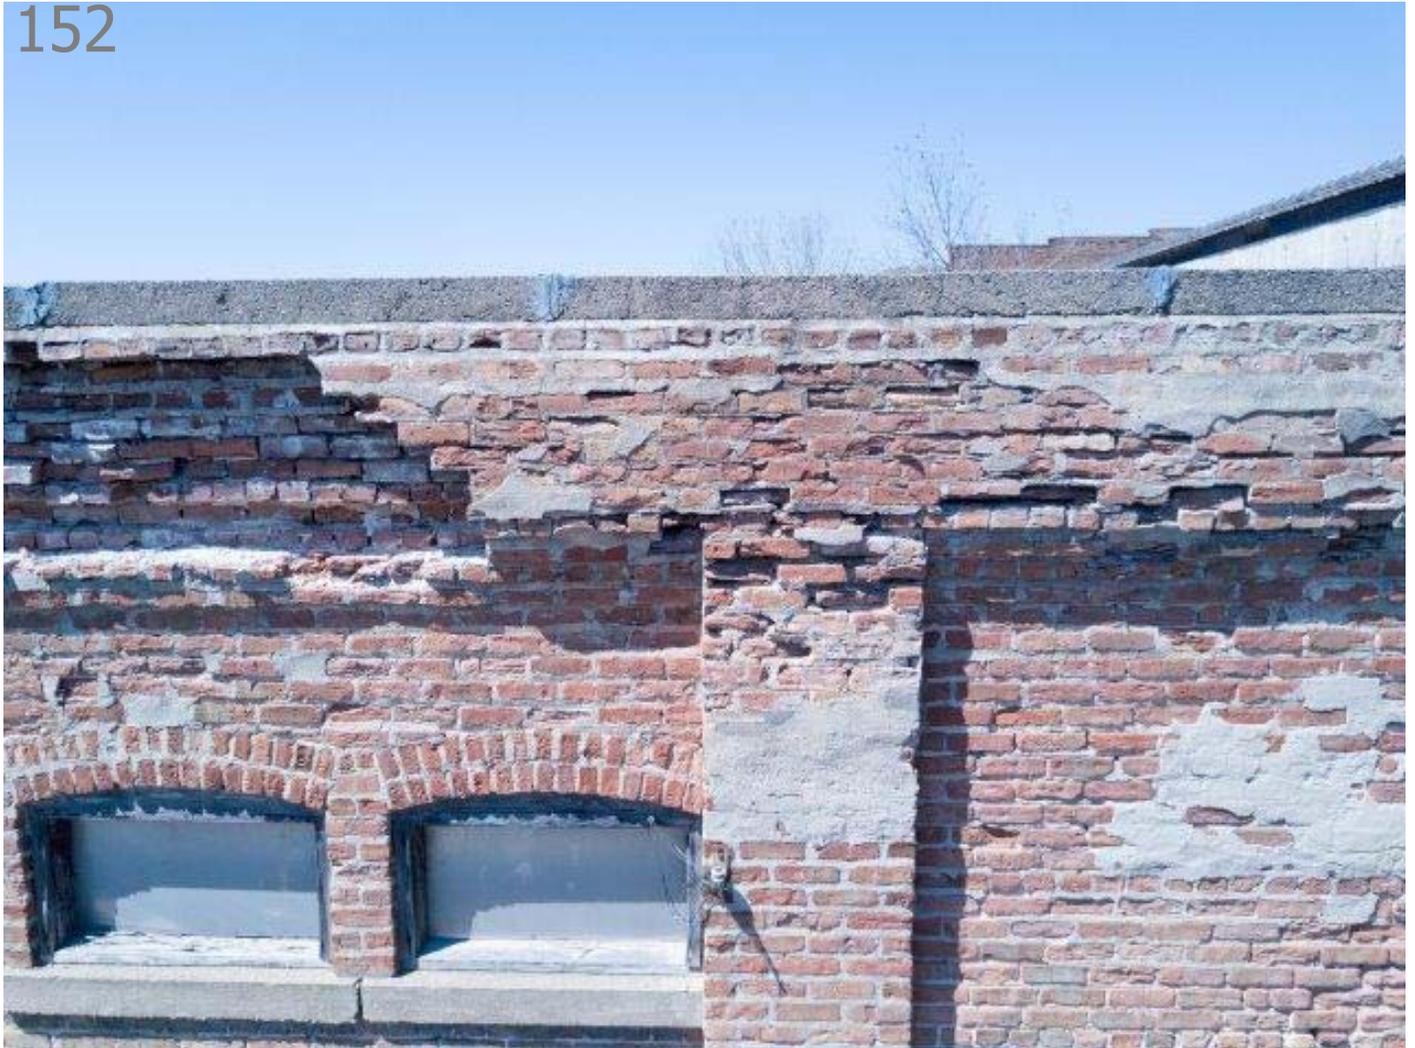
View of severe masonry deterioration.

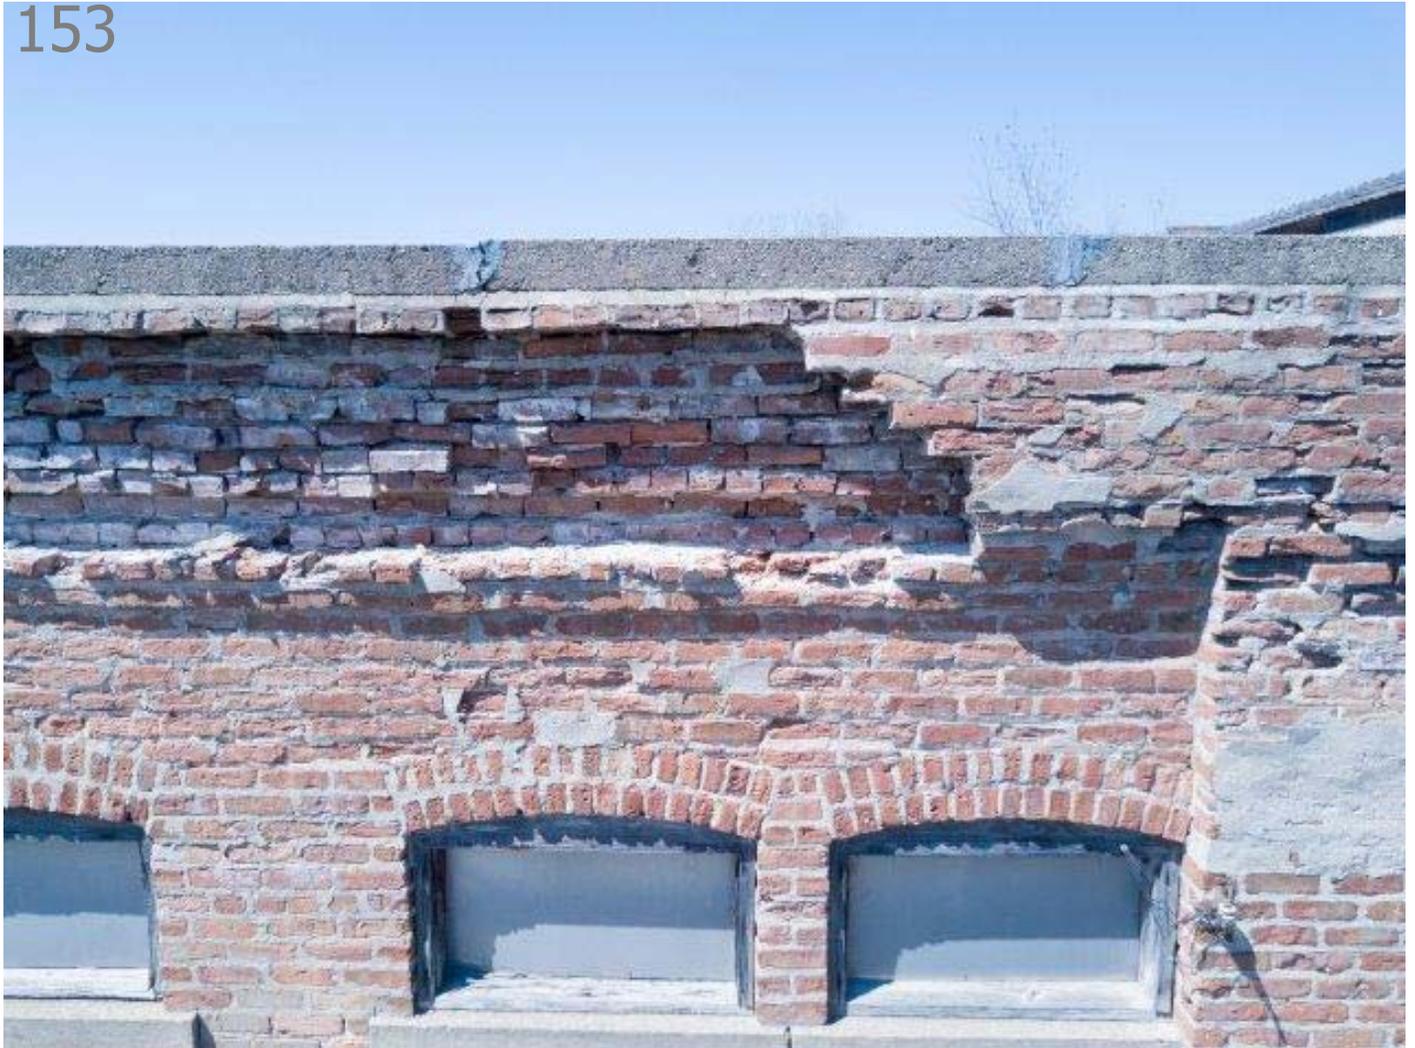
View of severe masonry deterioration.

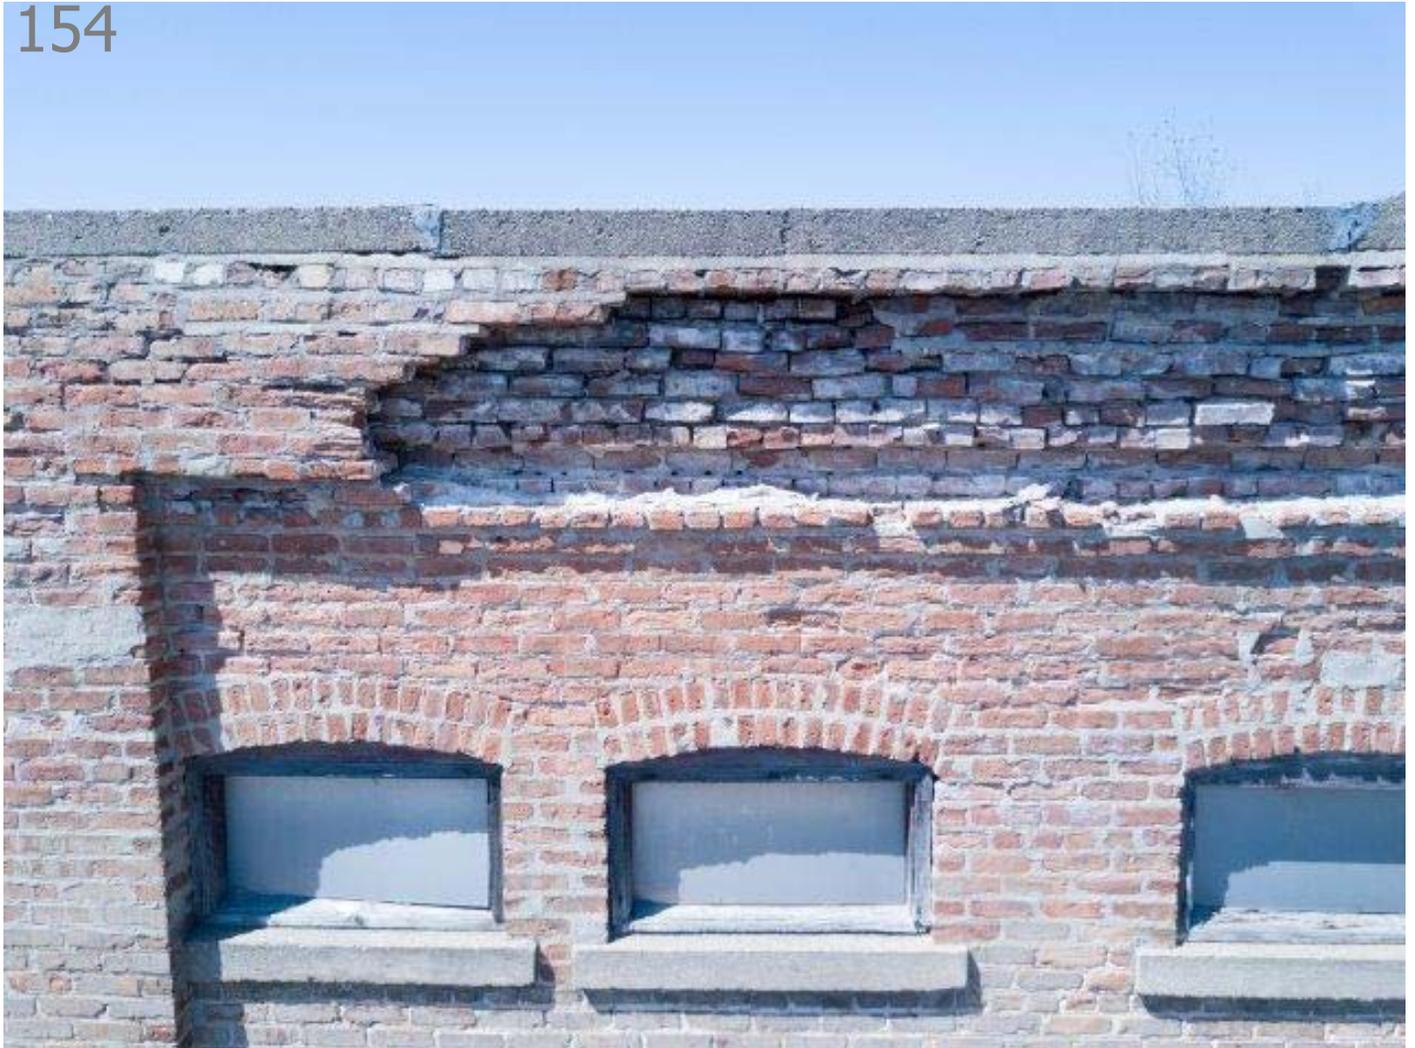
View of severe masonry deterioration.

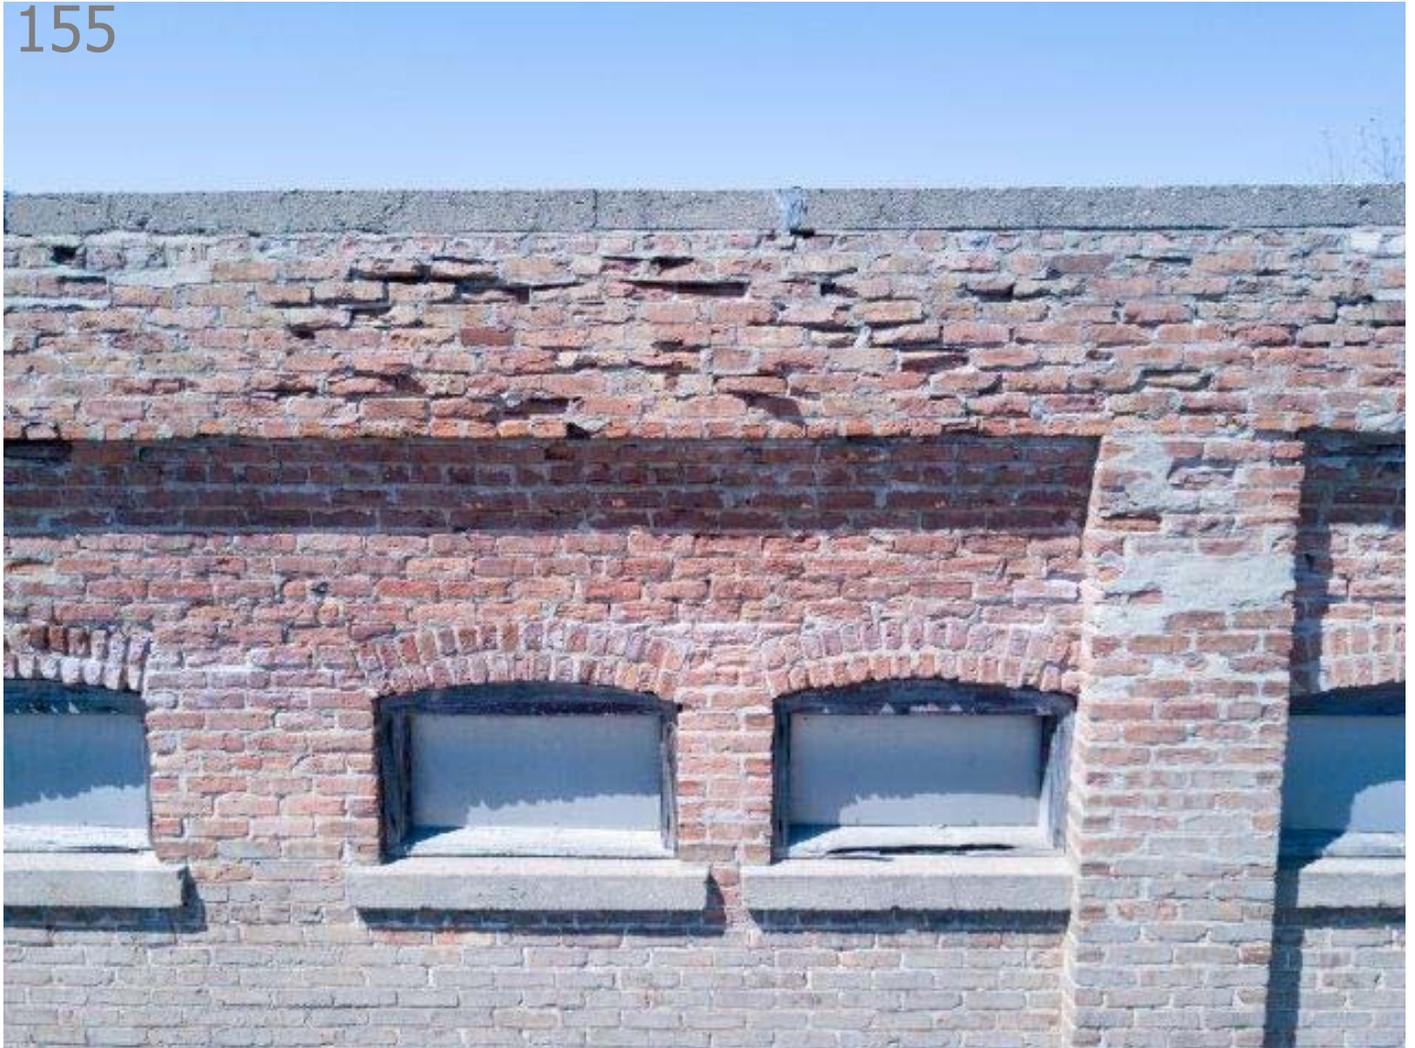
View of severe masonry deterioration.

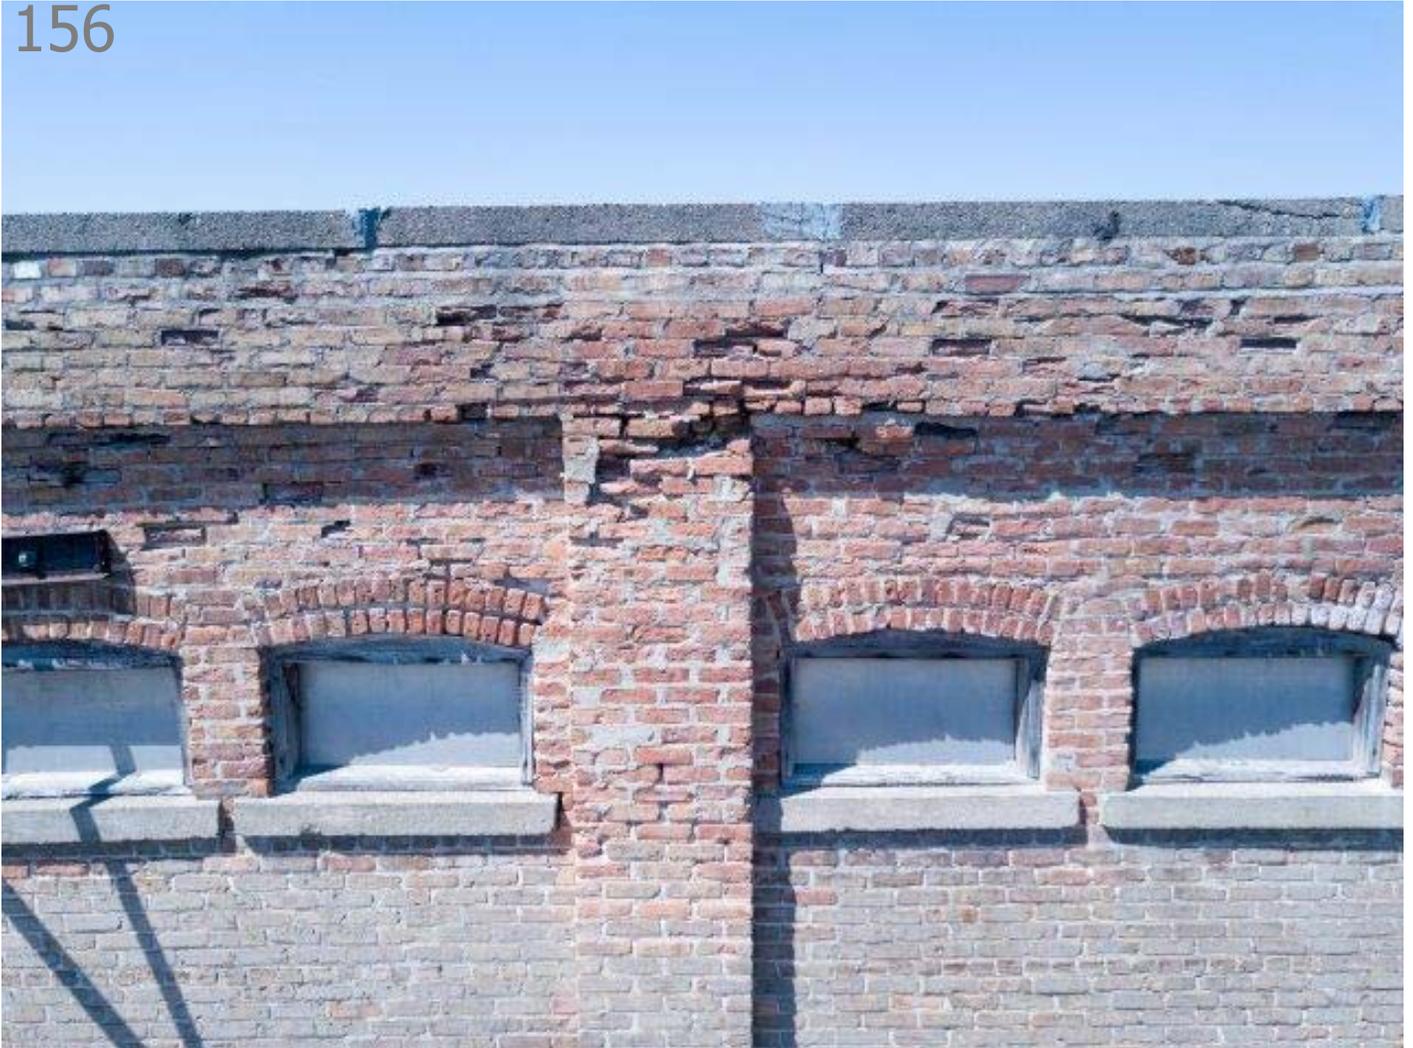
View of severe masonry deterioration.

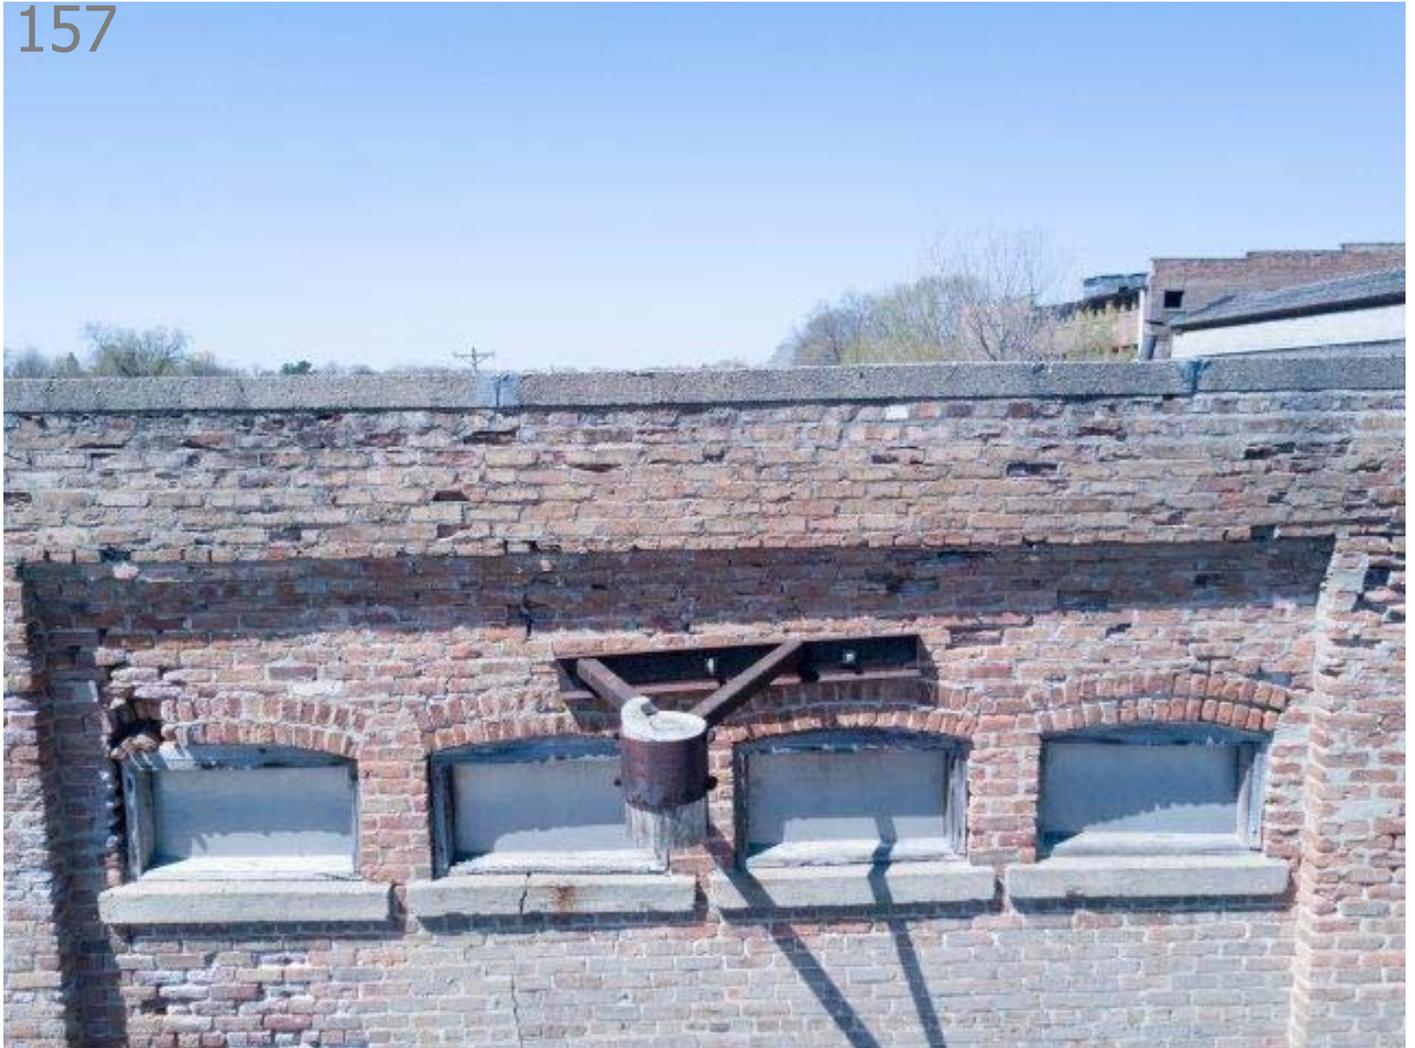
View of severe masonry deterioration.
