**STOUGHTON HIGHWAY TRAILER BUILDING COMPLEX
SURVEY REPORT
STOUGHTON, WISCONSIN**

July 12, 2017

The following is a summary report on our findings of onsite conditions and our recommendations for the treatment of the Highway Trailer Building Complex. We have based this report on a facility inspection conducted on May 18, 2017. This inspection was preceded by a drone survey to provide a safe close-up inspection of the exterior materials. Focus of inspection was to assess and make recommendations related to safety issues associated with potential structural collapse along E. South St., and to assess and make recommendations regarding existing structural masonry shell salvage and reuse throughout the facility. Partial and full deconstruction of connected structural systems considered for demolition is also addressed in our record of observations and opinions.

Stoughton Highway Trailer Building Complex Survey Image Report

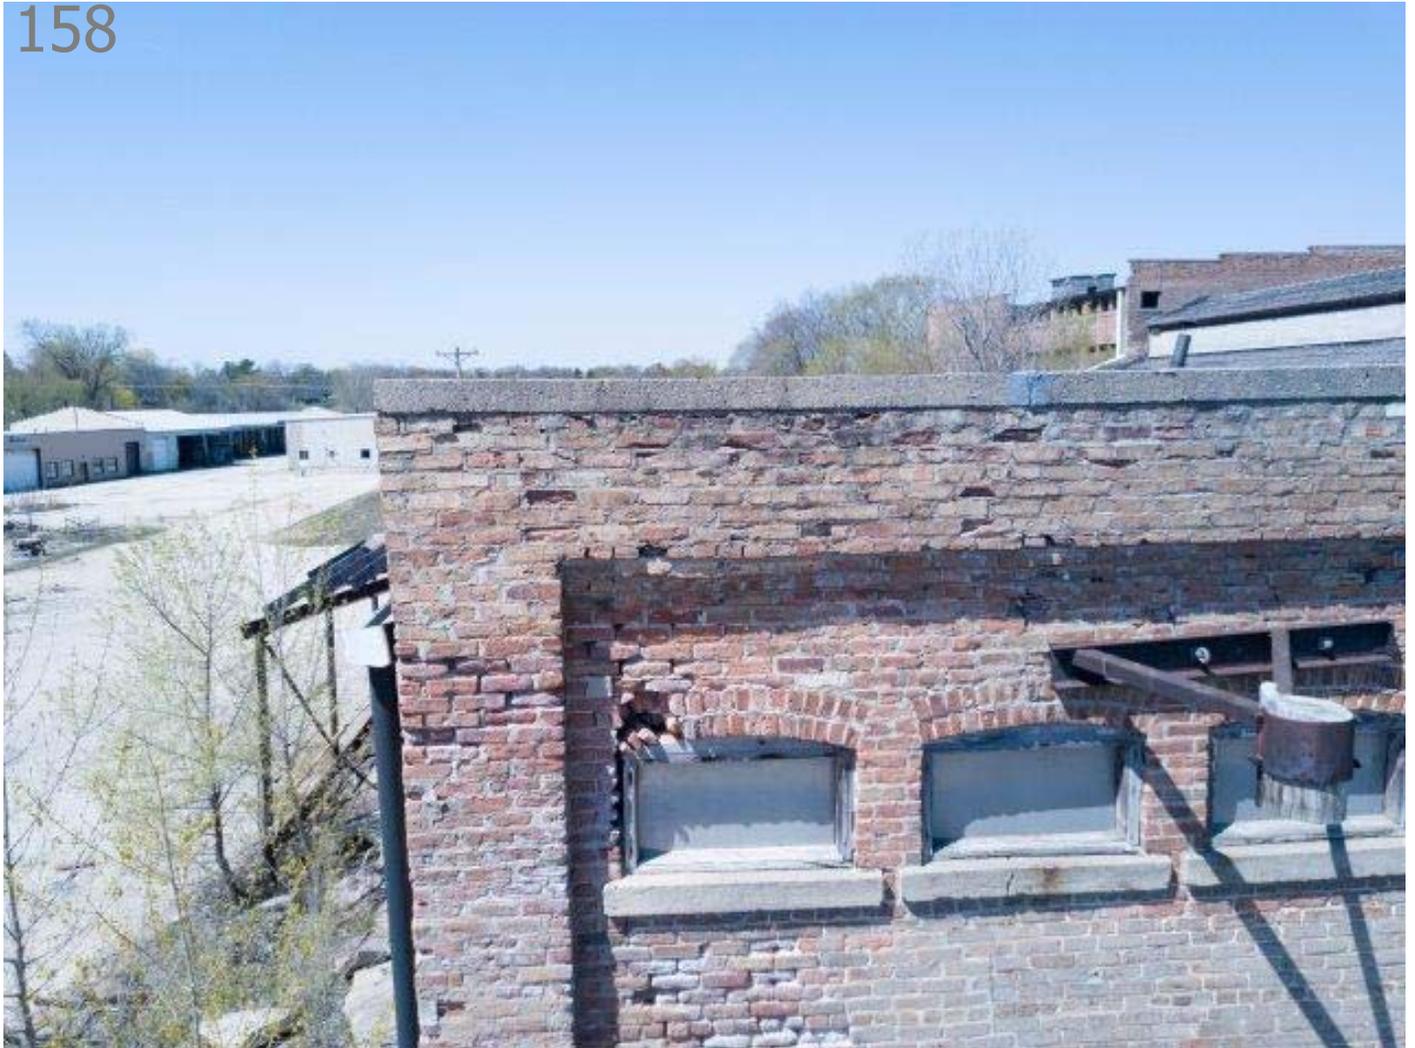
View of severe masonry deterioration.
