**STOUGHTON HIGHWAY TRAILER BUILDING COMPLEX
SURVEY REPORT
STOUGHTON, WISCONSIN**

July 12, 2017

The following is a summary report on our findings of onsite conditions and our recommendations for the treatment of the Highway Trailer Building Complex. We have based this report on a facility inspection conducted on May 18, 2017. This inspection was preceded by a drone survey to provide a safe close-up inspection of the exterior materials. Focus of inspection was to assess and make recommendations related to safety issues associated with potential structural collapse along E. South St., and to assess and make recommendations regarding existing structural masonry shell salvage and reuse throughout the facility. Partial and full deconstruction of connected structural systems considered for demolition is also addressed in our record of observations and opinions.

Stoughton Highway Trailer Building Complex Survey Image Report

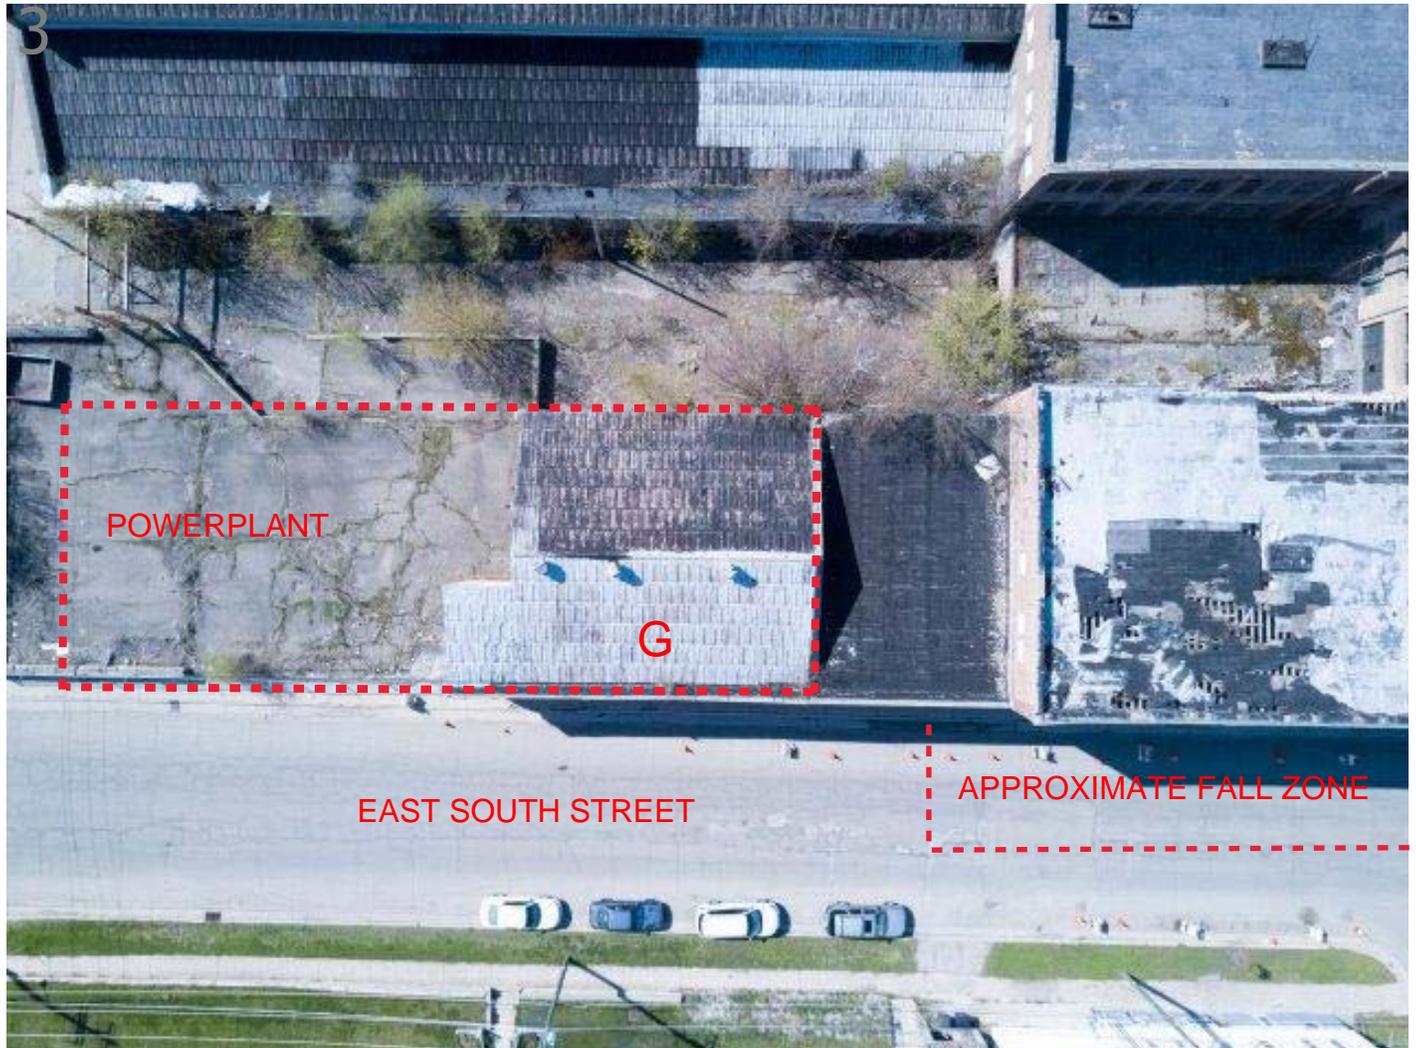
View of original Power Plant

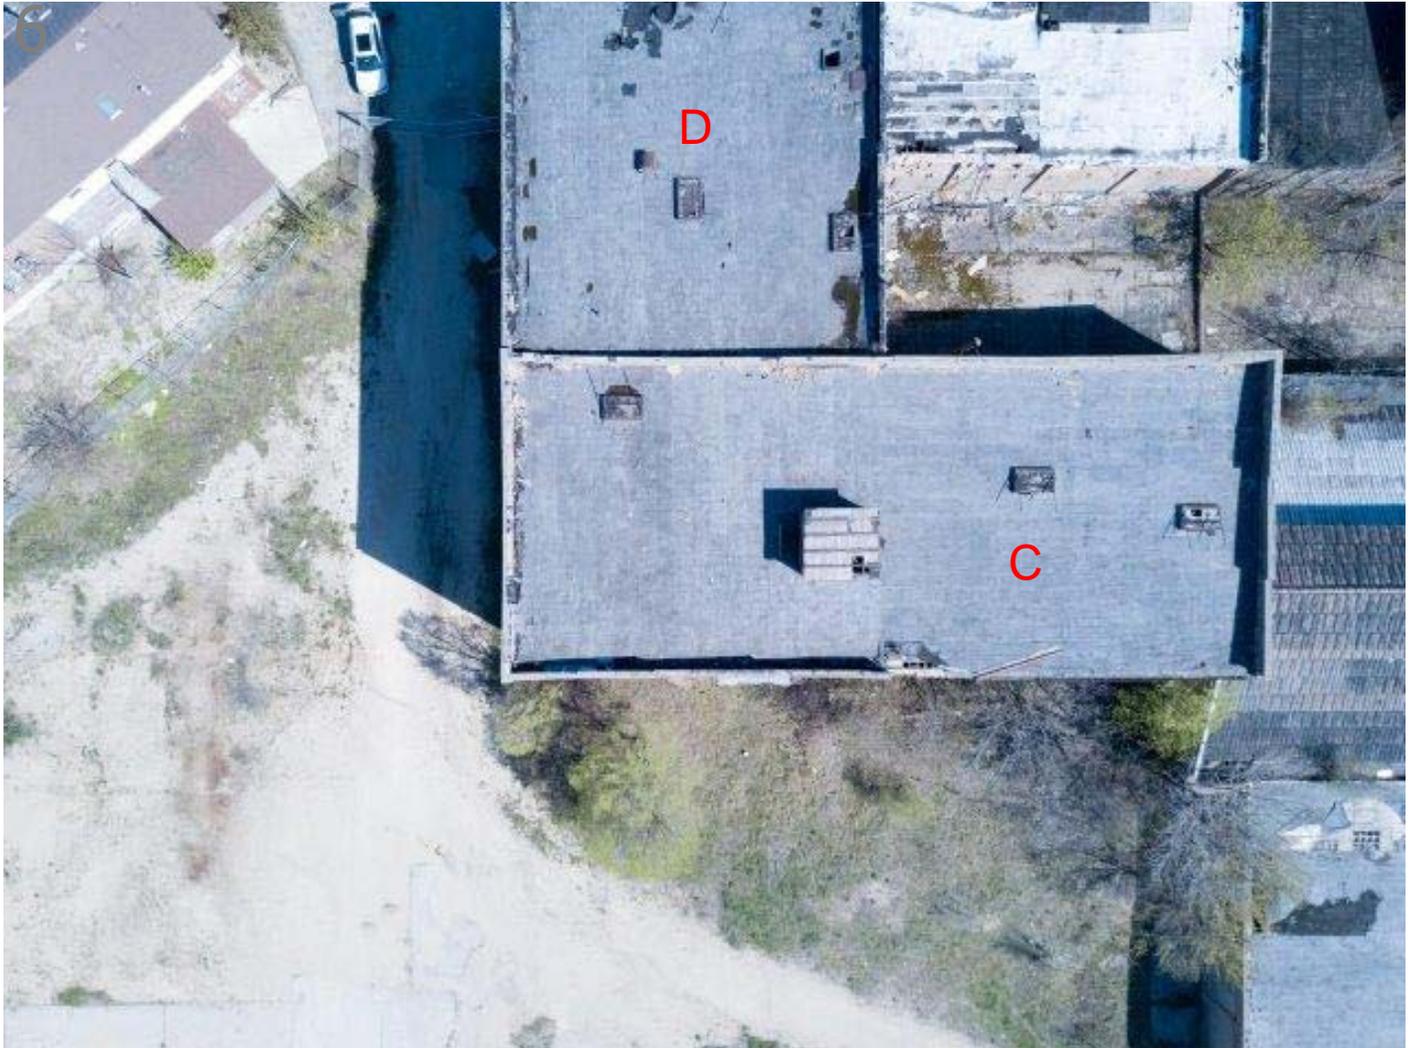
View of "Southern Quadrant" and Factory South

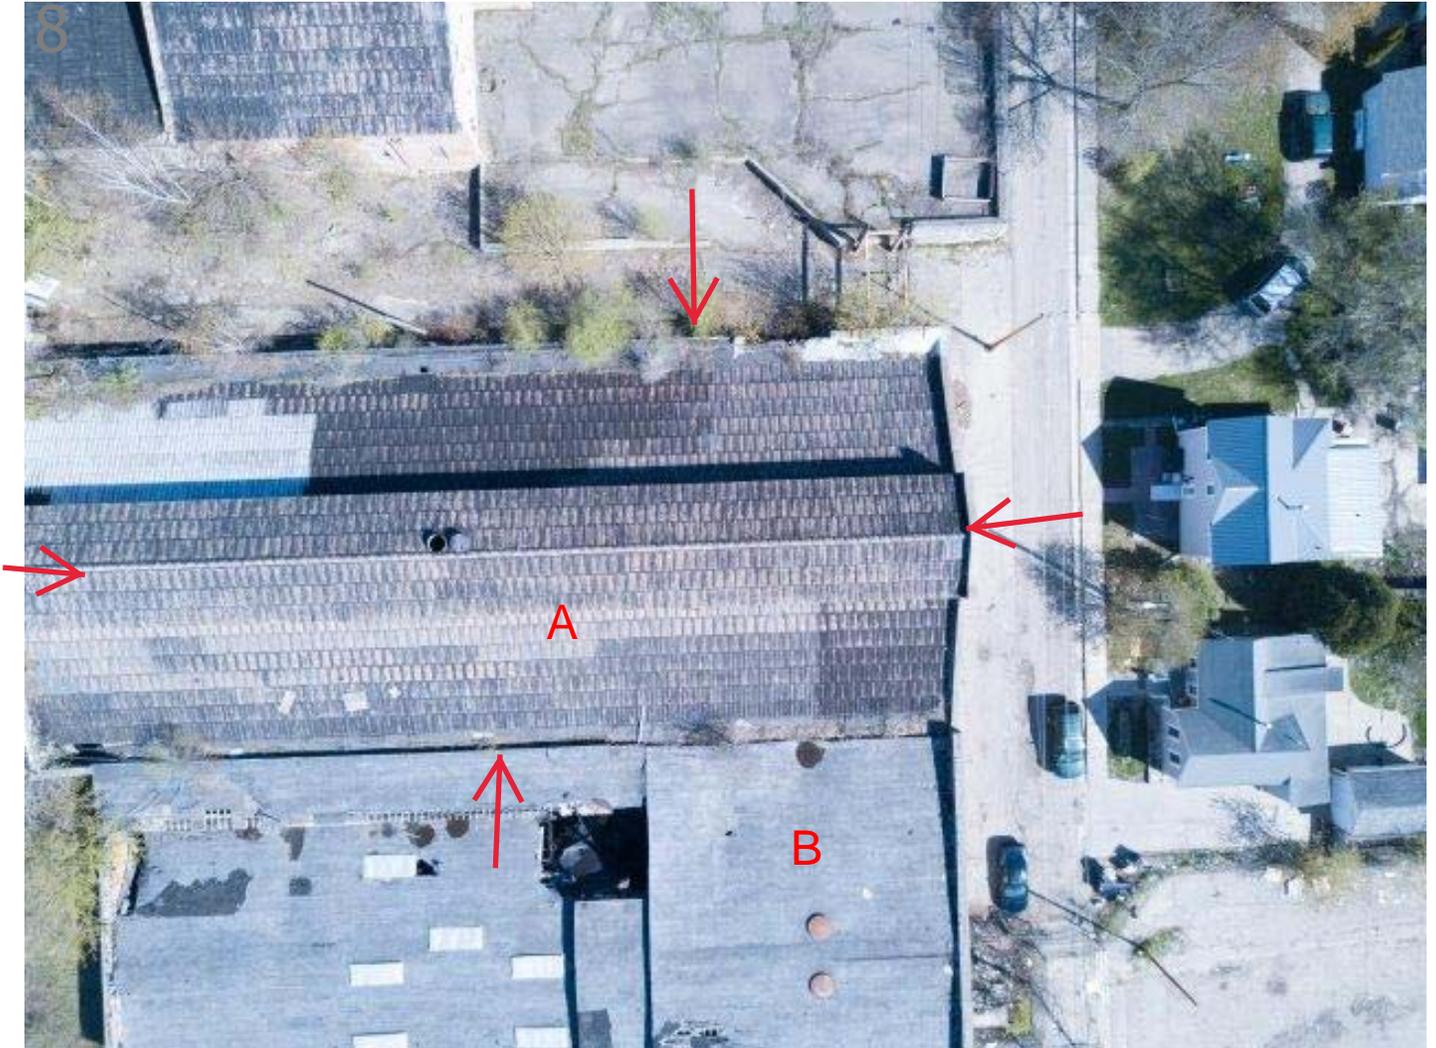
View of Blacksmith Shop and South Building

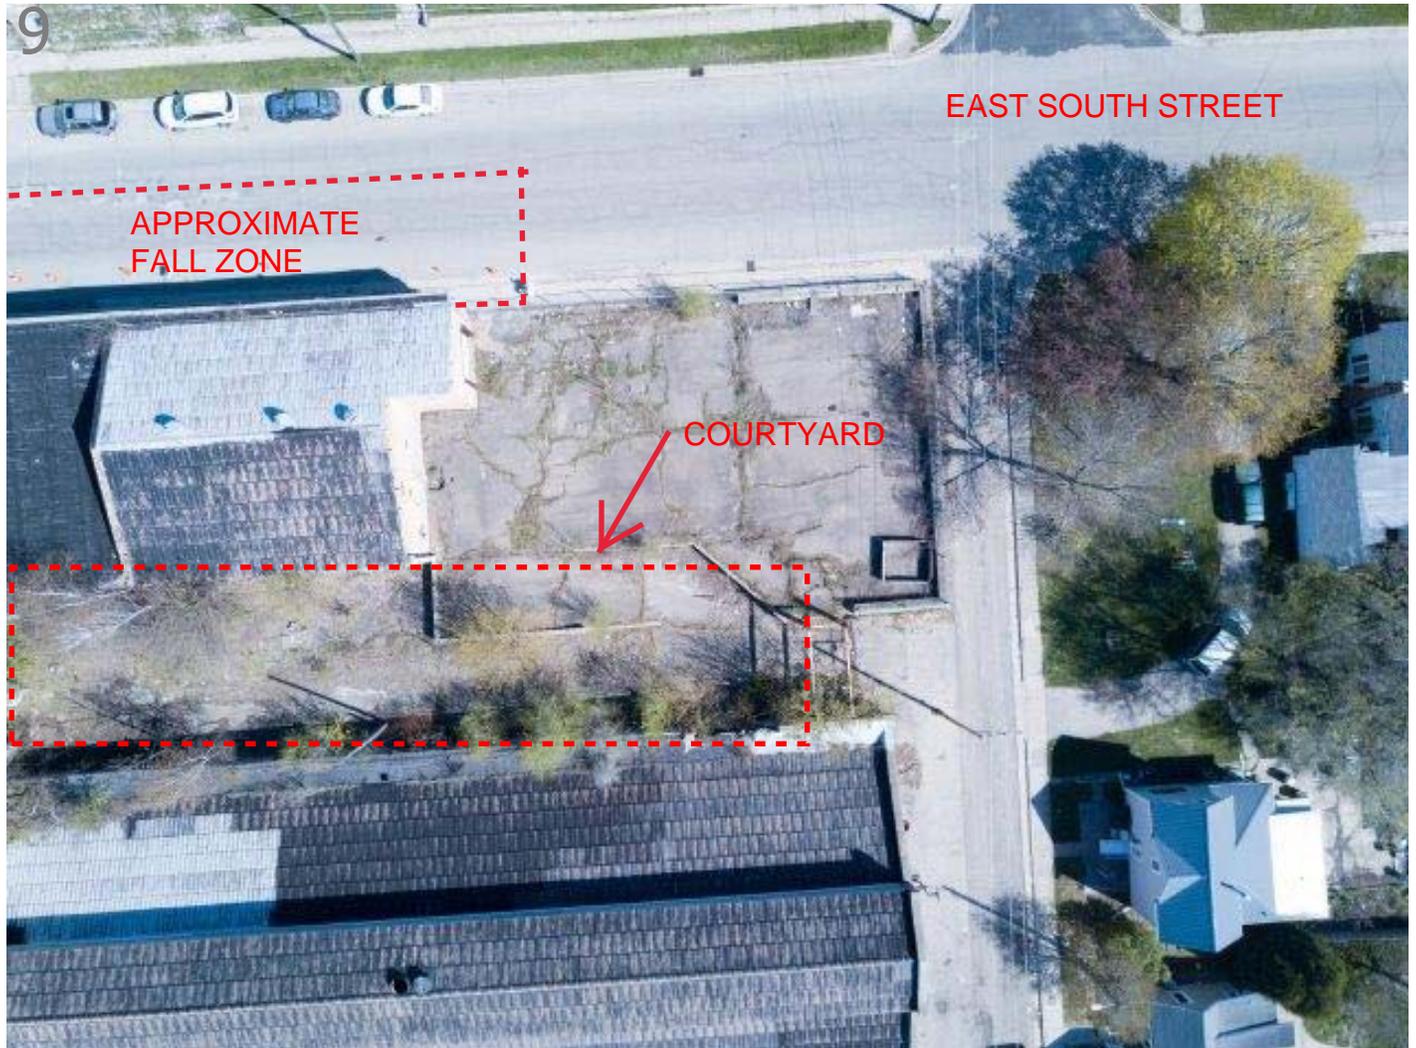
View of courtyard between Blacksmith Shop and Power Plant (partially demolished)

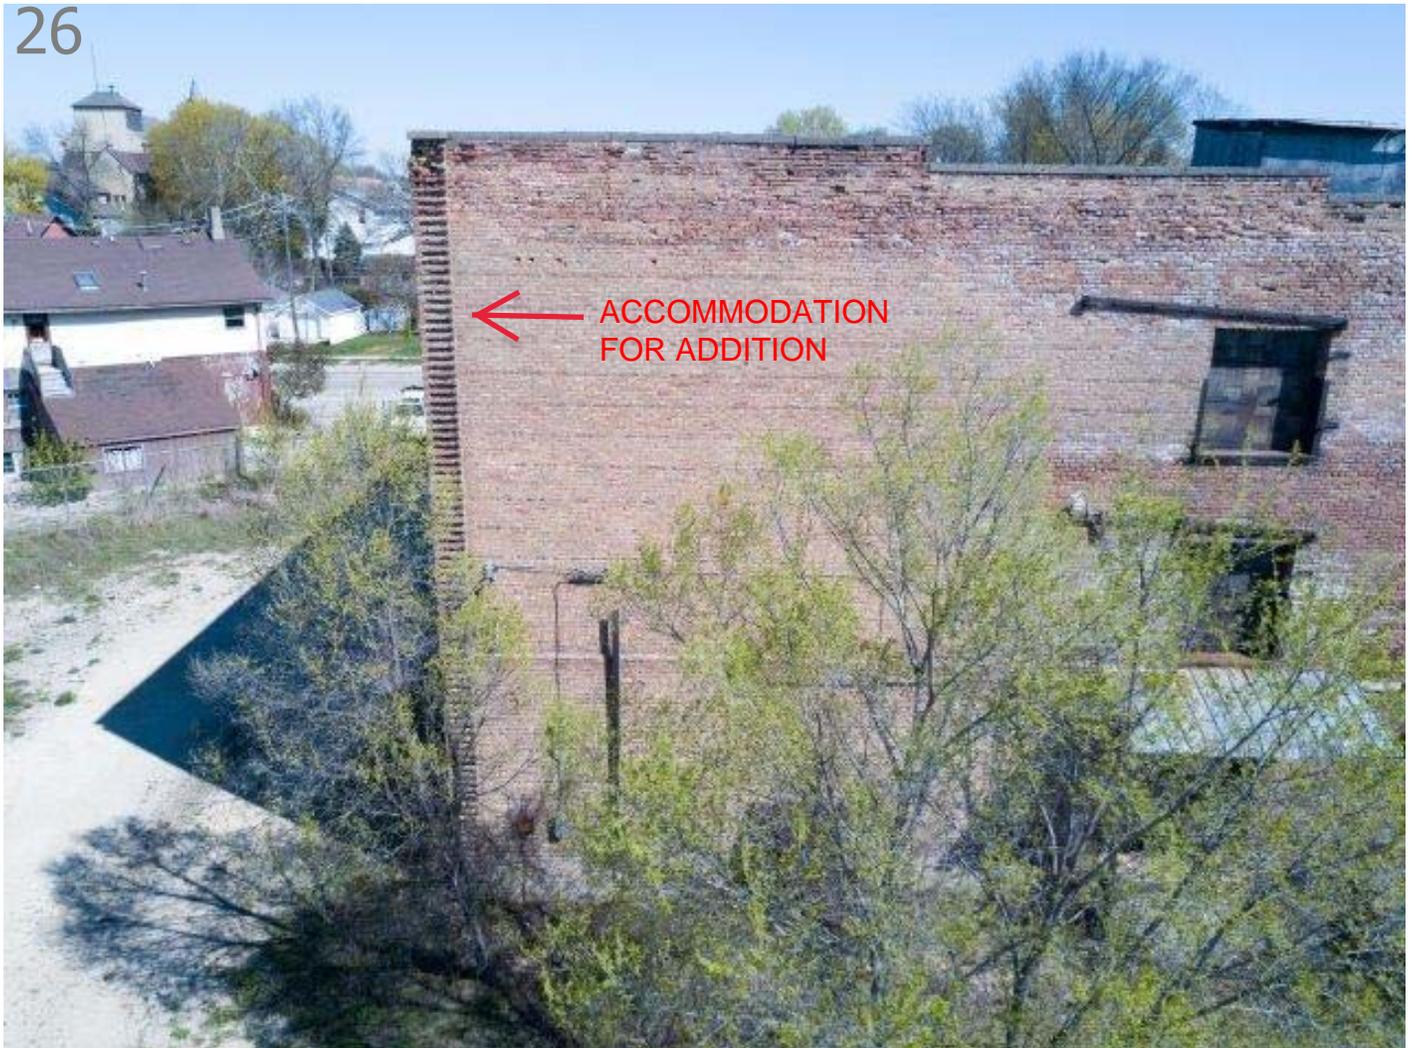
26

Note set-up for future addition - South Façade at West Side

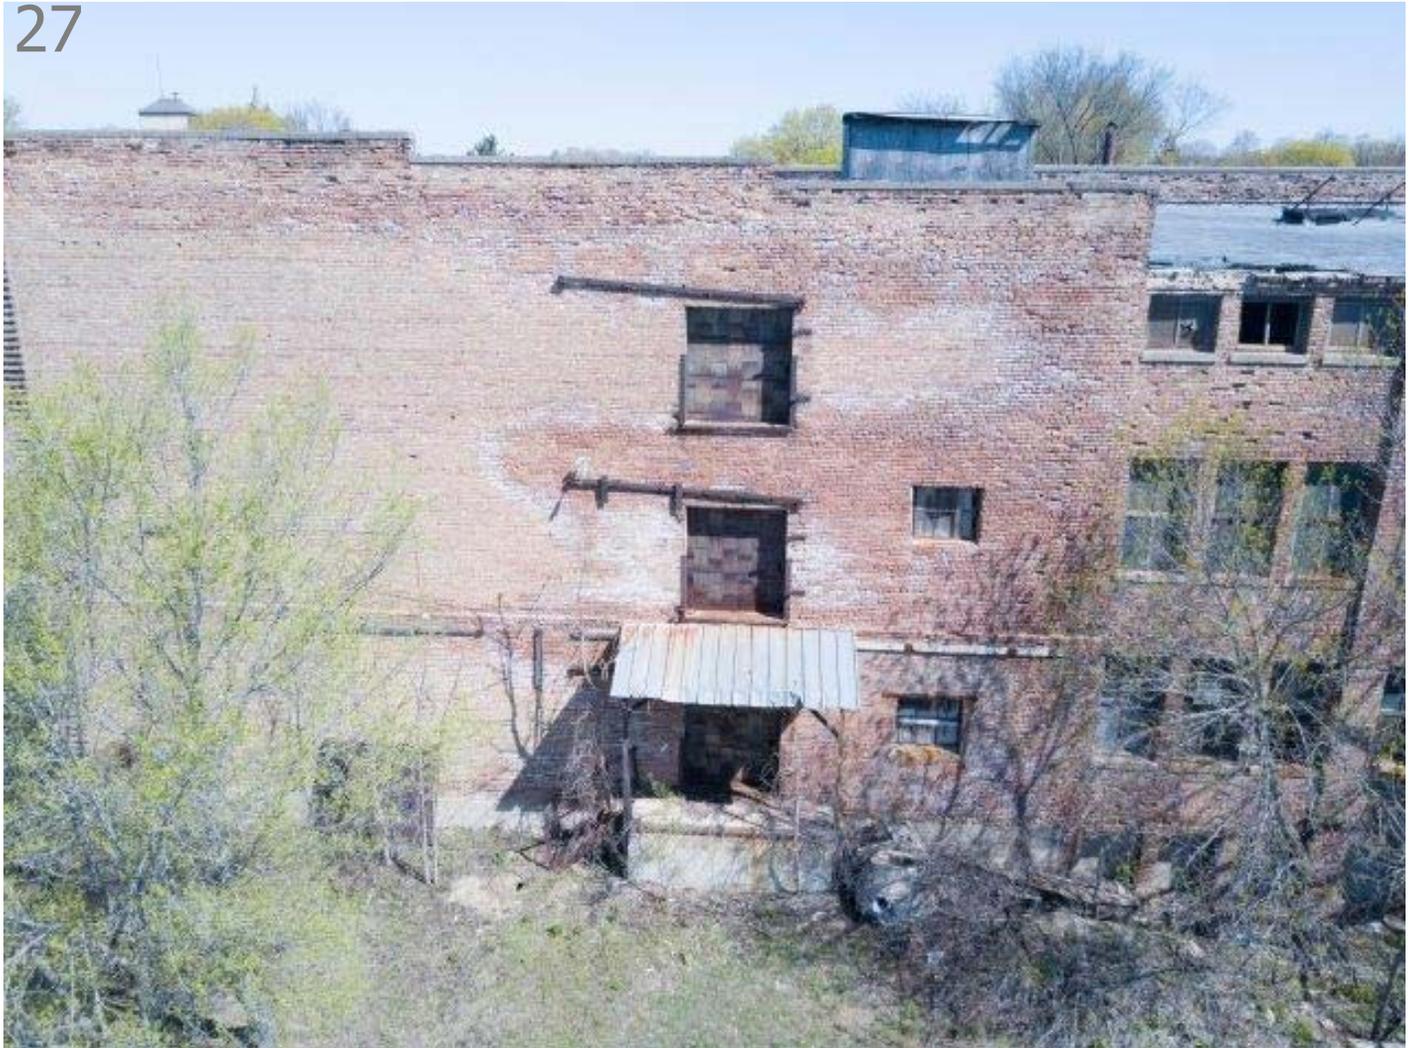
27

View of South Façade with Future sliding fire doors.

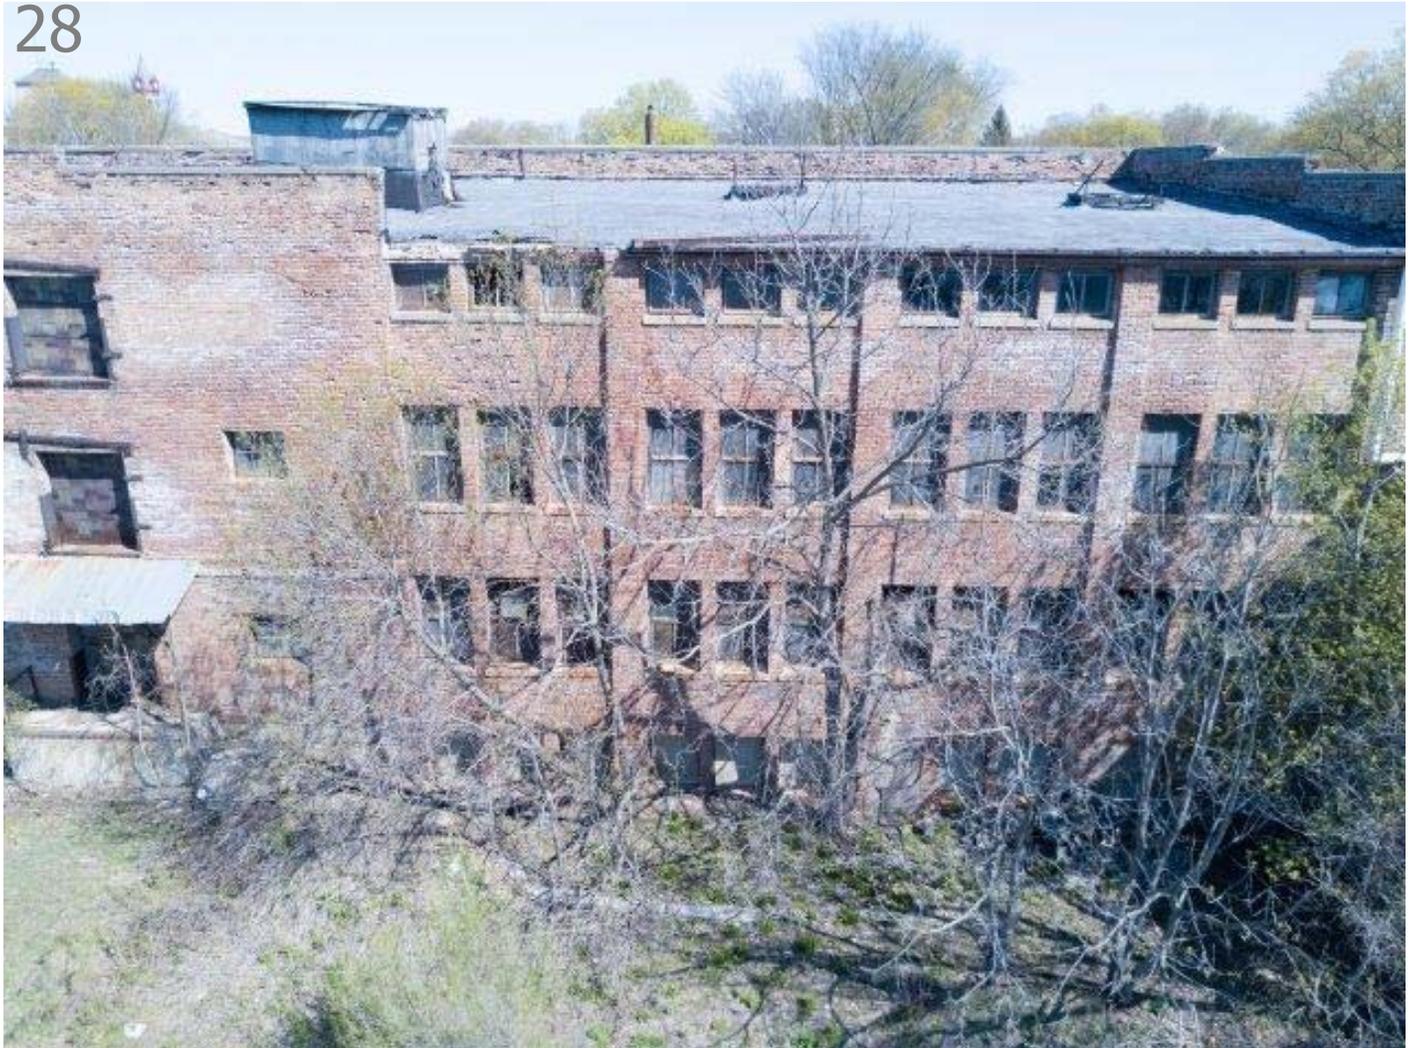
28

View of South Façade - One of the most unique aspects of the complex, exceptional design and very adaptable.

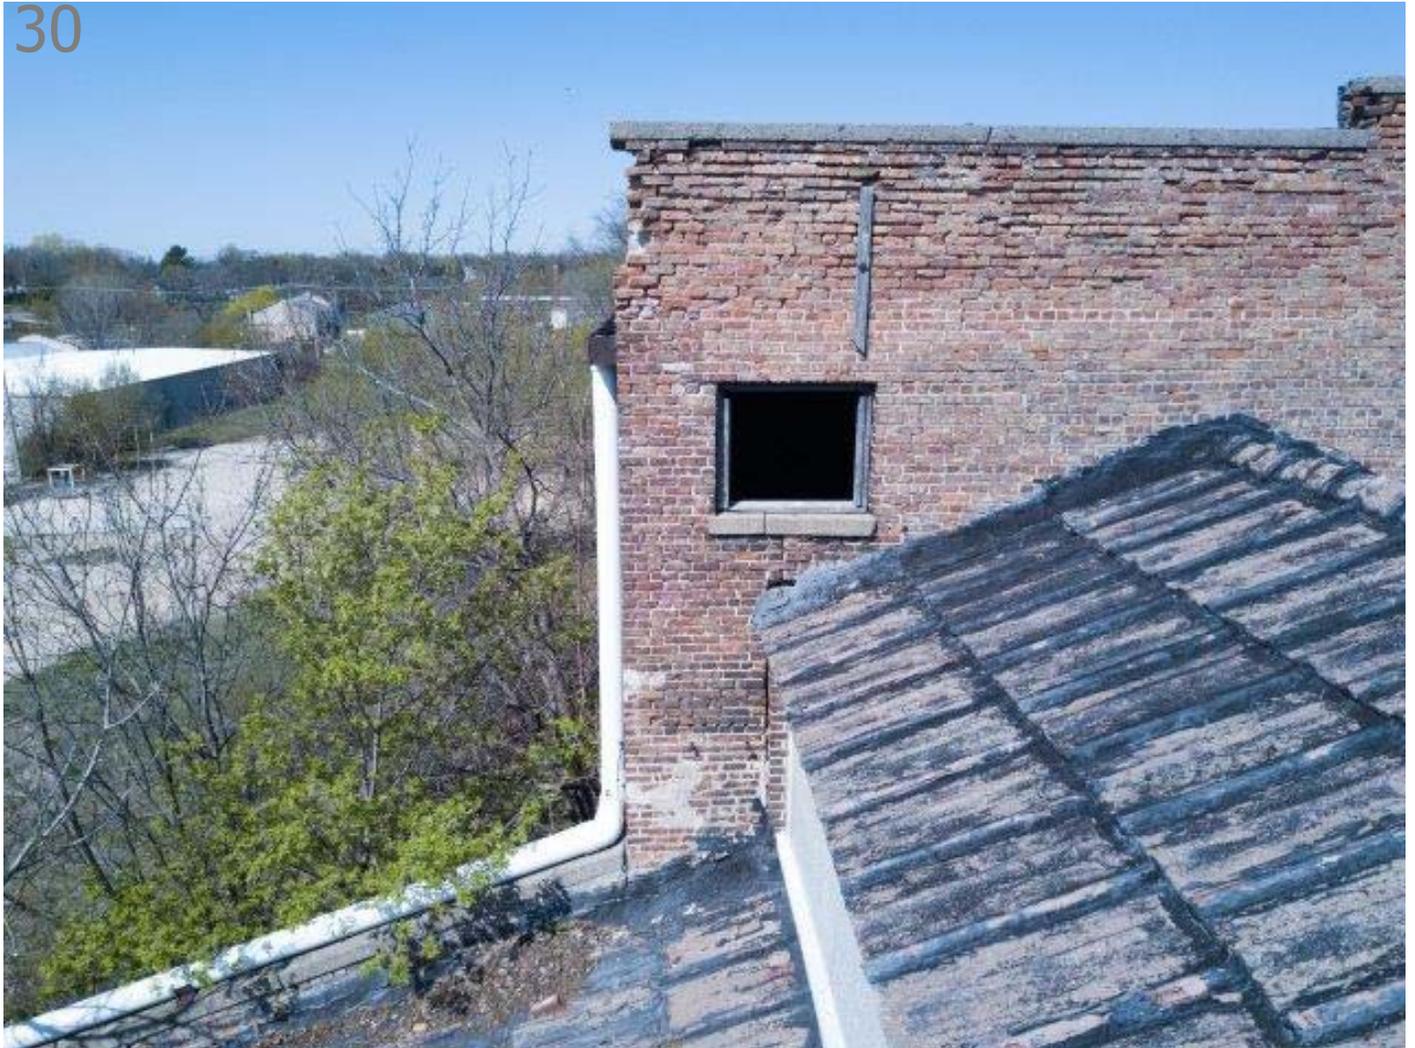
30

Close-Up view of wall at parapet at the "Junction" of the Blacksmith Shop and the Factory

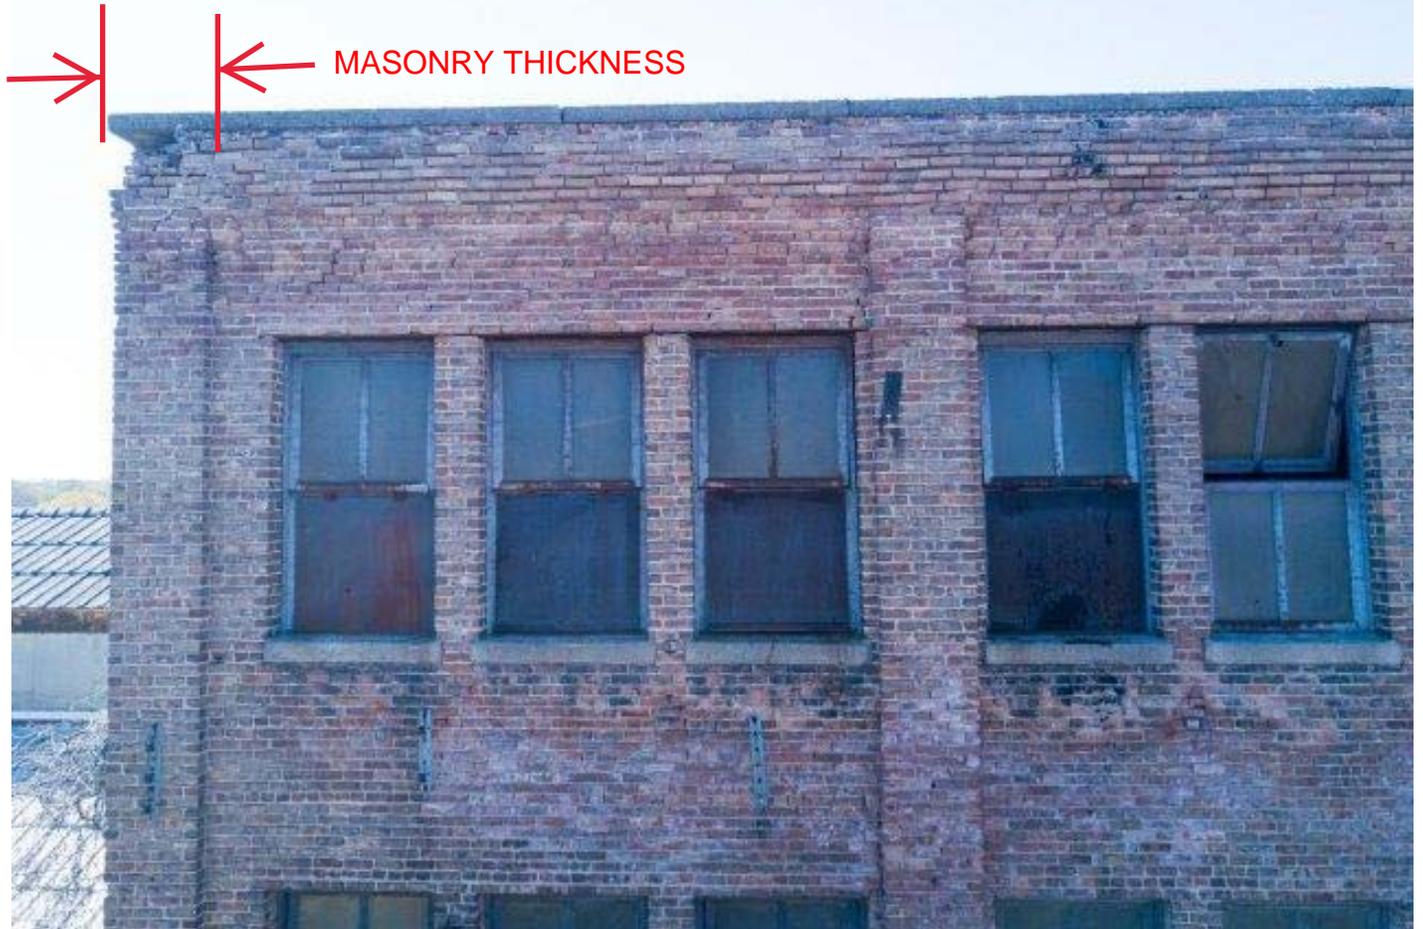
39

Additional view of condition at Figure 35.

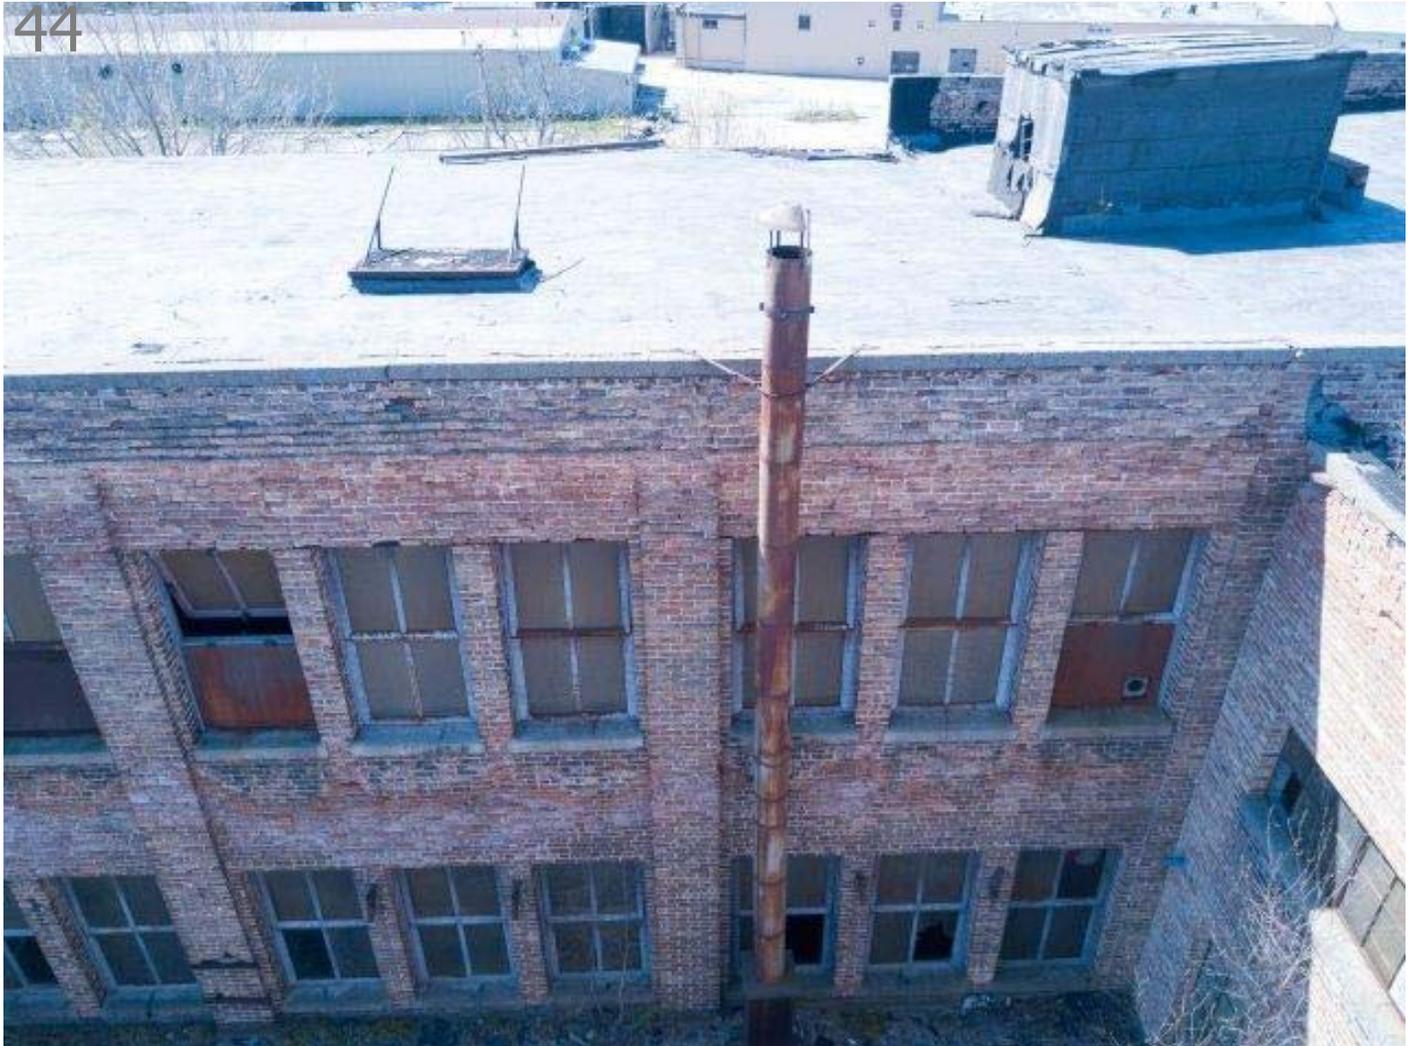
44

The construction is mostly square, plumb and true.

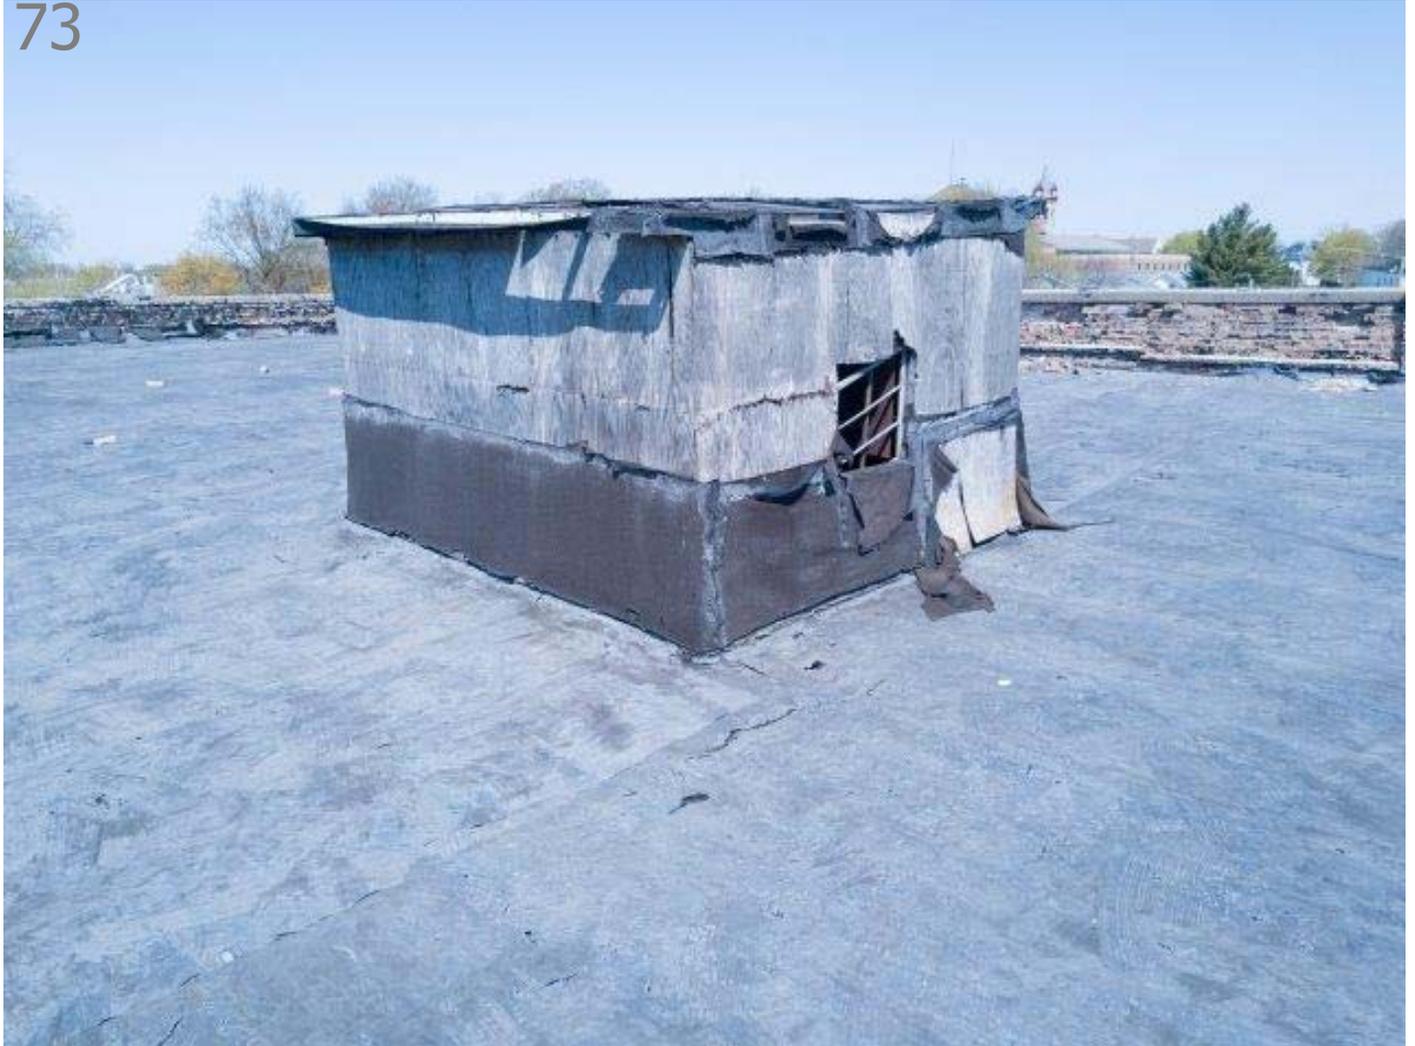
73

View of "doghouse."

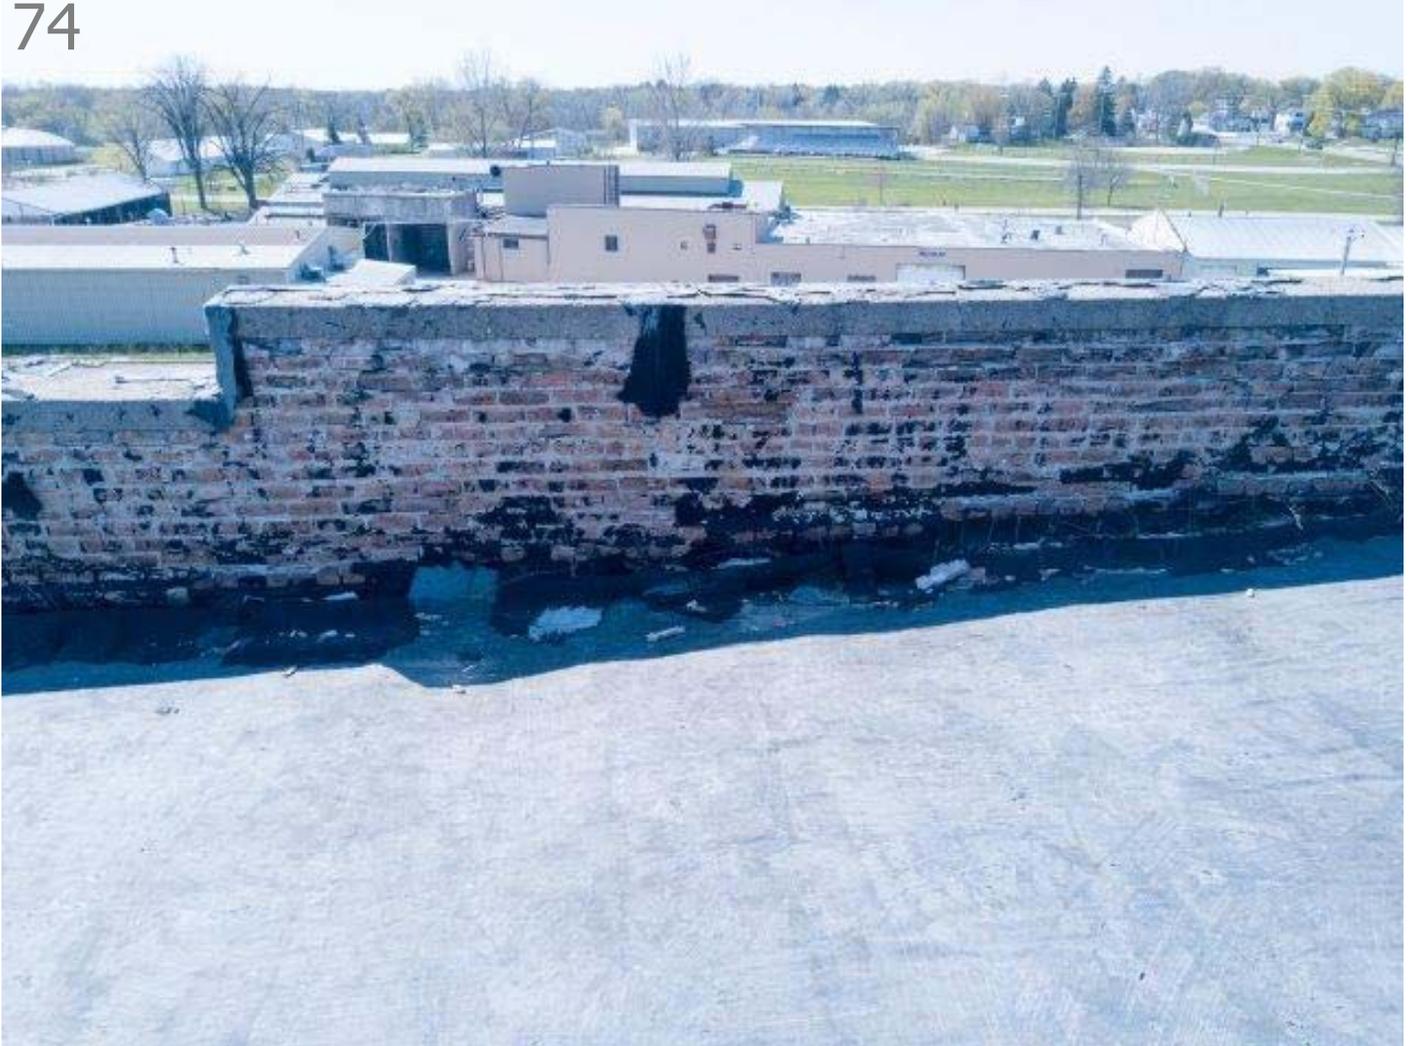
74

View of interior of parapet.

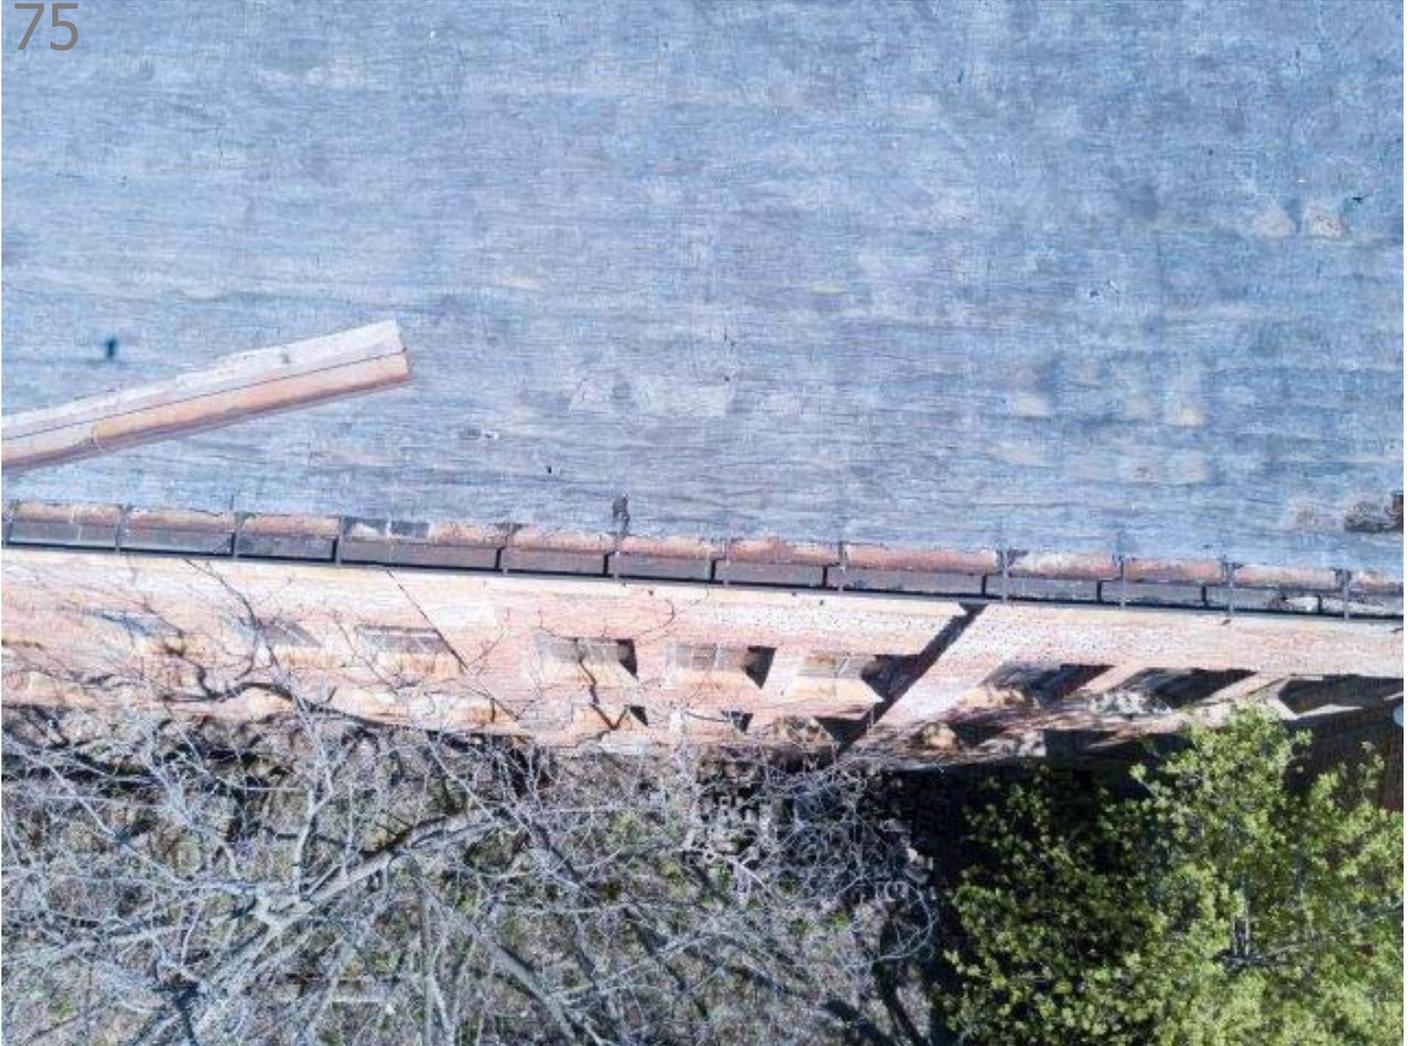
75

View of parapet/gutter from above.

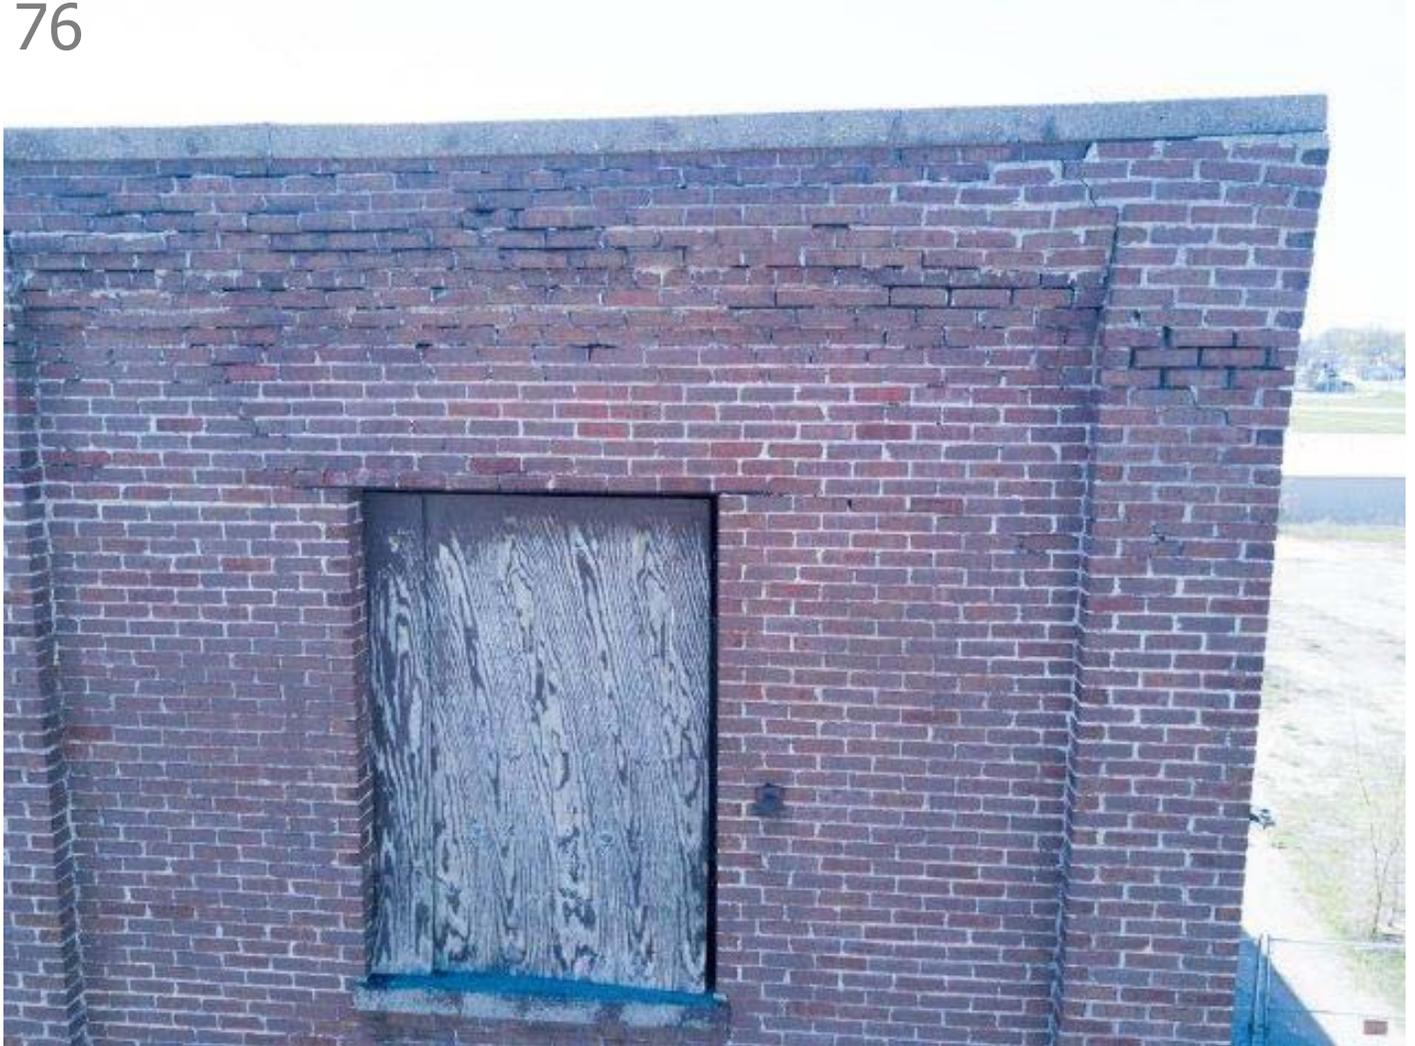
76

View of parapet at corner - u-turned corner is from poor quality rebuild and is relatively stable.

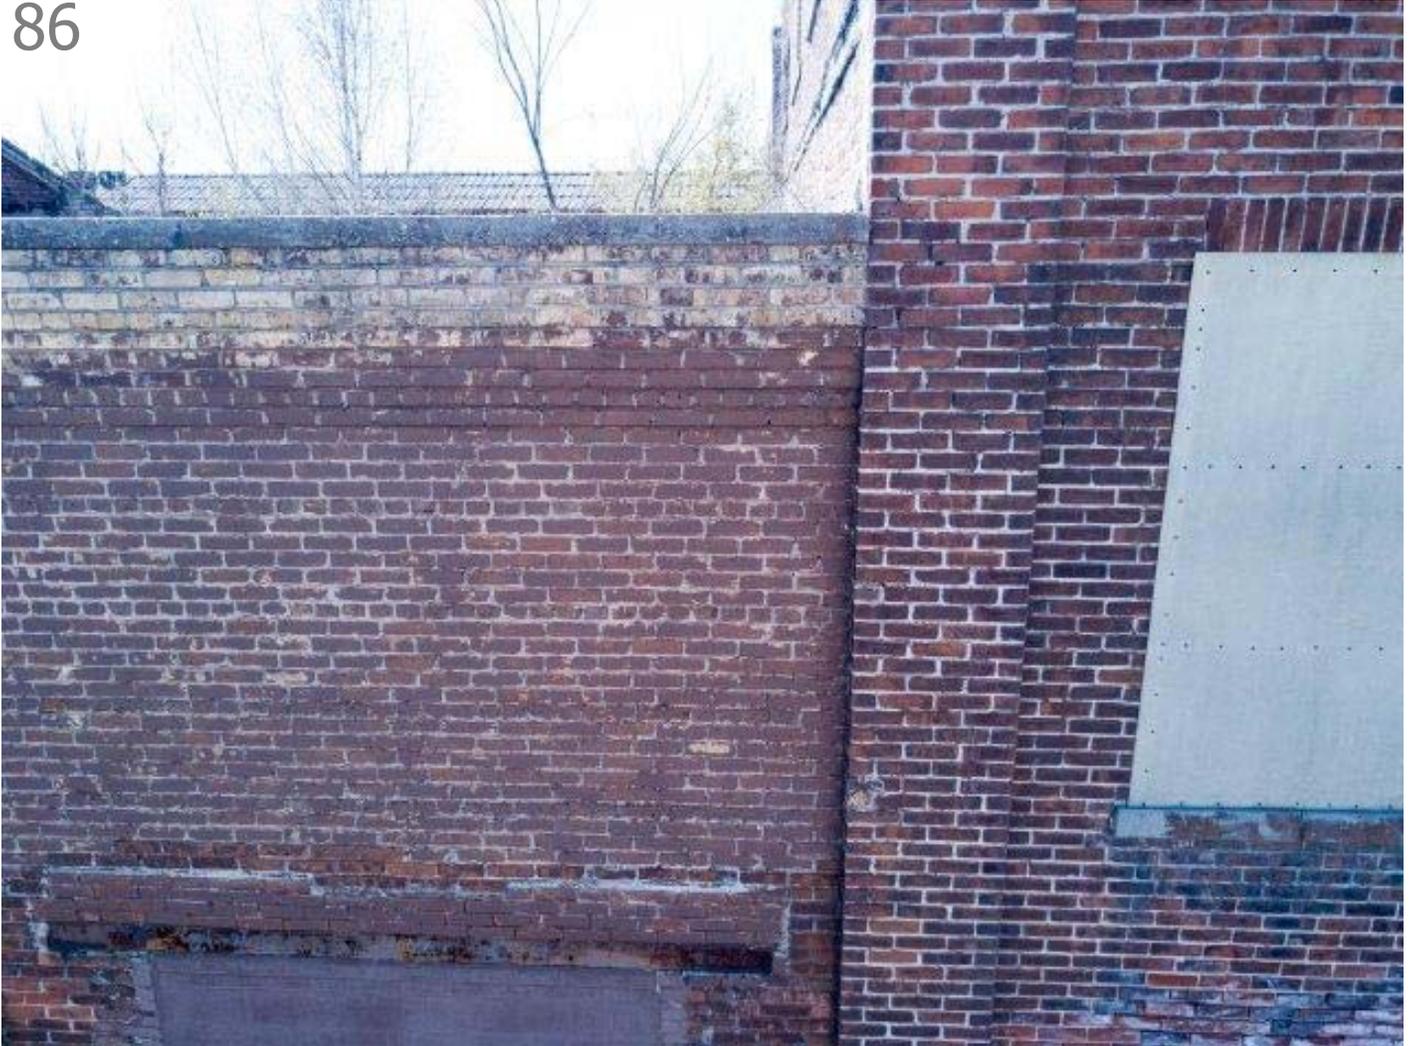
86

View of rebuilt parapet.
