**STOUGHTON HIGHWAY TRAILER BUILDING COMPLEX
SURVEY REPORT
STOUGHTON, WISCONSIN**

July 12, 2017

The following is a summary report on our findings of onsite conditions and our recommendations for the treatment of the Highway Trailer Building Complex. We have based this report on a facility inspection conducted on May 18, 2017. This inspection was preceded by a drone survey to provide a safe close-up inspection of the exterior materials. Focus of inspection was to assess and make recommendations related to safety issues associated with potential structural collapse along E. South St., and to assess and make recommendations regarding existing structural masonry shell salvage and reuse throughout the facility. Partial and full deconstruction of connected structural systems considered for demolition is also addressed in our record of observations and opinions.

Stoughton Highway Trailer Building Complex Survey Image Report

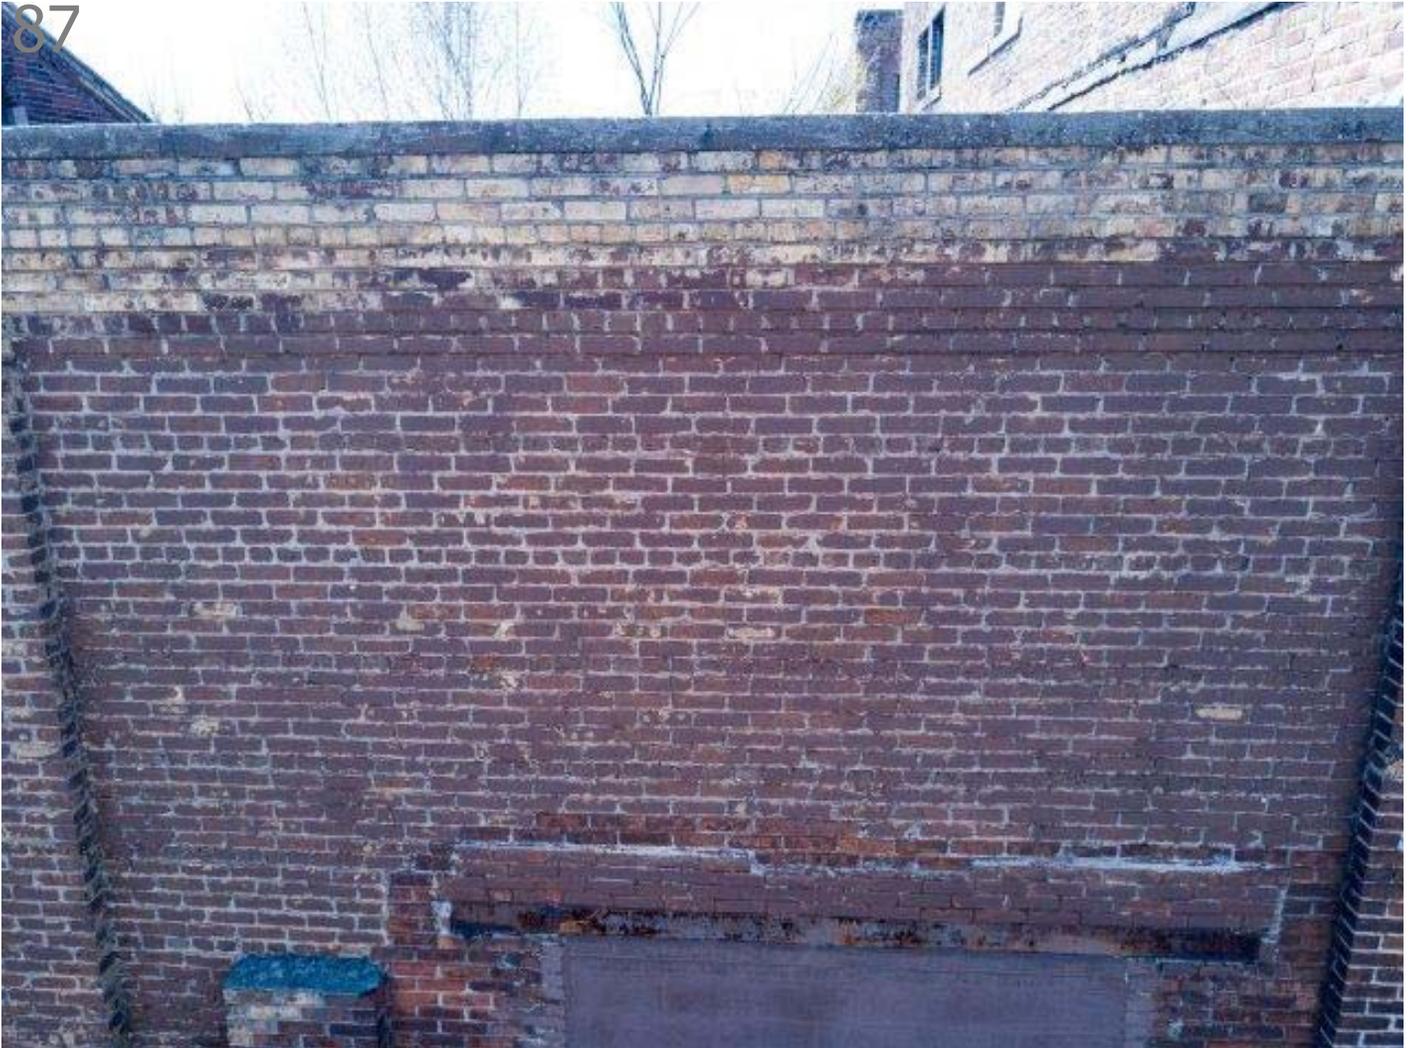
87

View of rebuilt parapet.

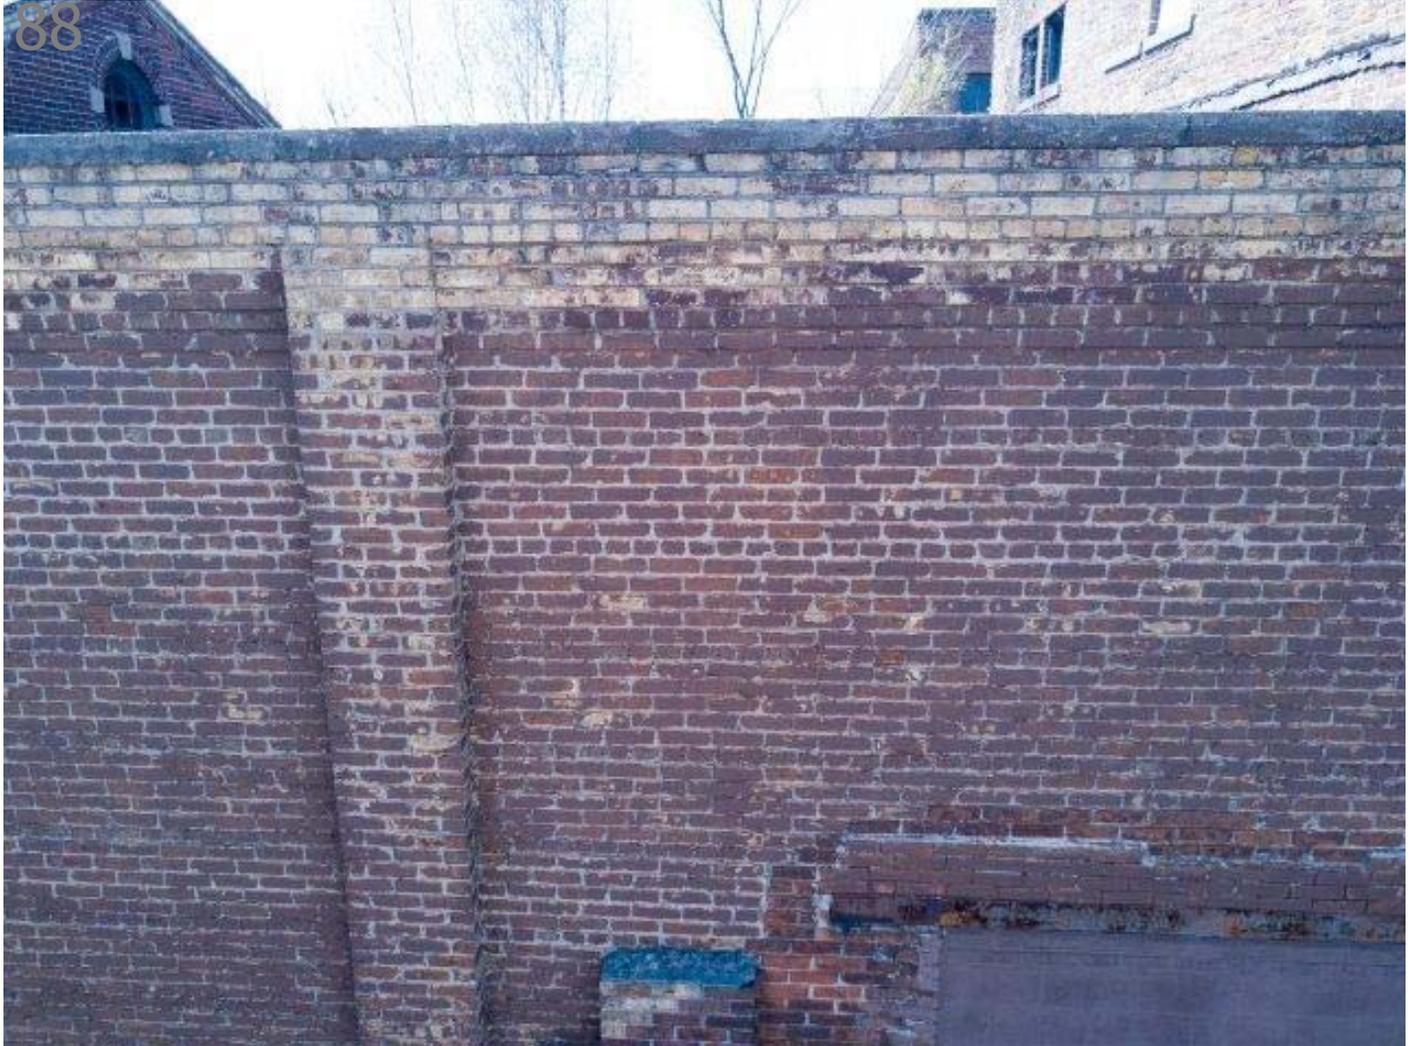
View of rebuilt parapet.

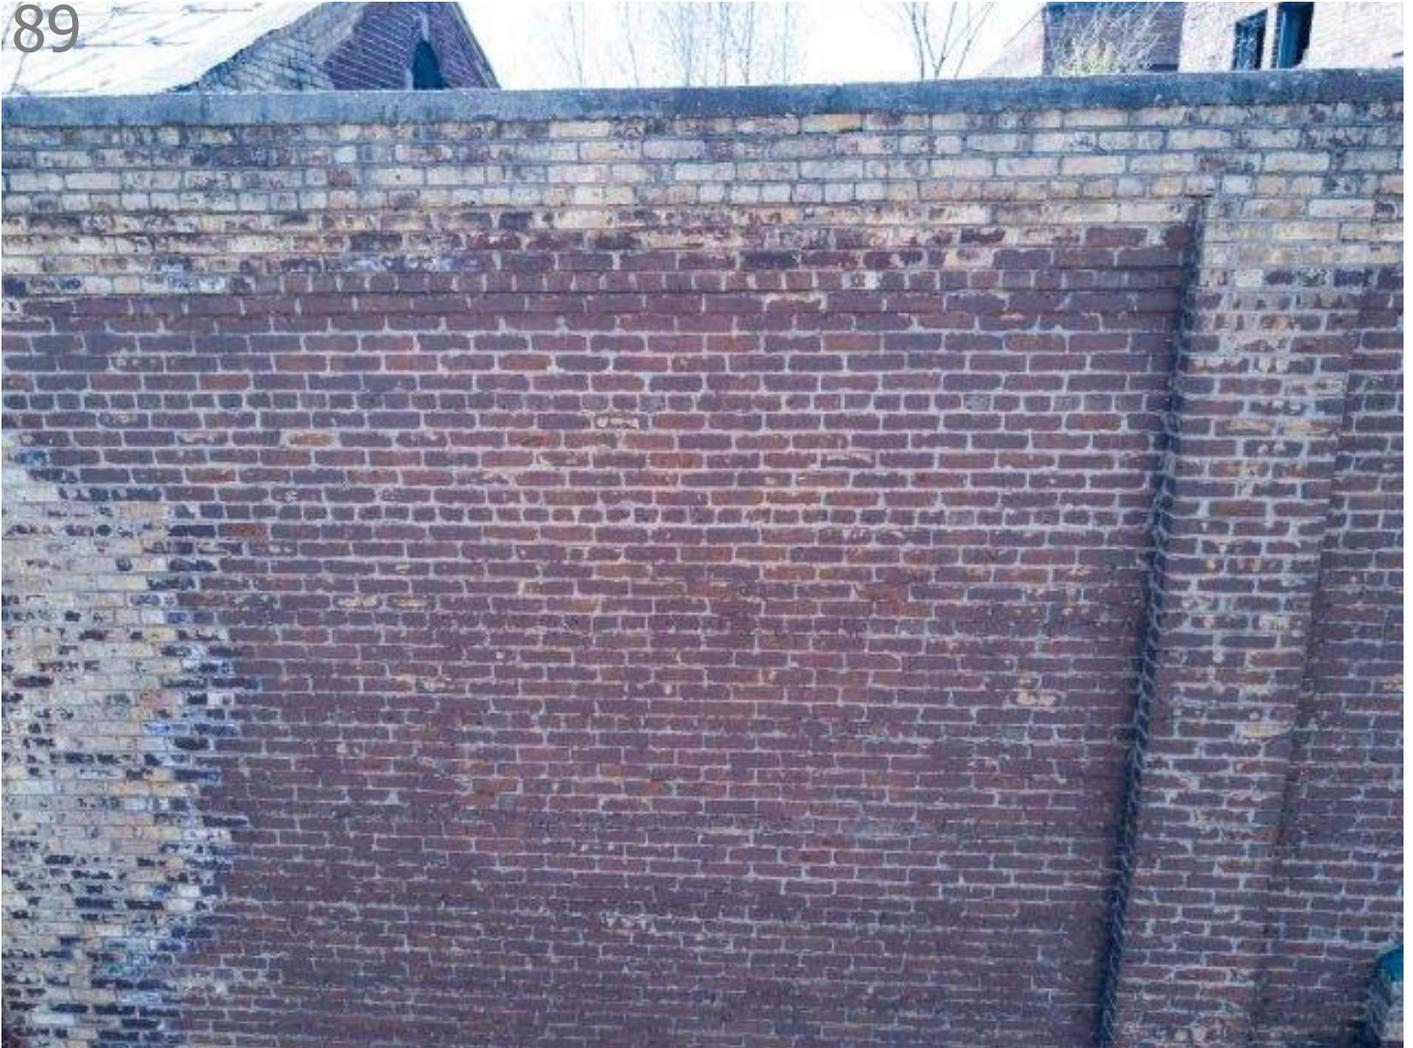
89

View of rebuilt parapet.

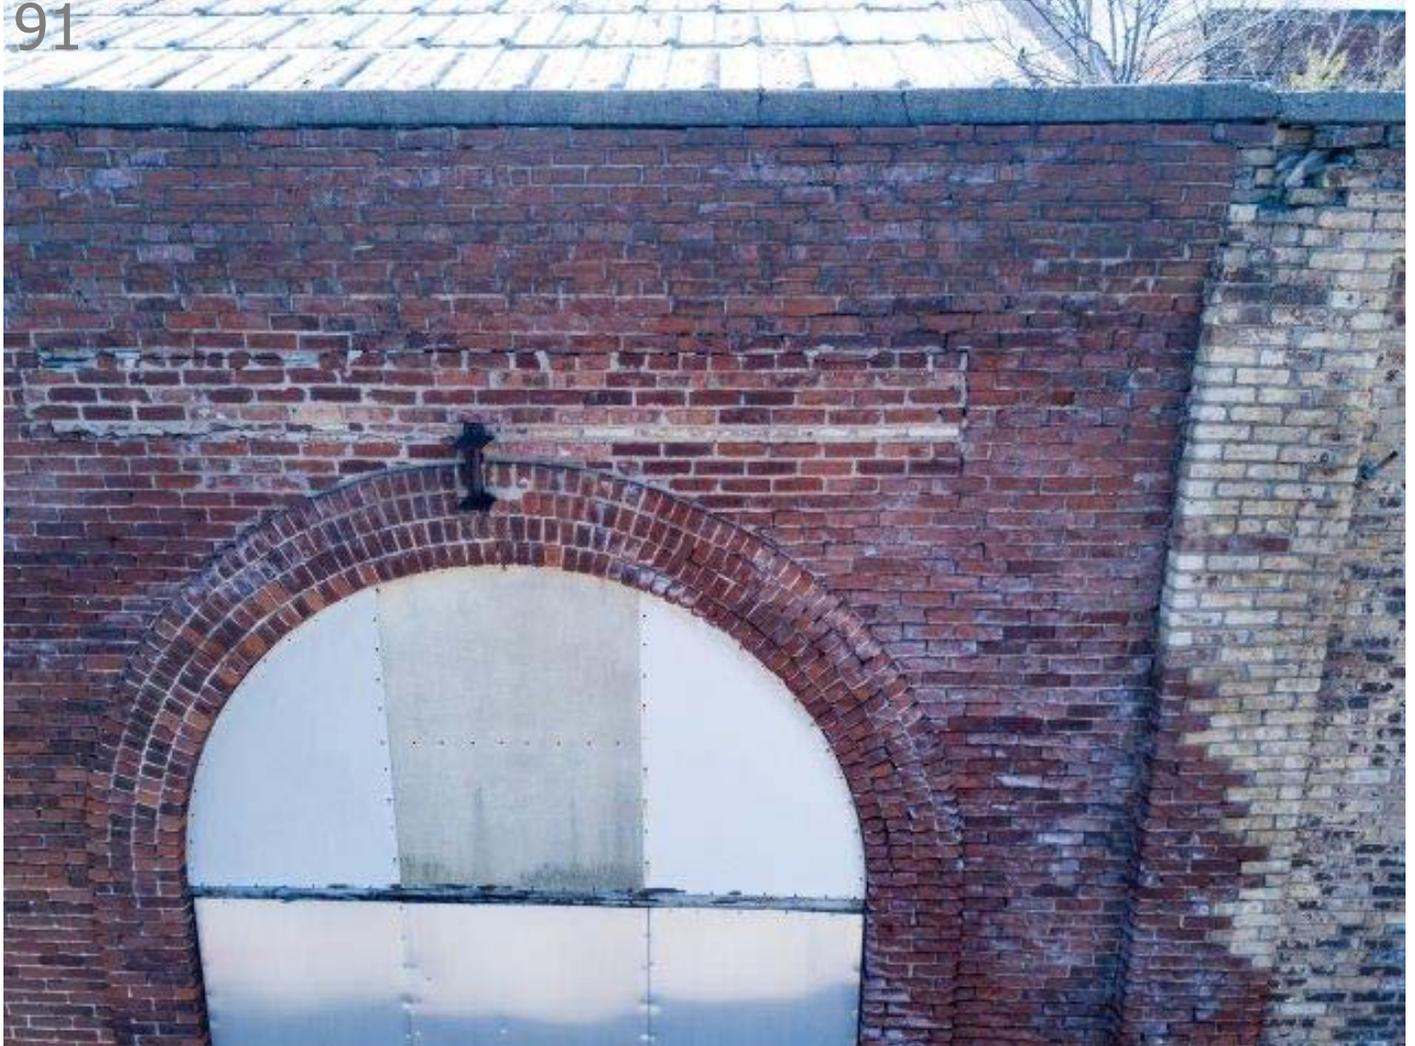
91

View of arched window at Power Plant.

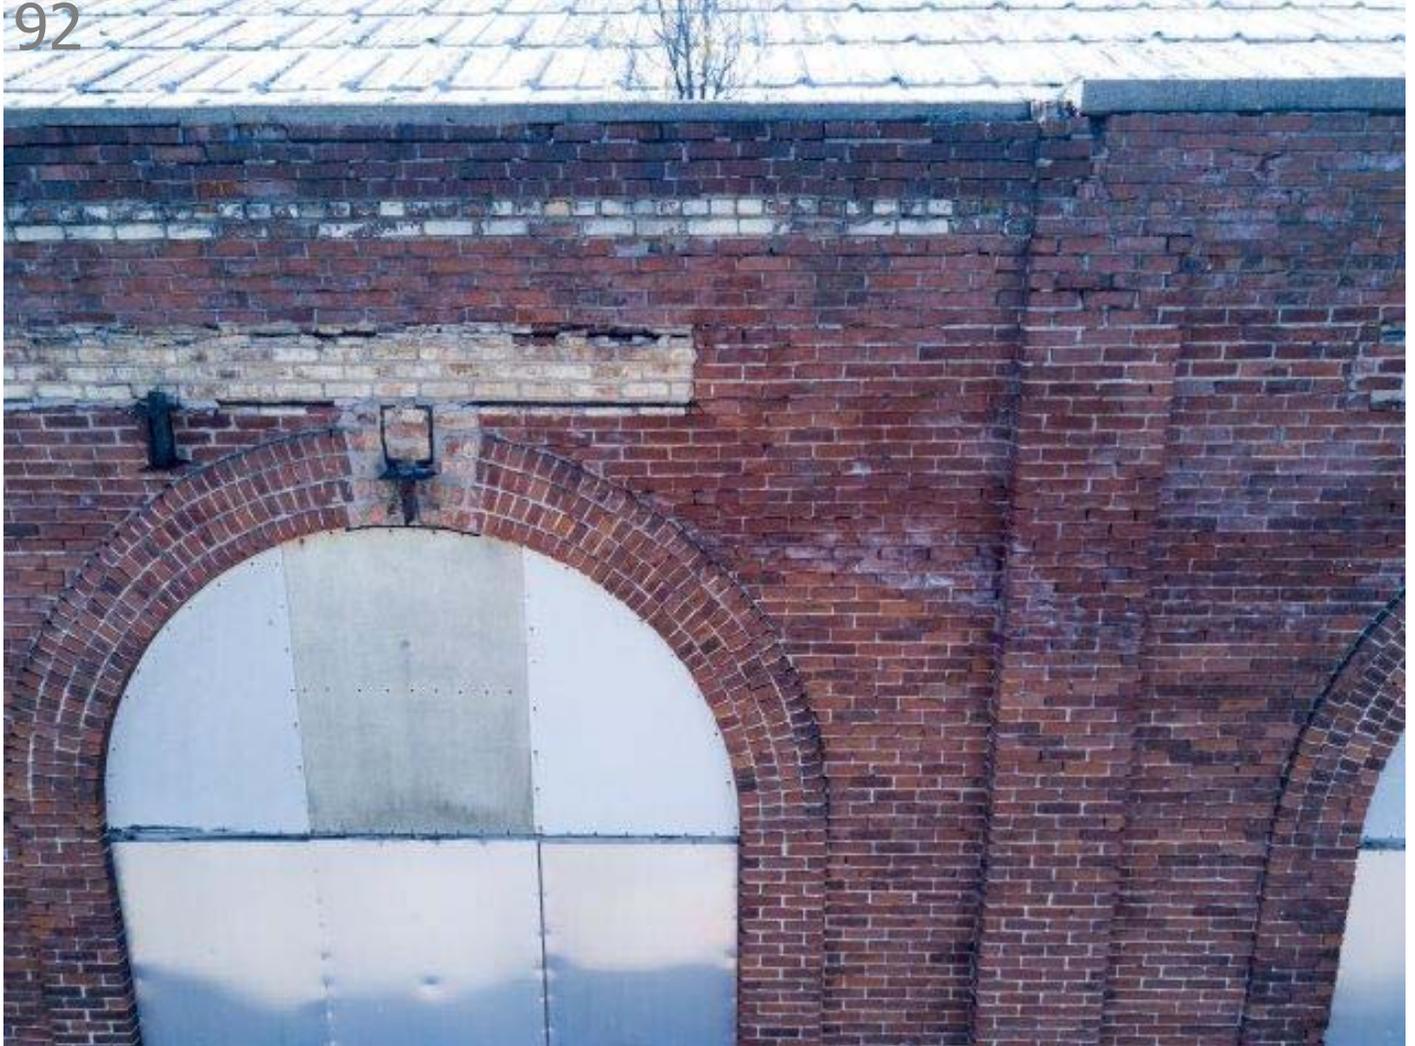
92

View of arched window at Power Plant.

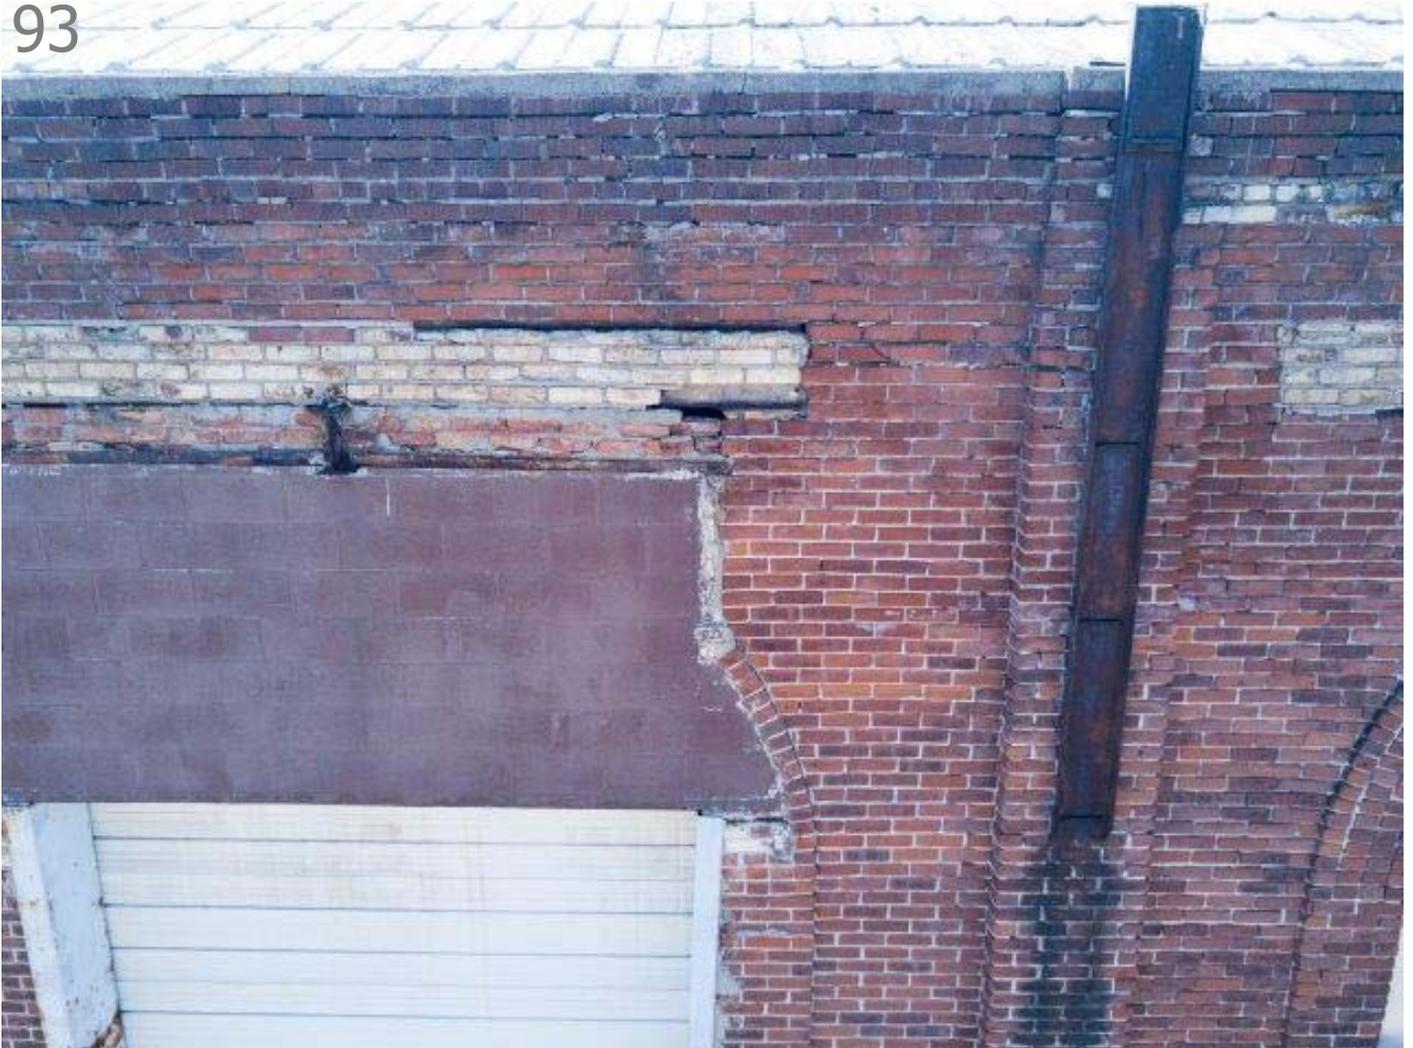
93

View of rebuilt opening.

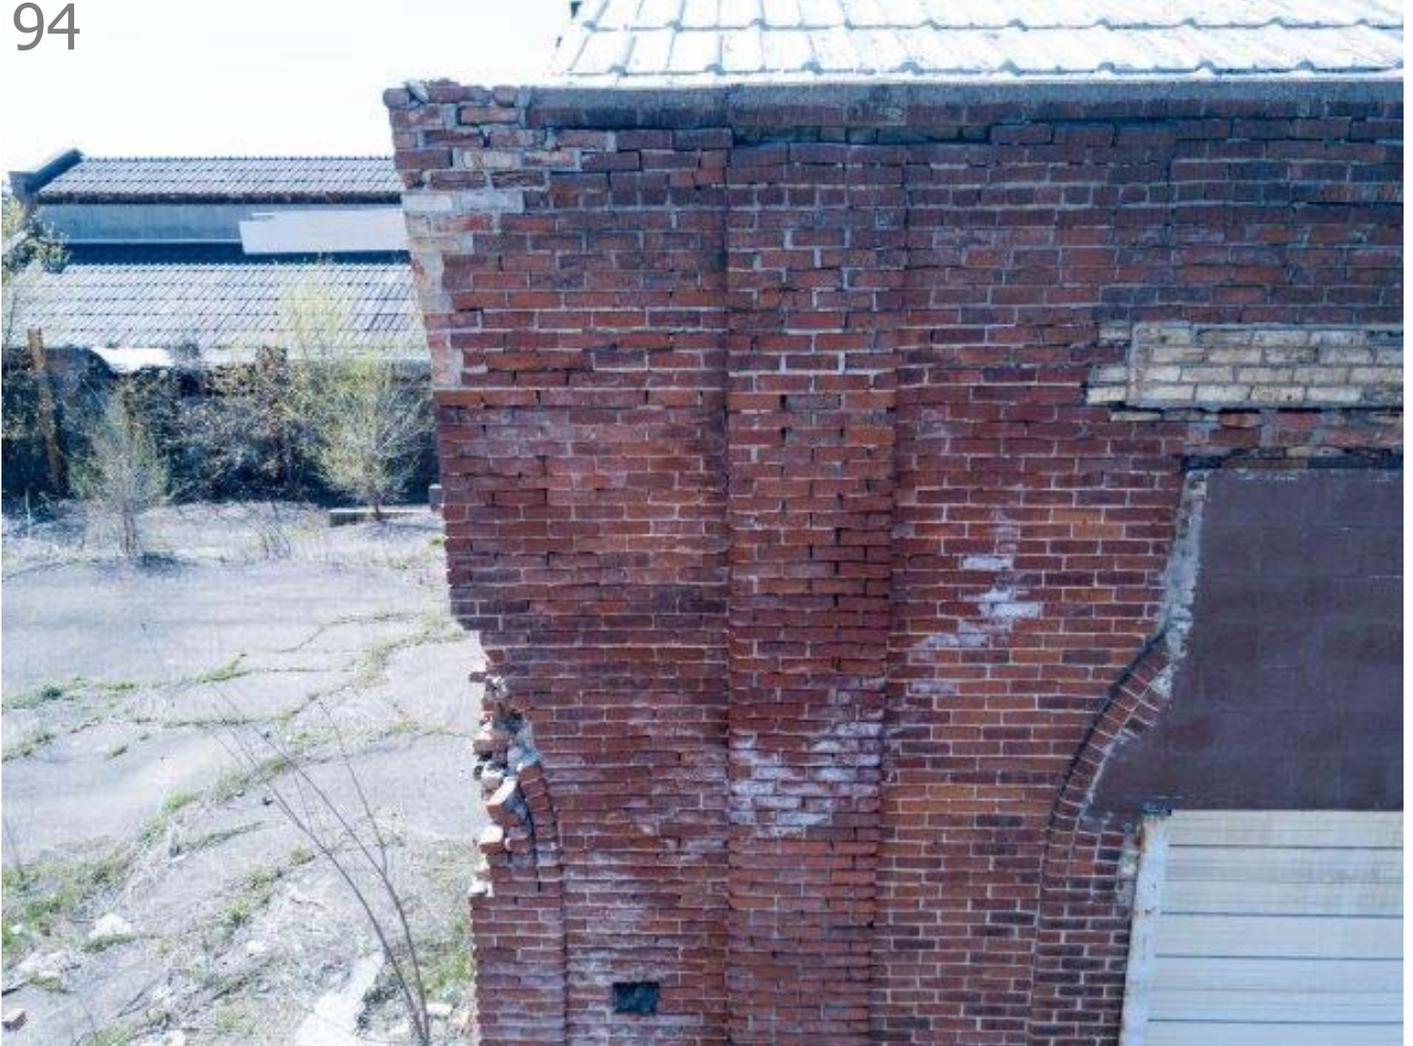
94

View of distressed corner.

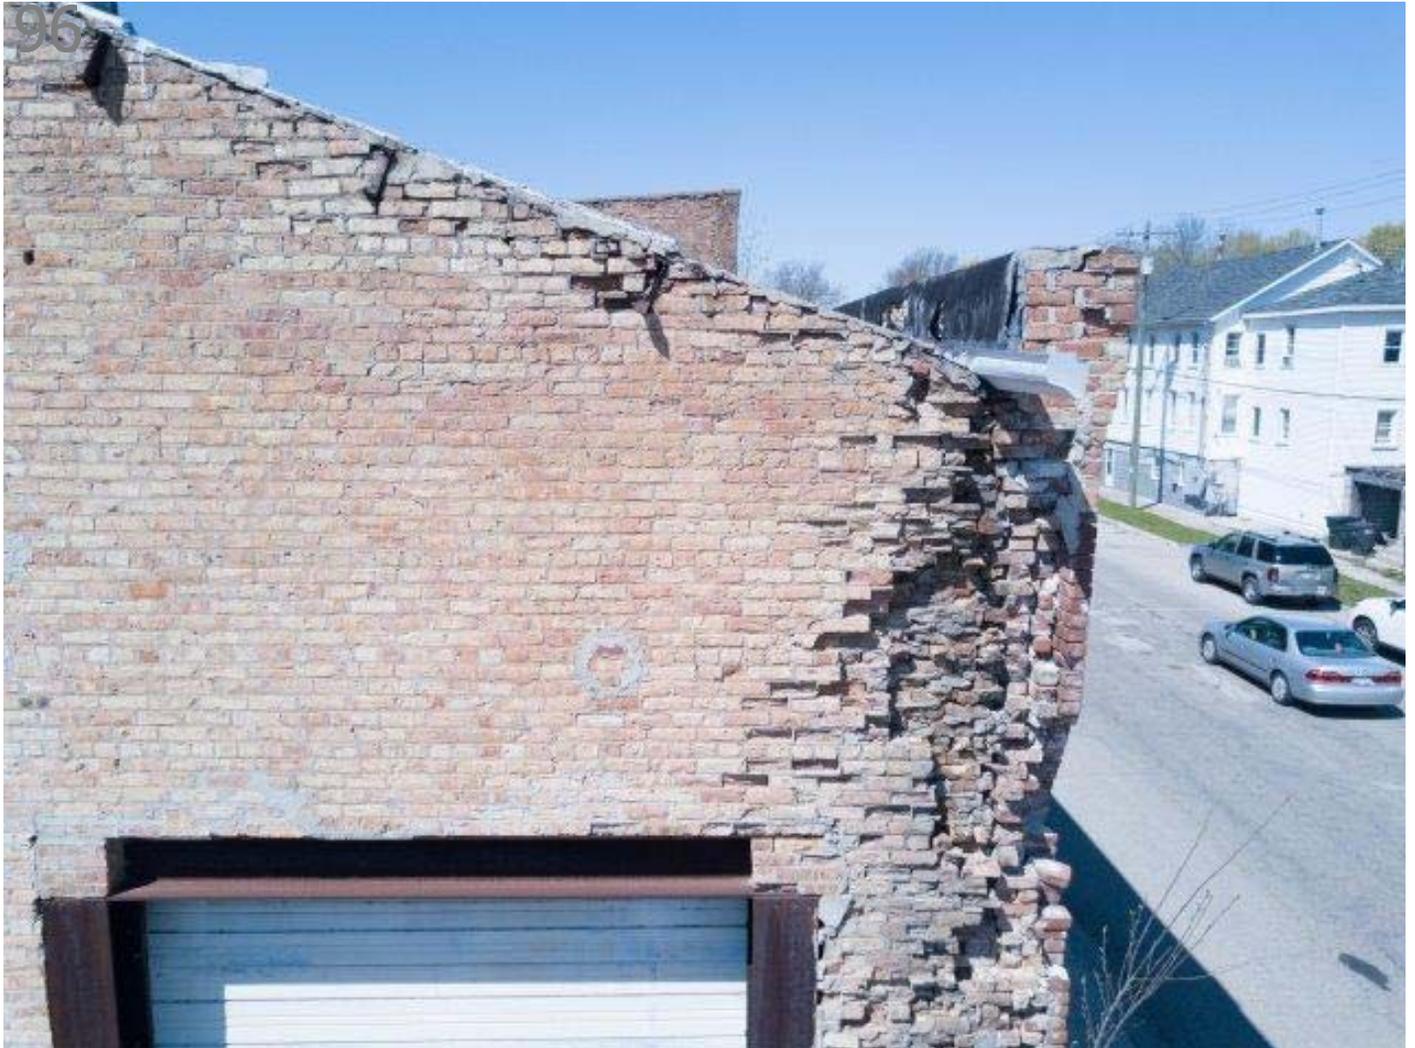
Evidence of the massive brick utilized in this complex.

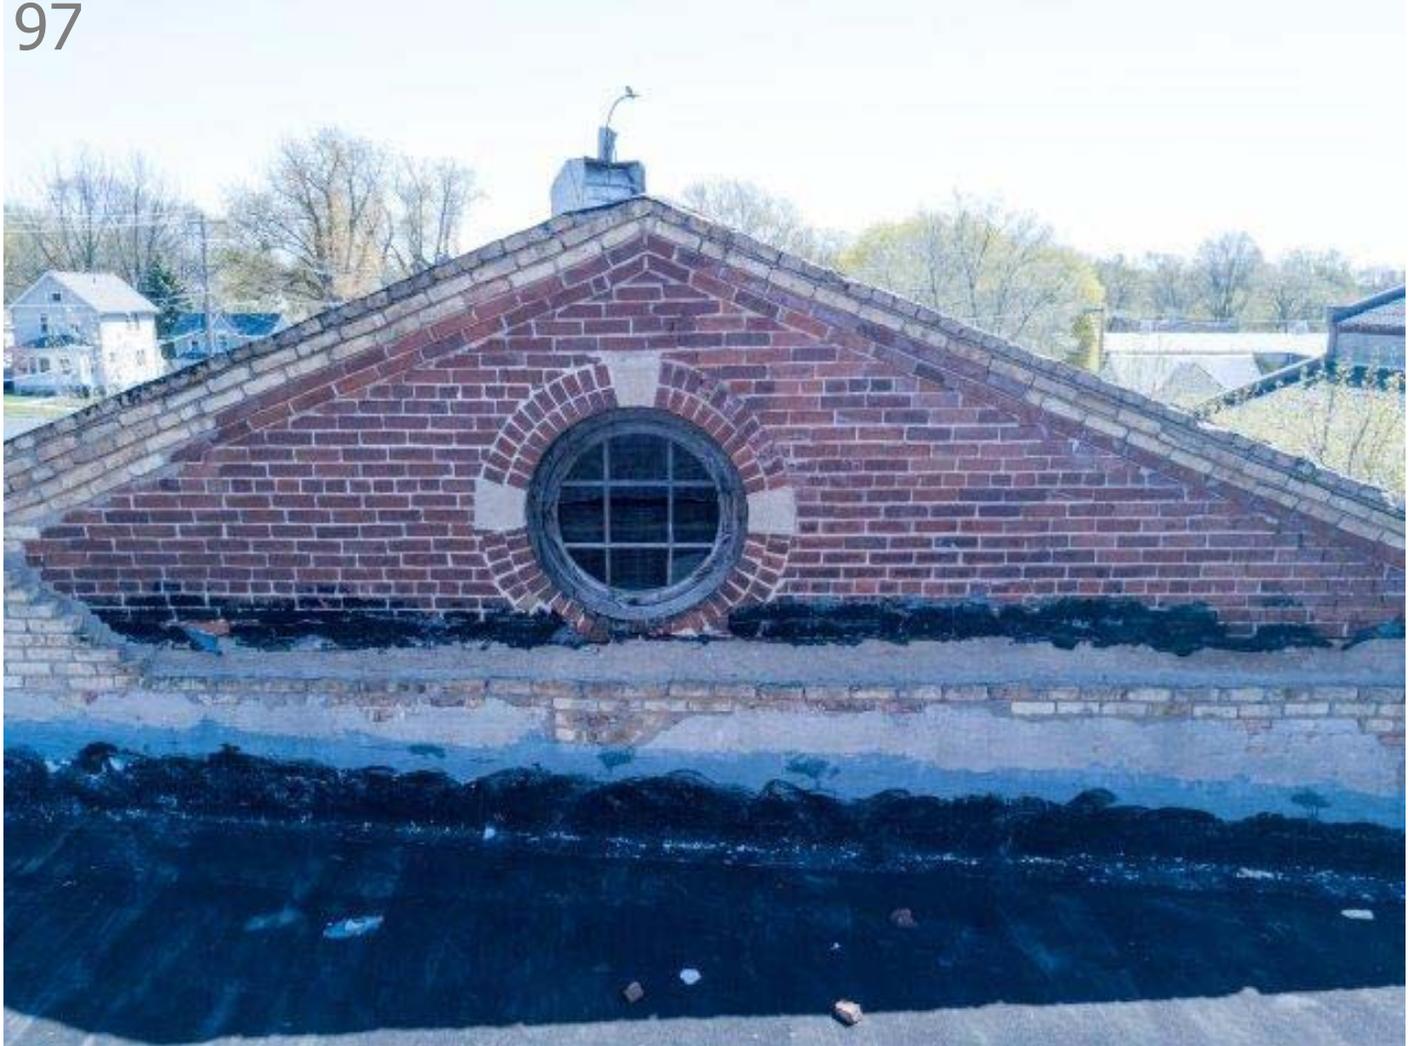
97

View of oculus window.

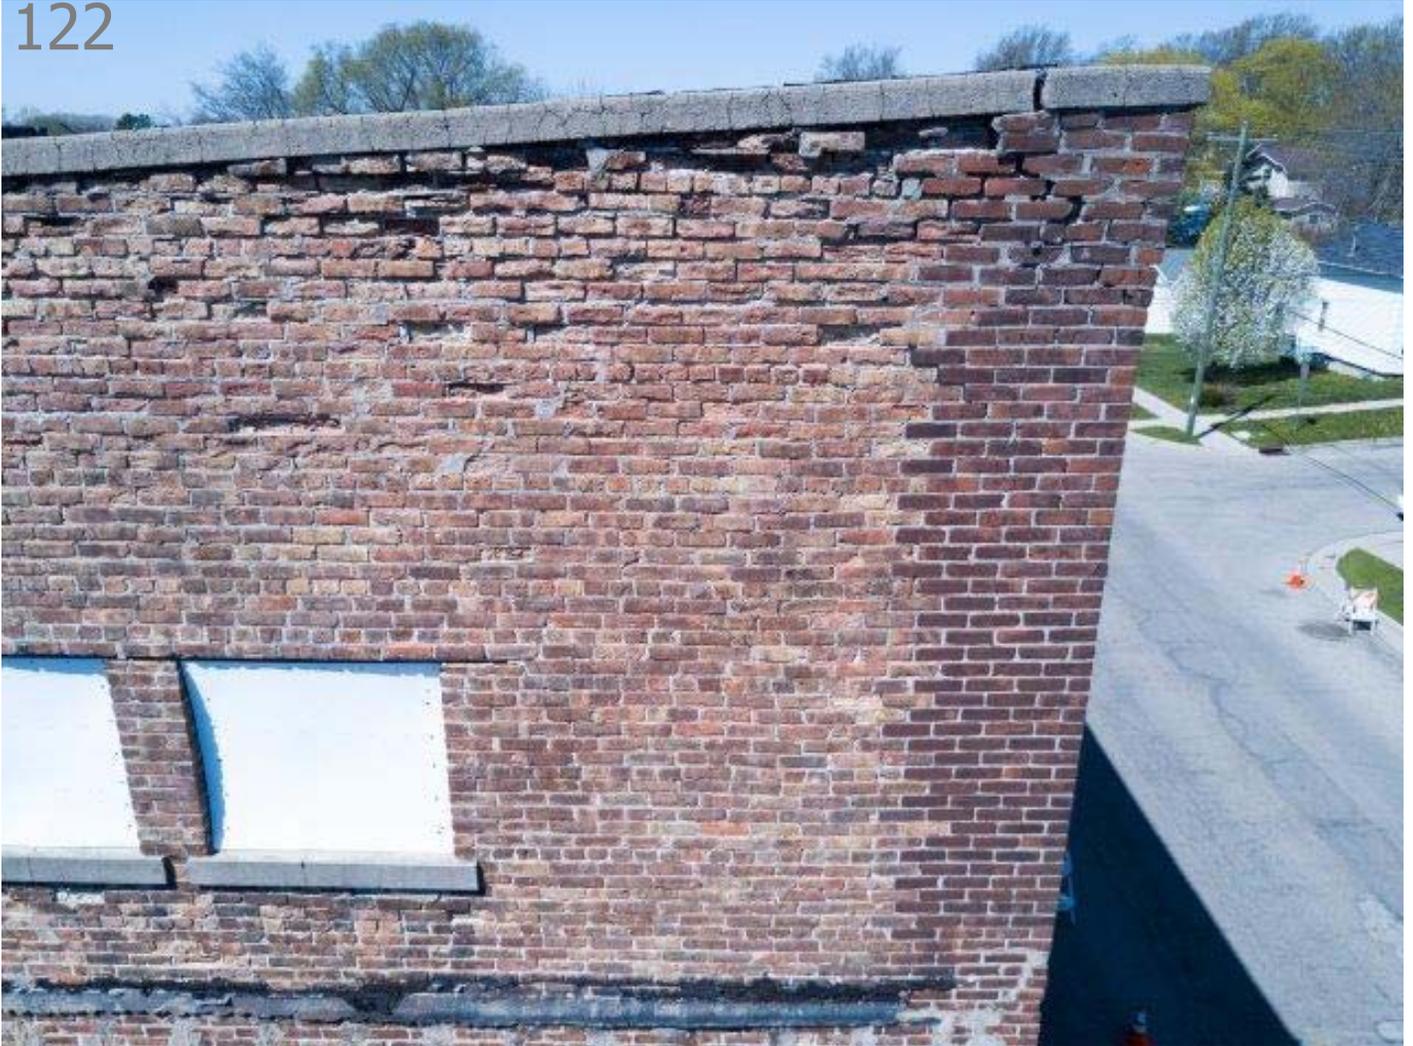
122

Evidence of the massive brick utilized in this complex.

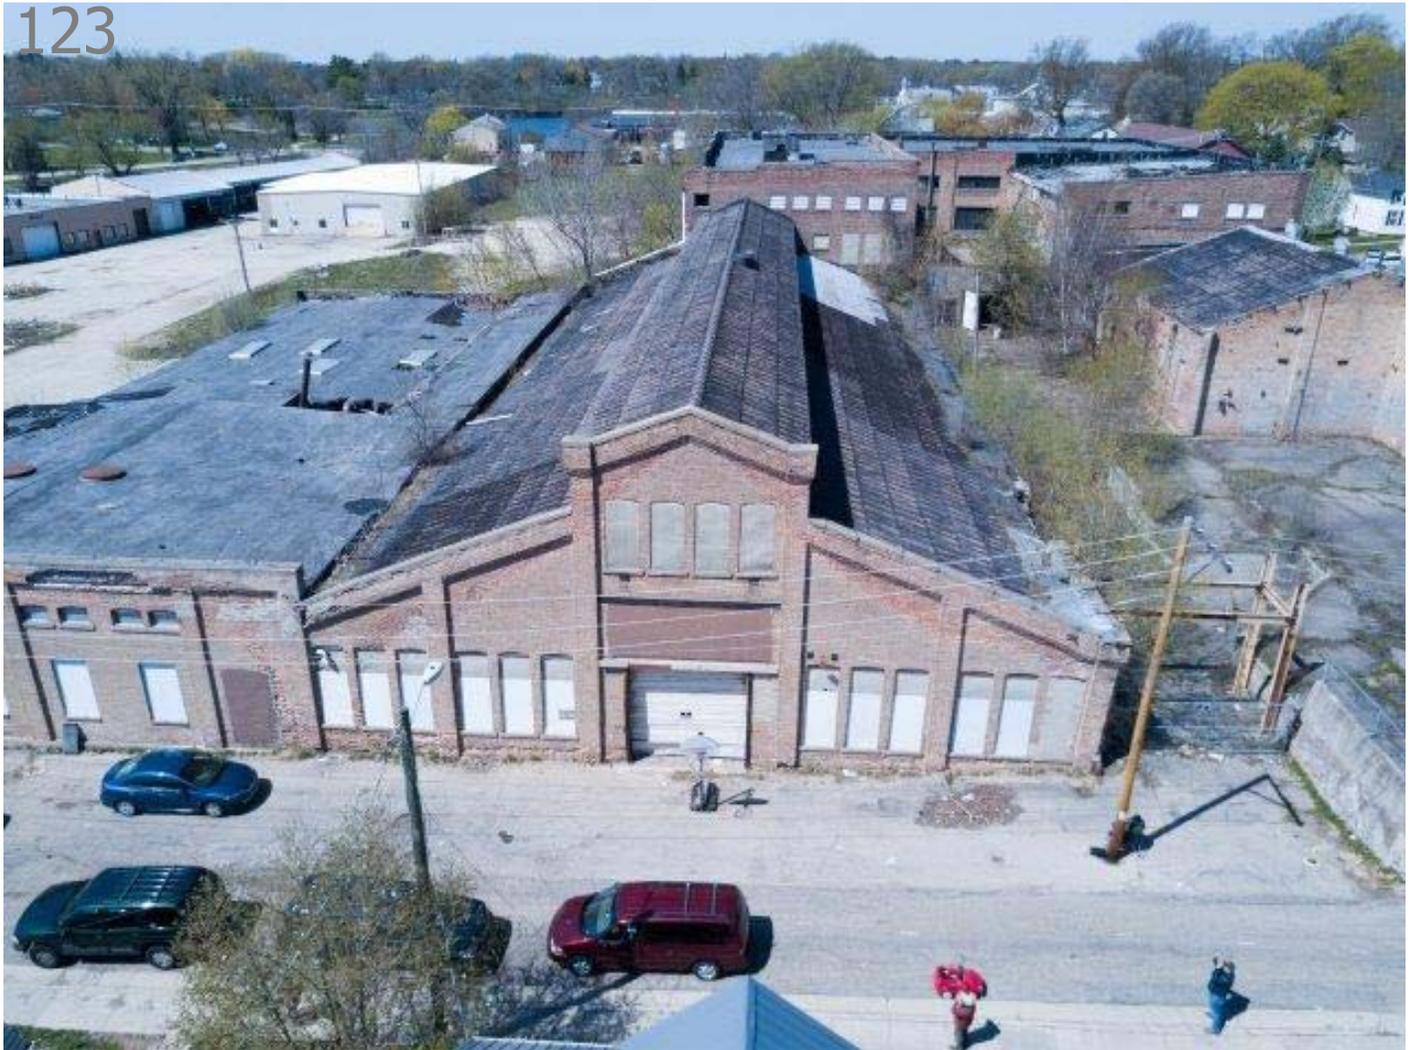
Overall view of Blacksmith Shop.

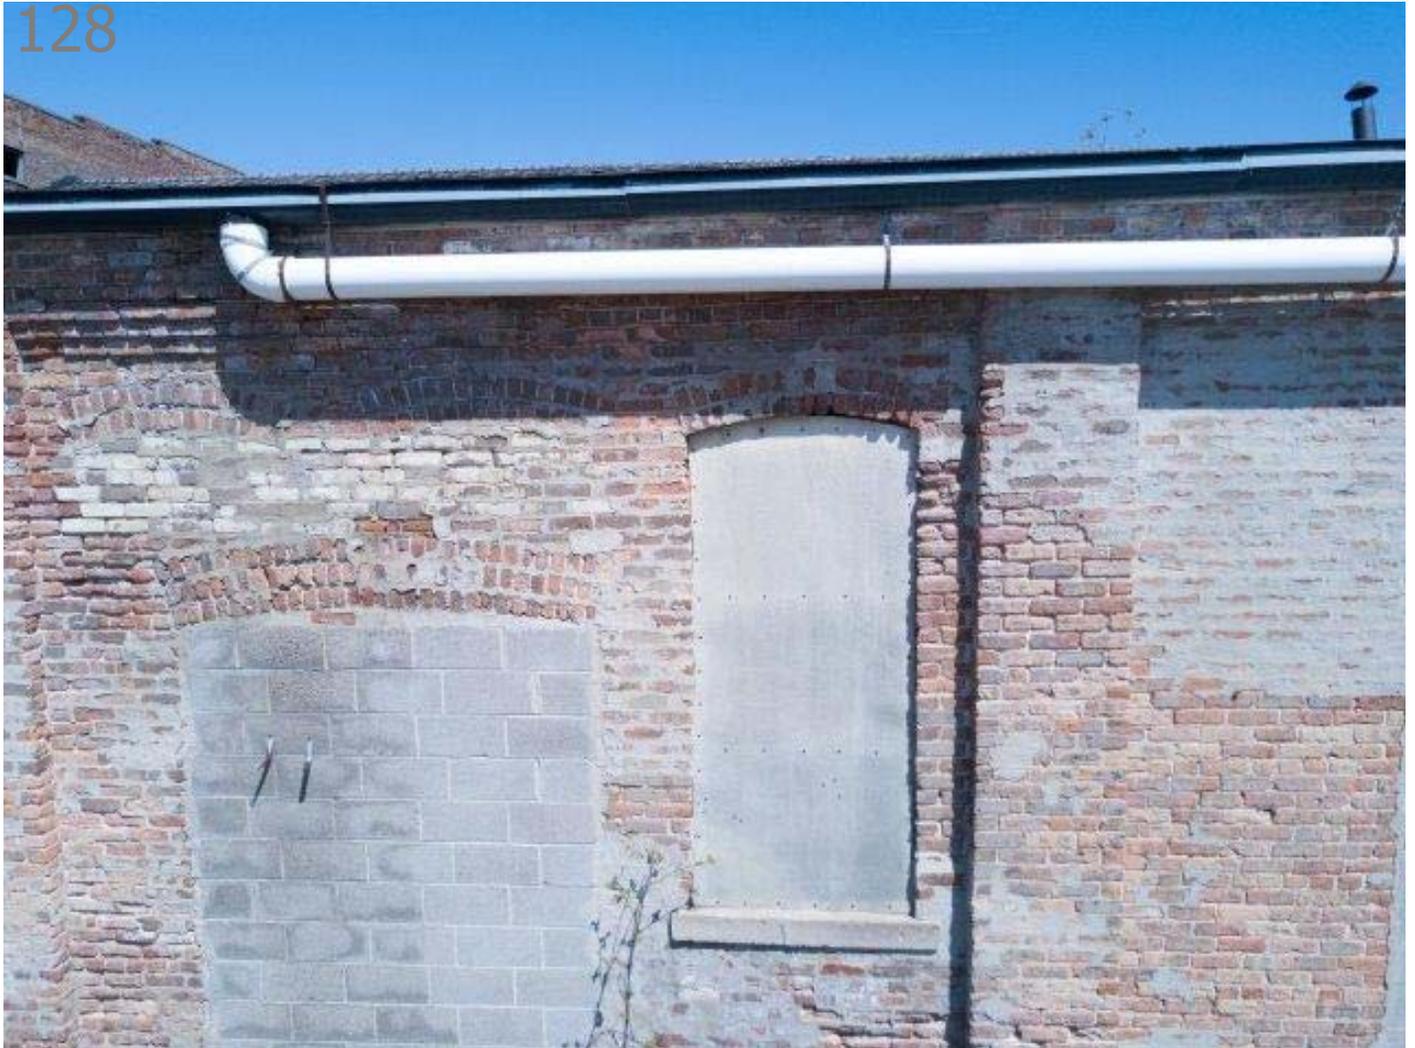
128

View of infill masonry.

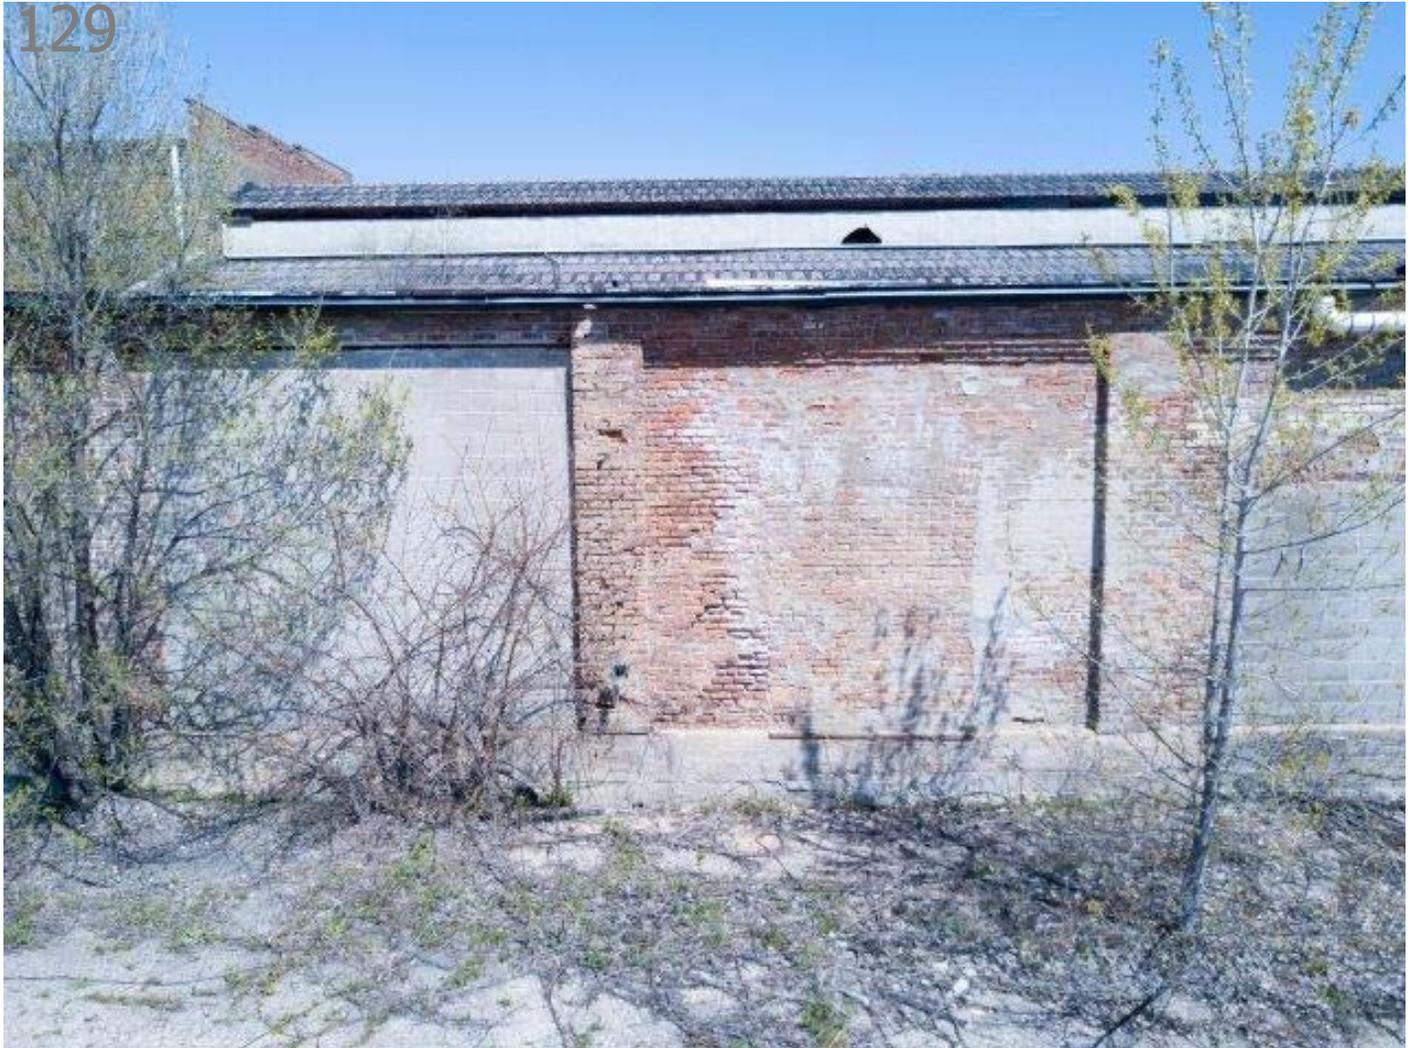
View of courtyard façade.

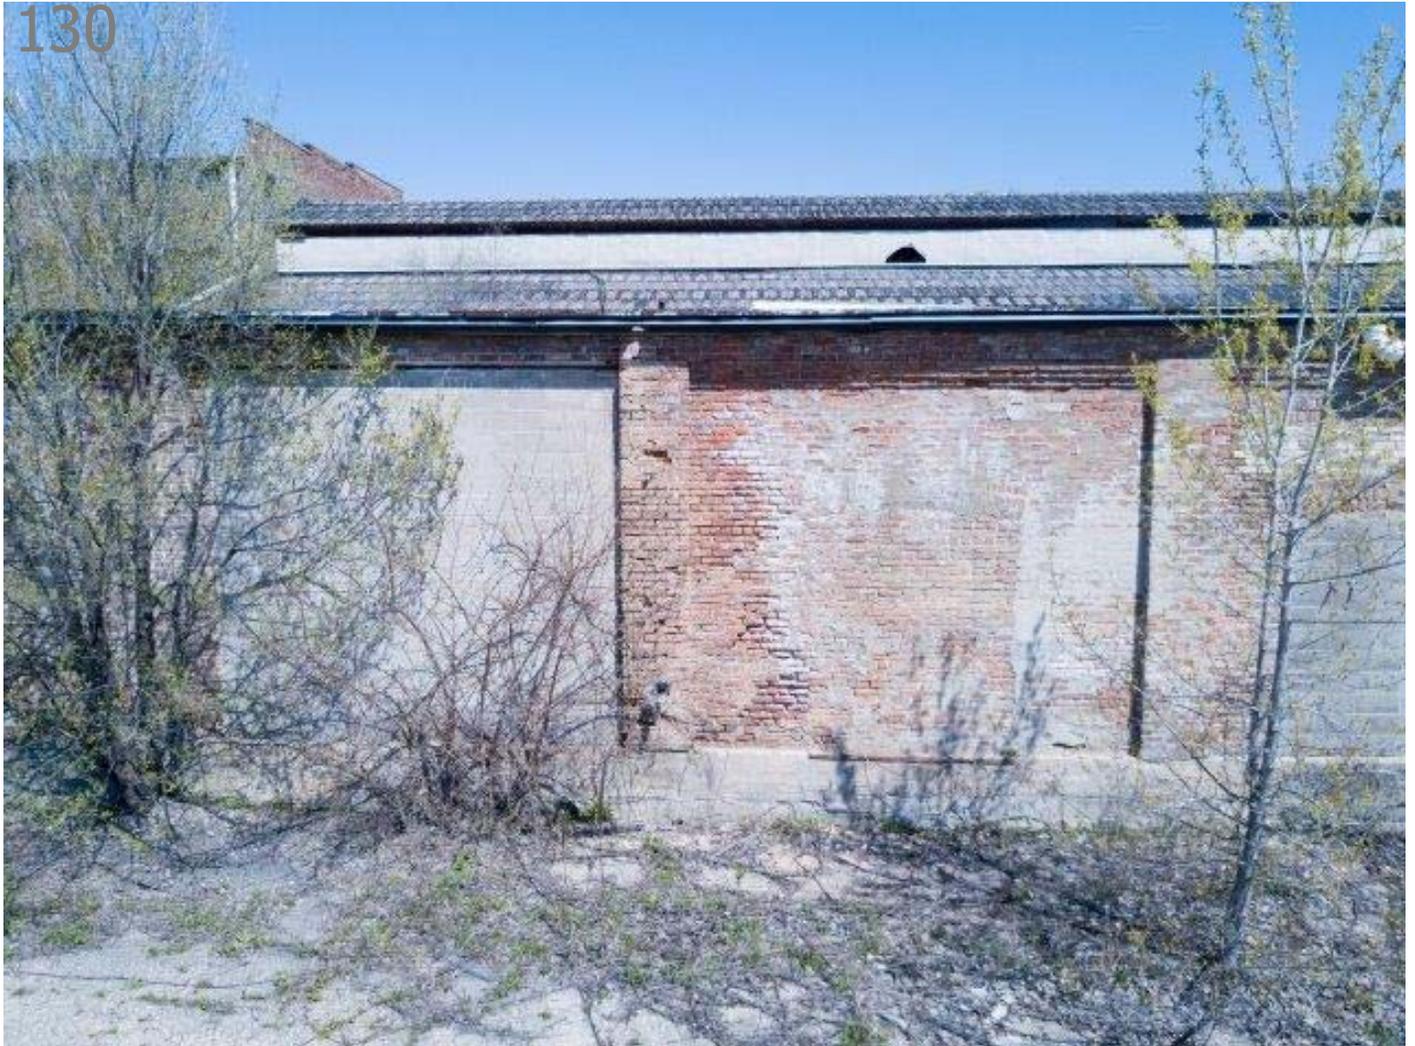
View of courtyard façade.

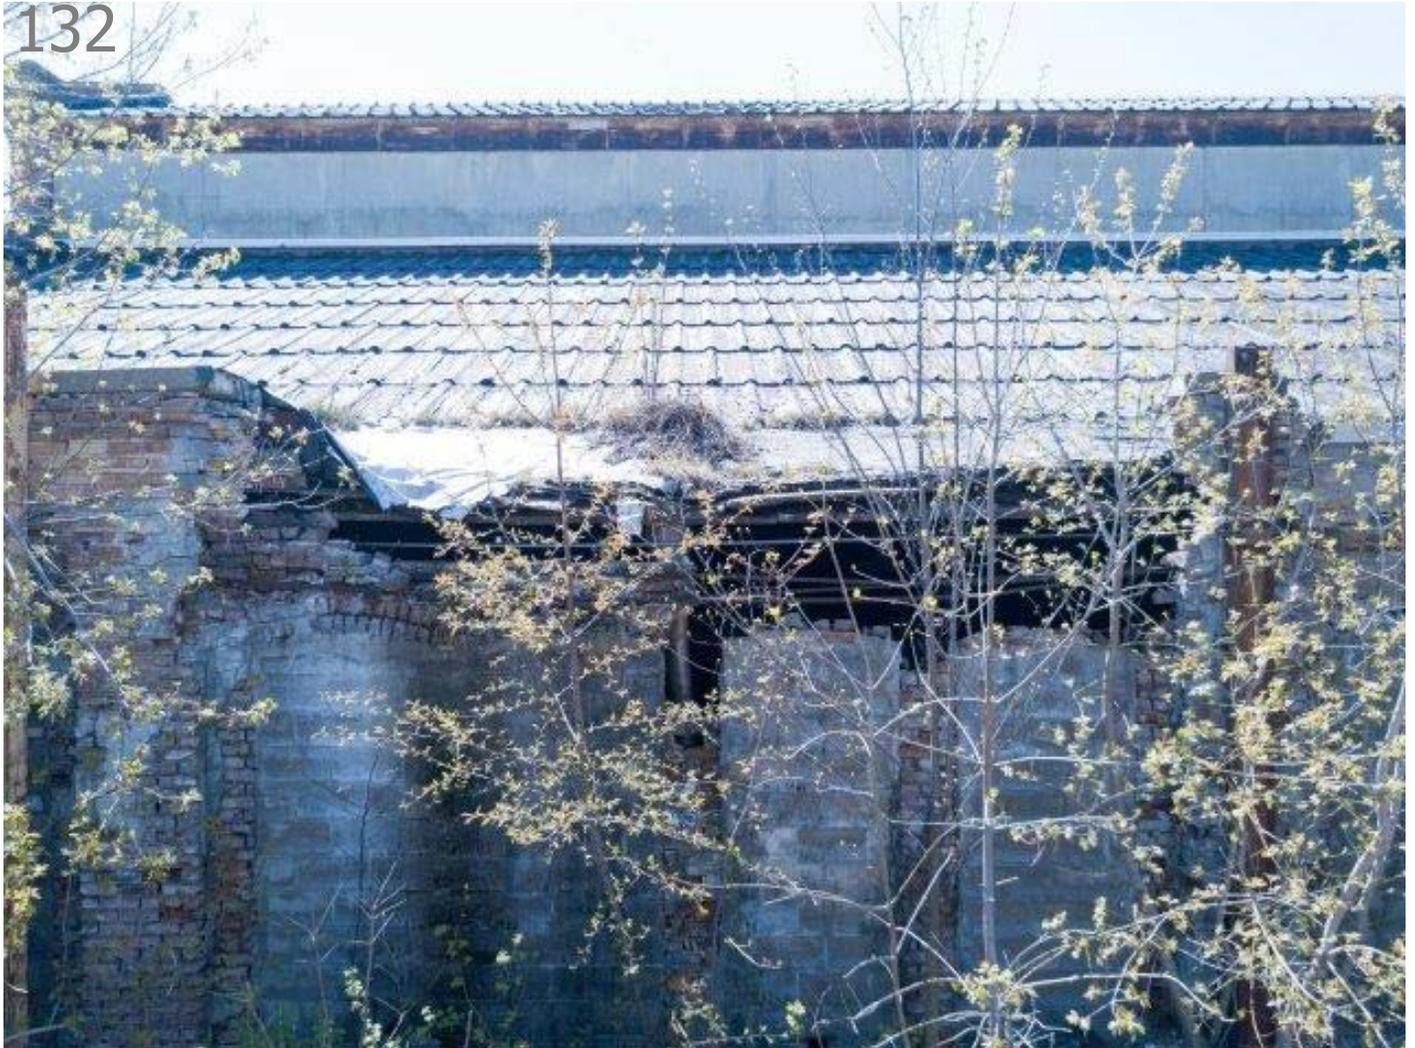
View of courtyard façade.
