**STOUGHTON HIGHWAY TRAILER BUILDING COMPLEX
SURVEY REPORT
STOUGHTON, WISCONSIN**

July 12, 2017

The following is a summary report on our findings of onsite conditions and our recommendations for the treatment of the Highway Trailer Building Complex. We have based this report on a facility inspection conducted on May 18, 2017. This inspection was preceded by a drone survey to provide a safe close-up inspection of the exterior materials. Focus of inspection was to assess and make recommendations related to safety issues associated with potential structural collapse along E. South St., and to assess and make recommendations regarding existing structural masonry shell salvage and reuse throughout the facility. Partial and full deconstruction of connected structural systems considered for demolition is also addressed in our record of observations and opinions.

Stoughton Highway Trailer Building Complex Survey Image Report

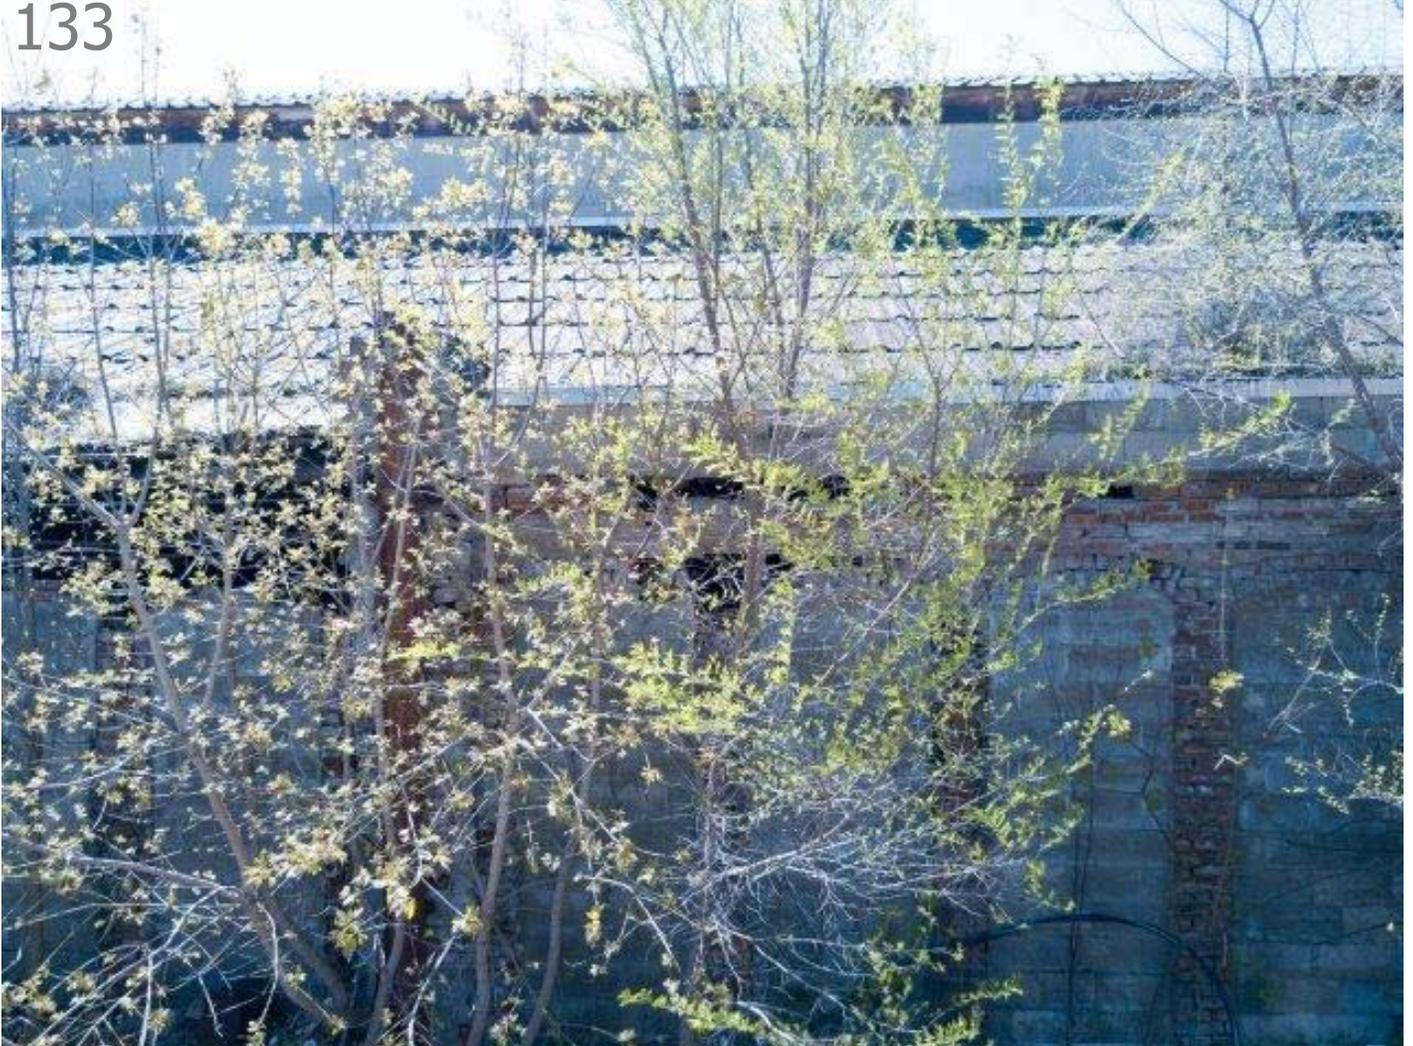
133

View of courtyard façade.

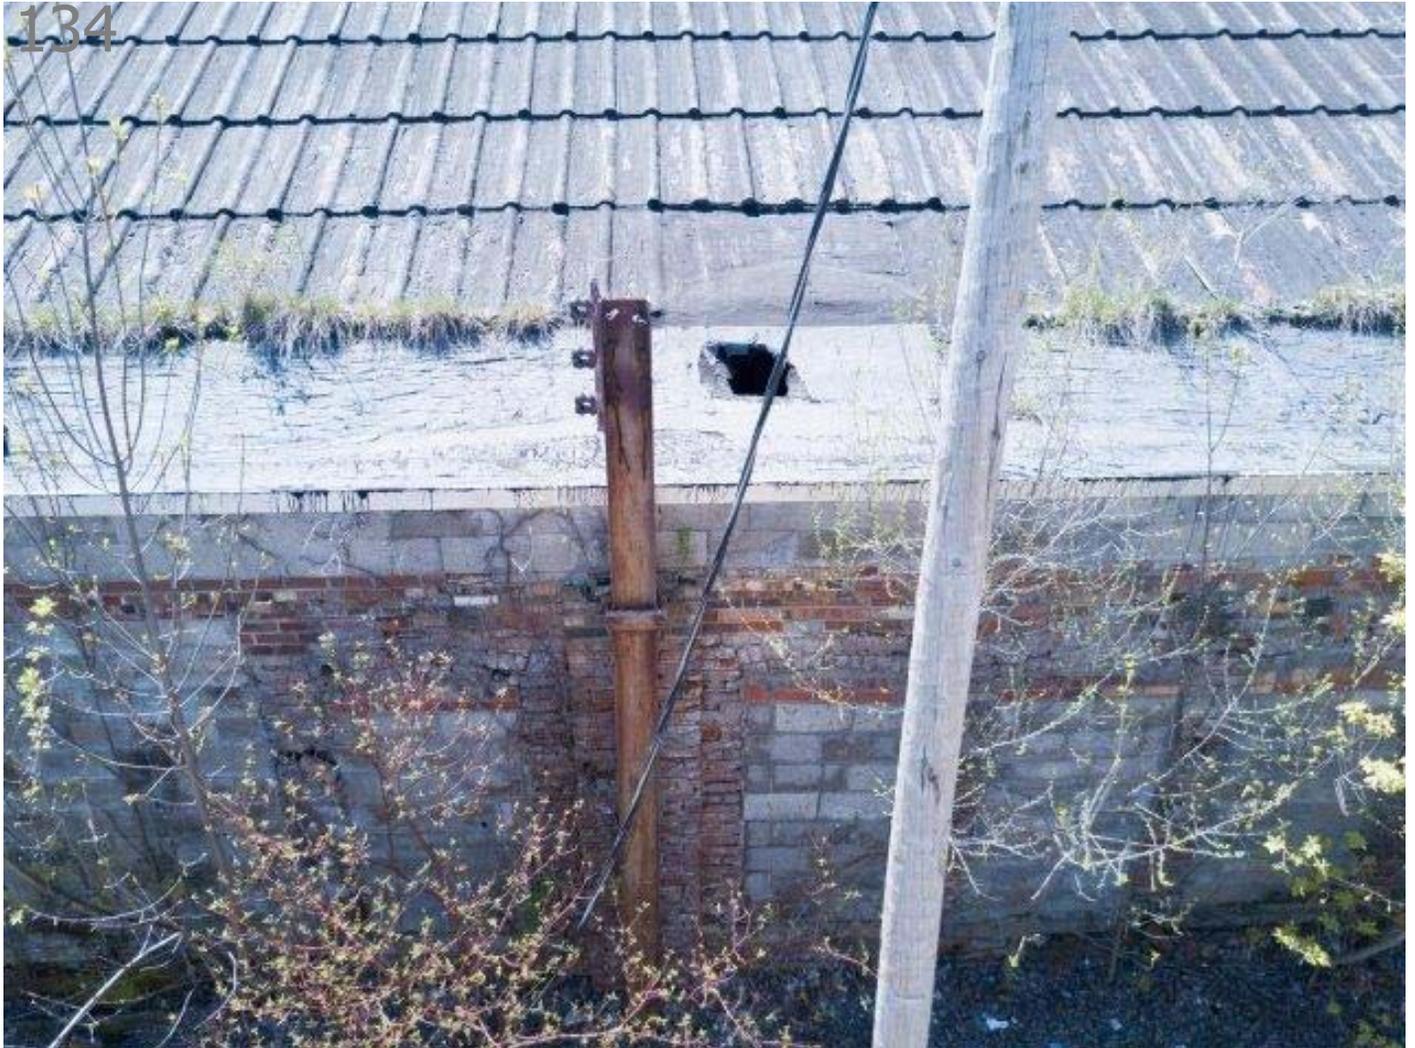
View of courtyard façade.

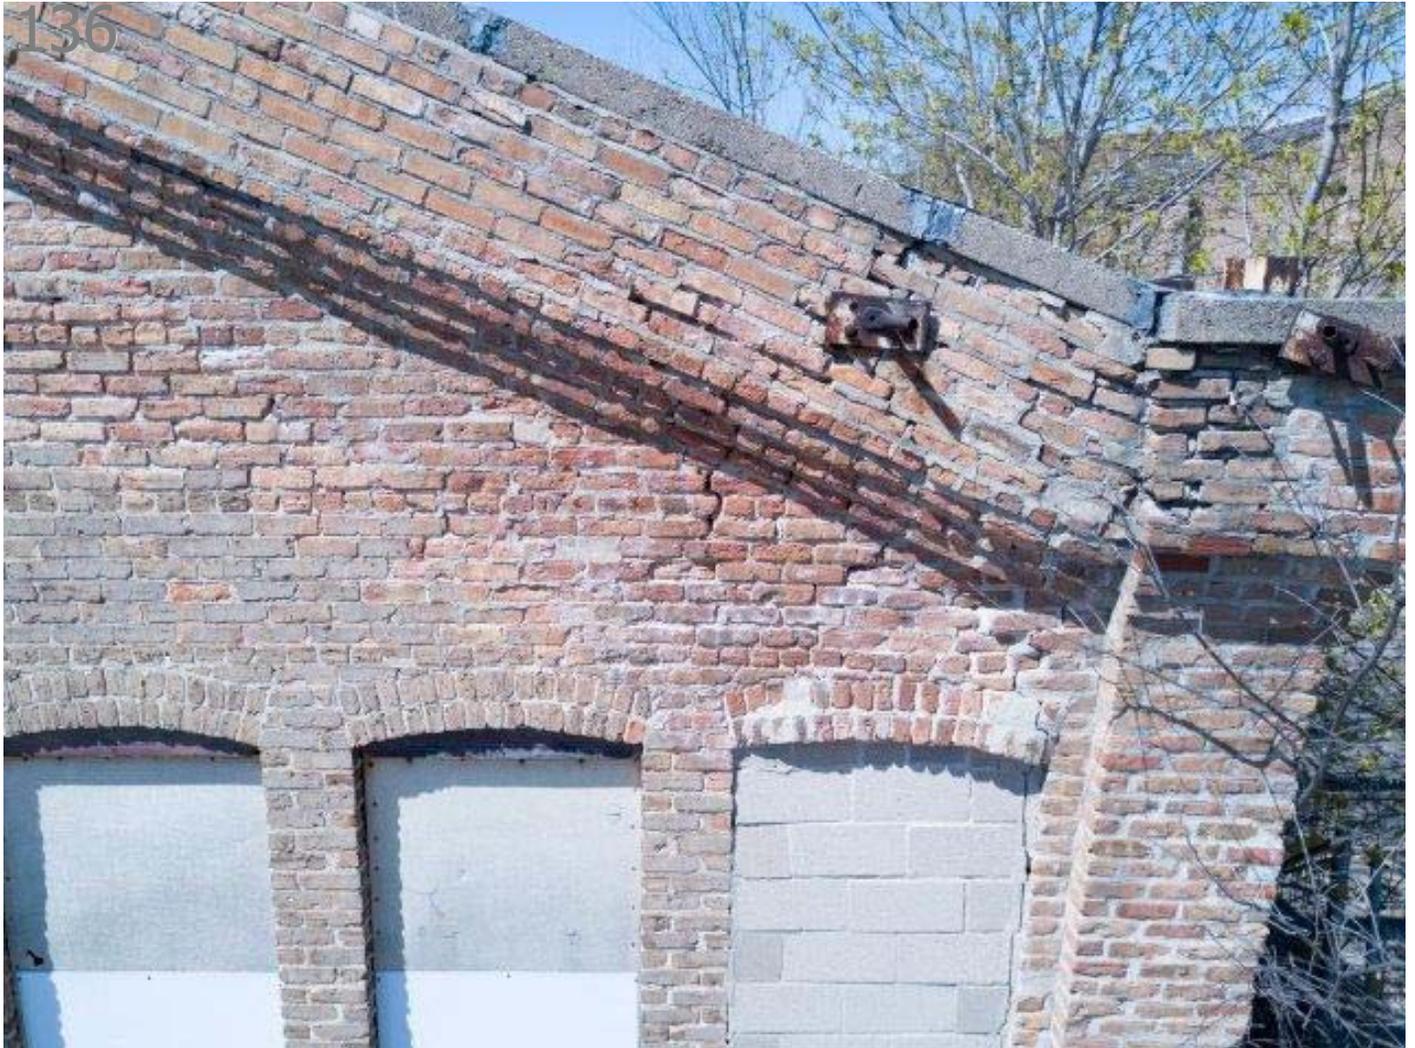
View of gable at Blacksmith Shop.

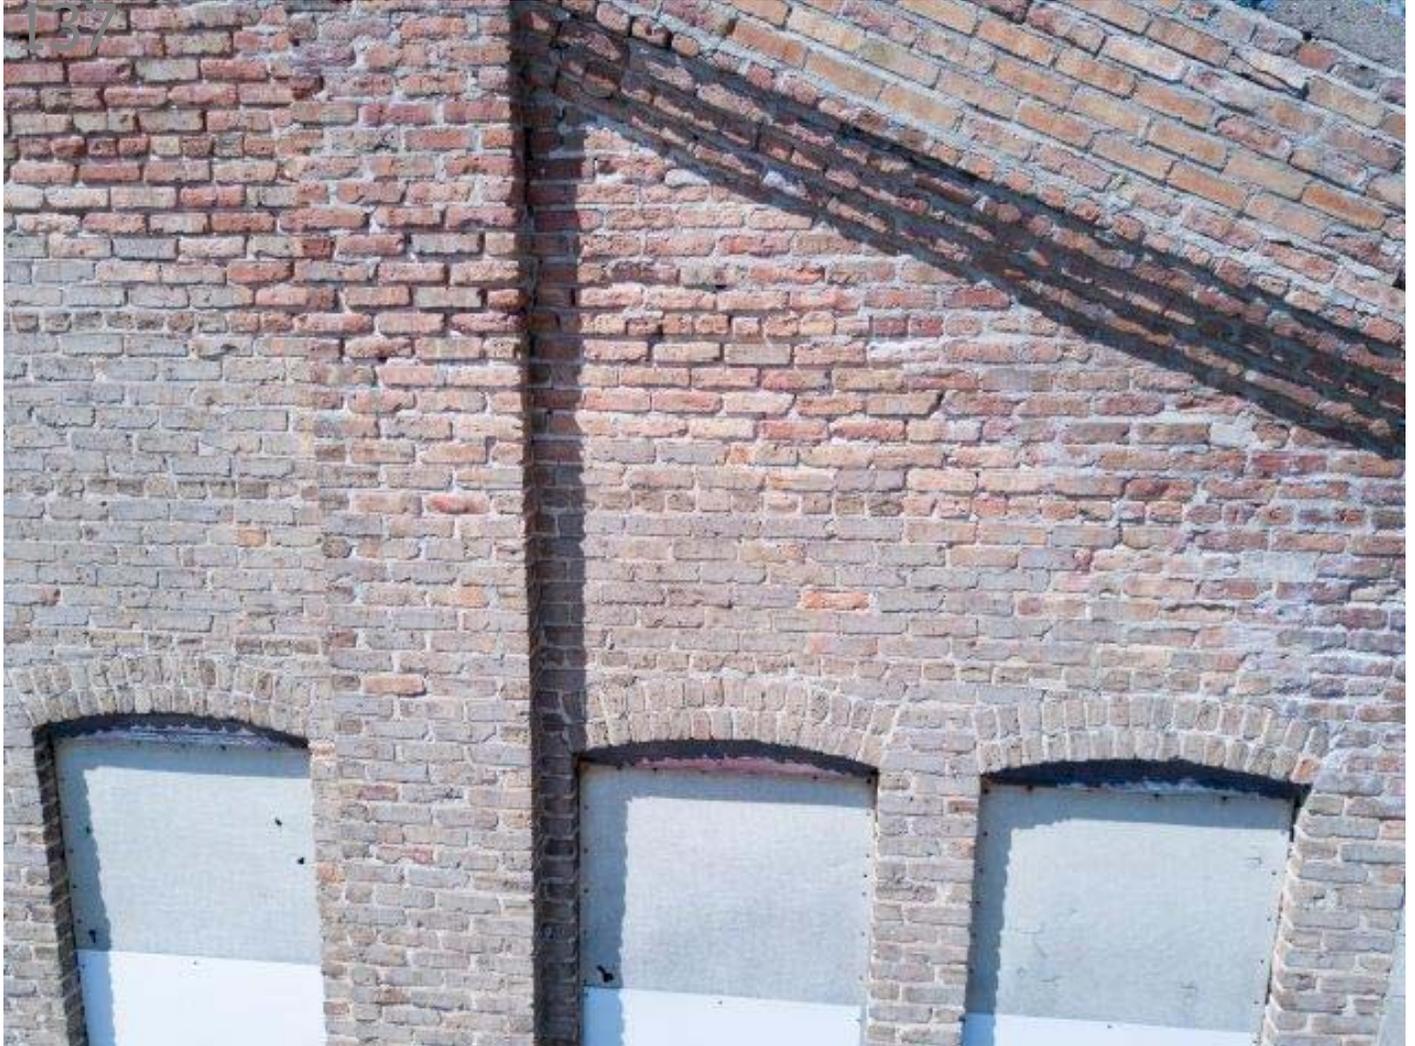
View of gable at Blacksmith Shop.

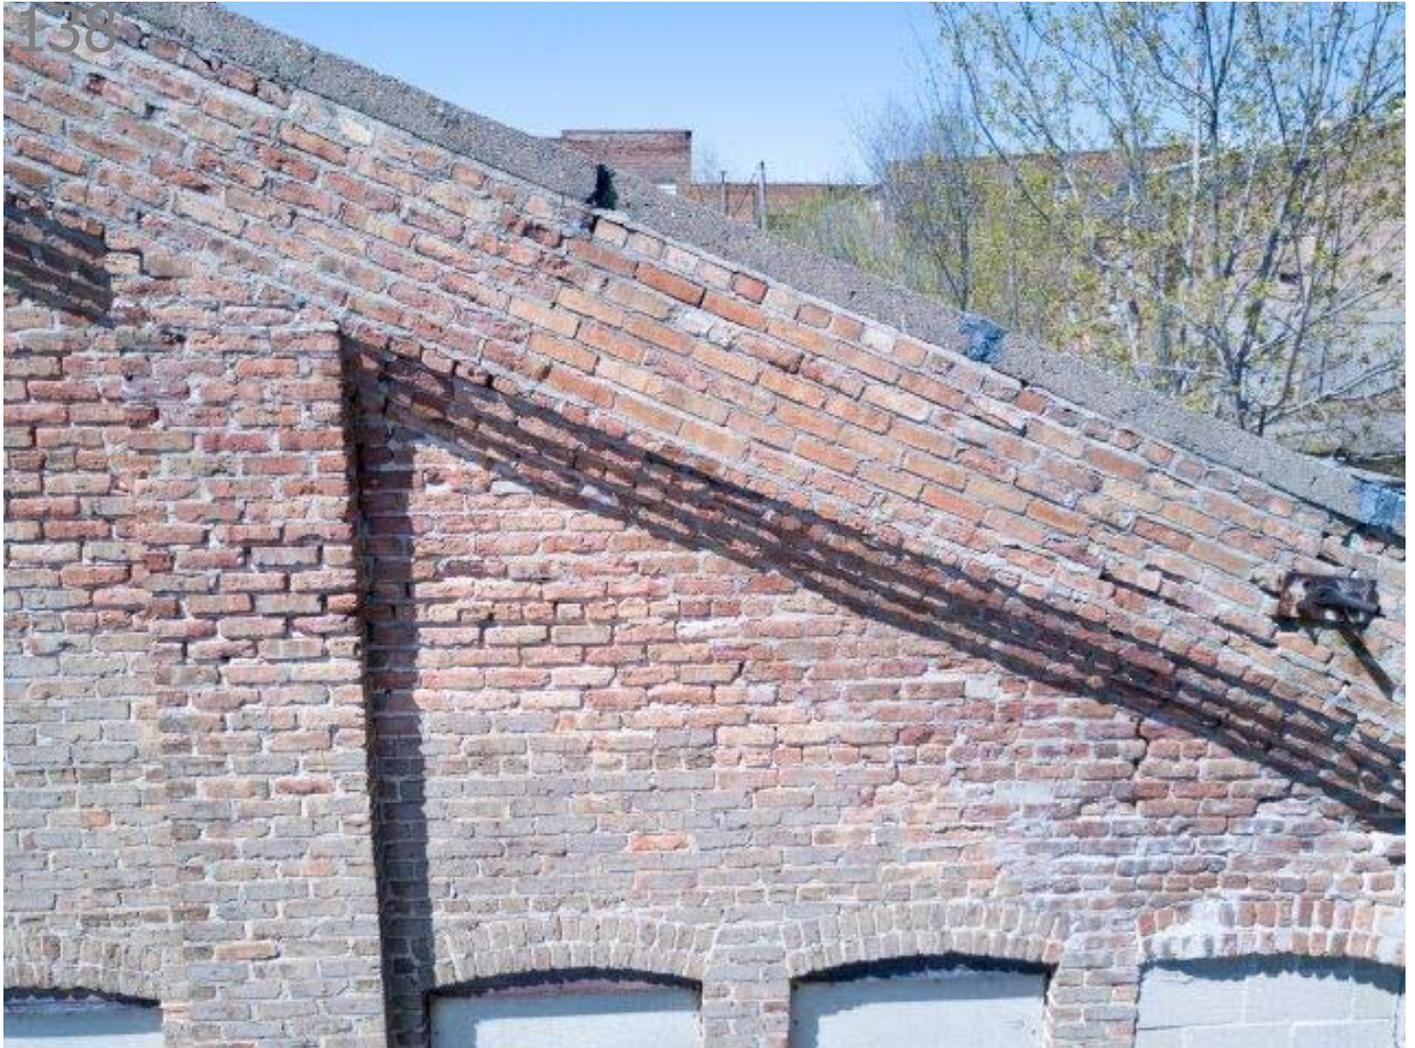
View of gable at Blacksmith Shop.

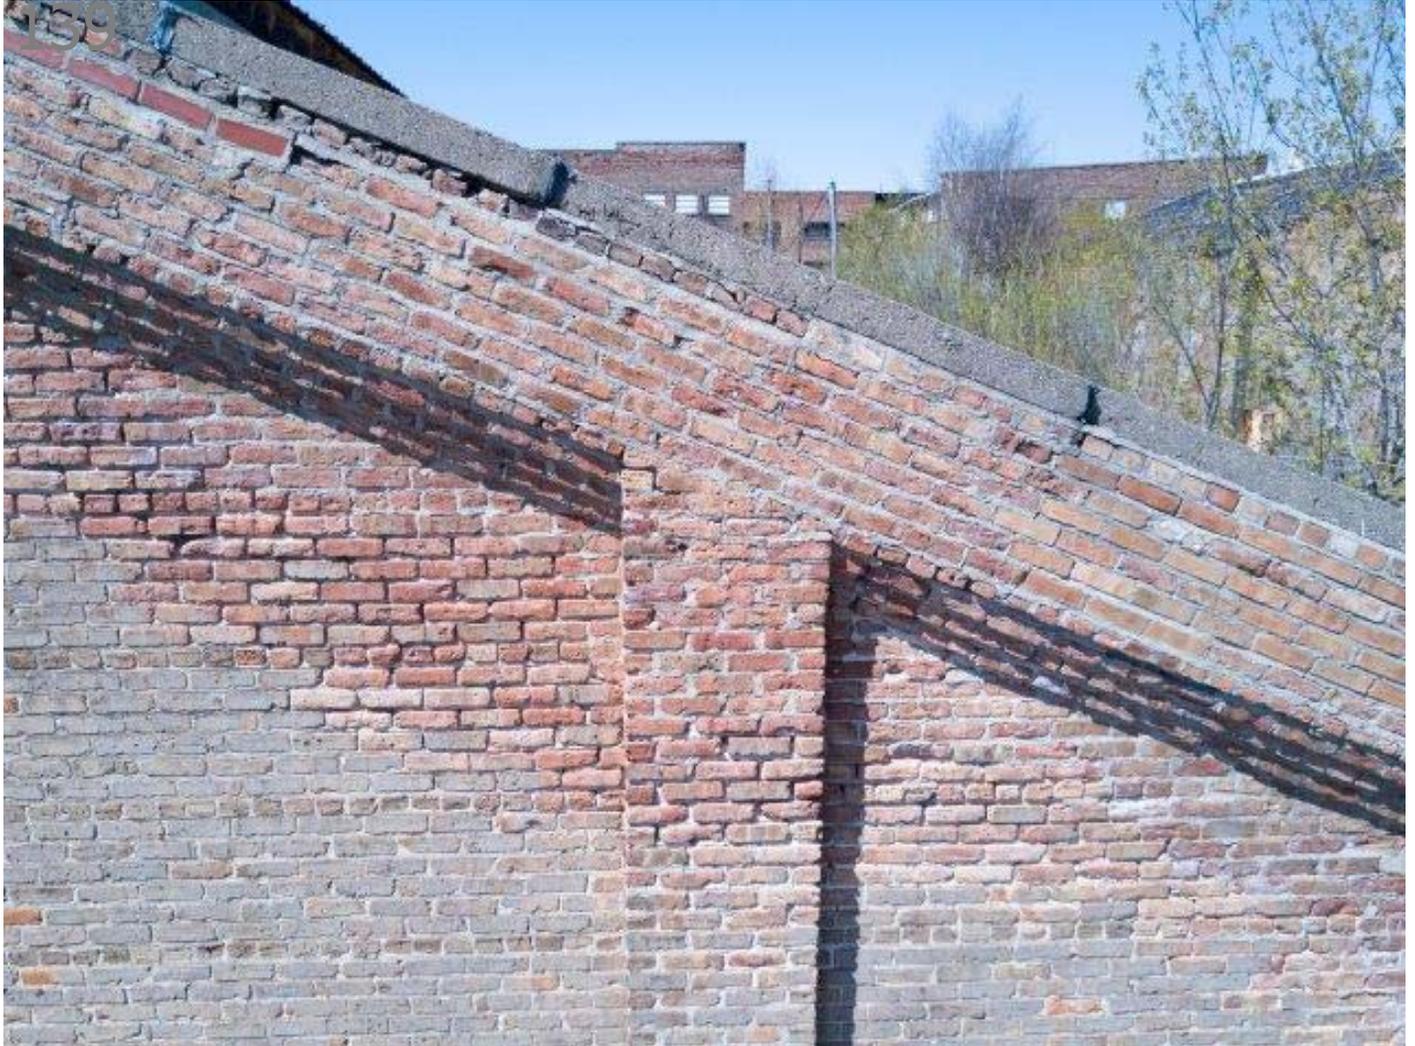
View of gable at Blacksmith Shop.

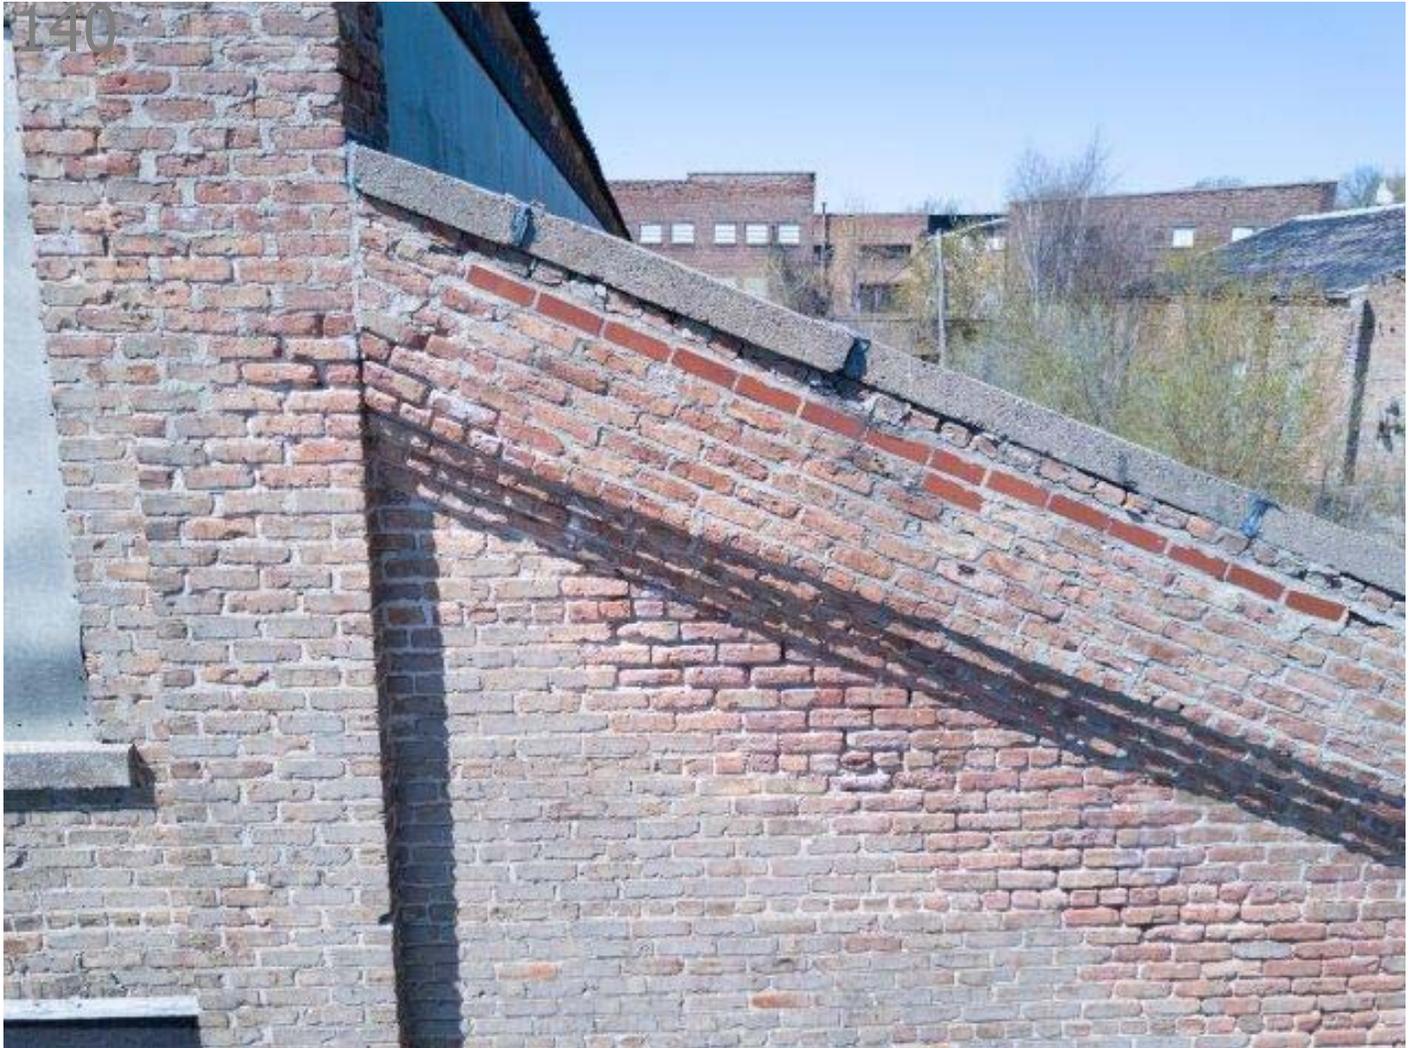
View of gable at Blacksmith Shop.

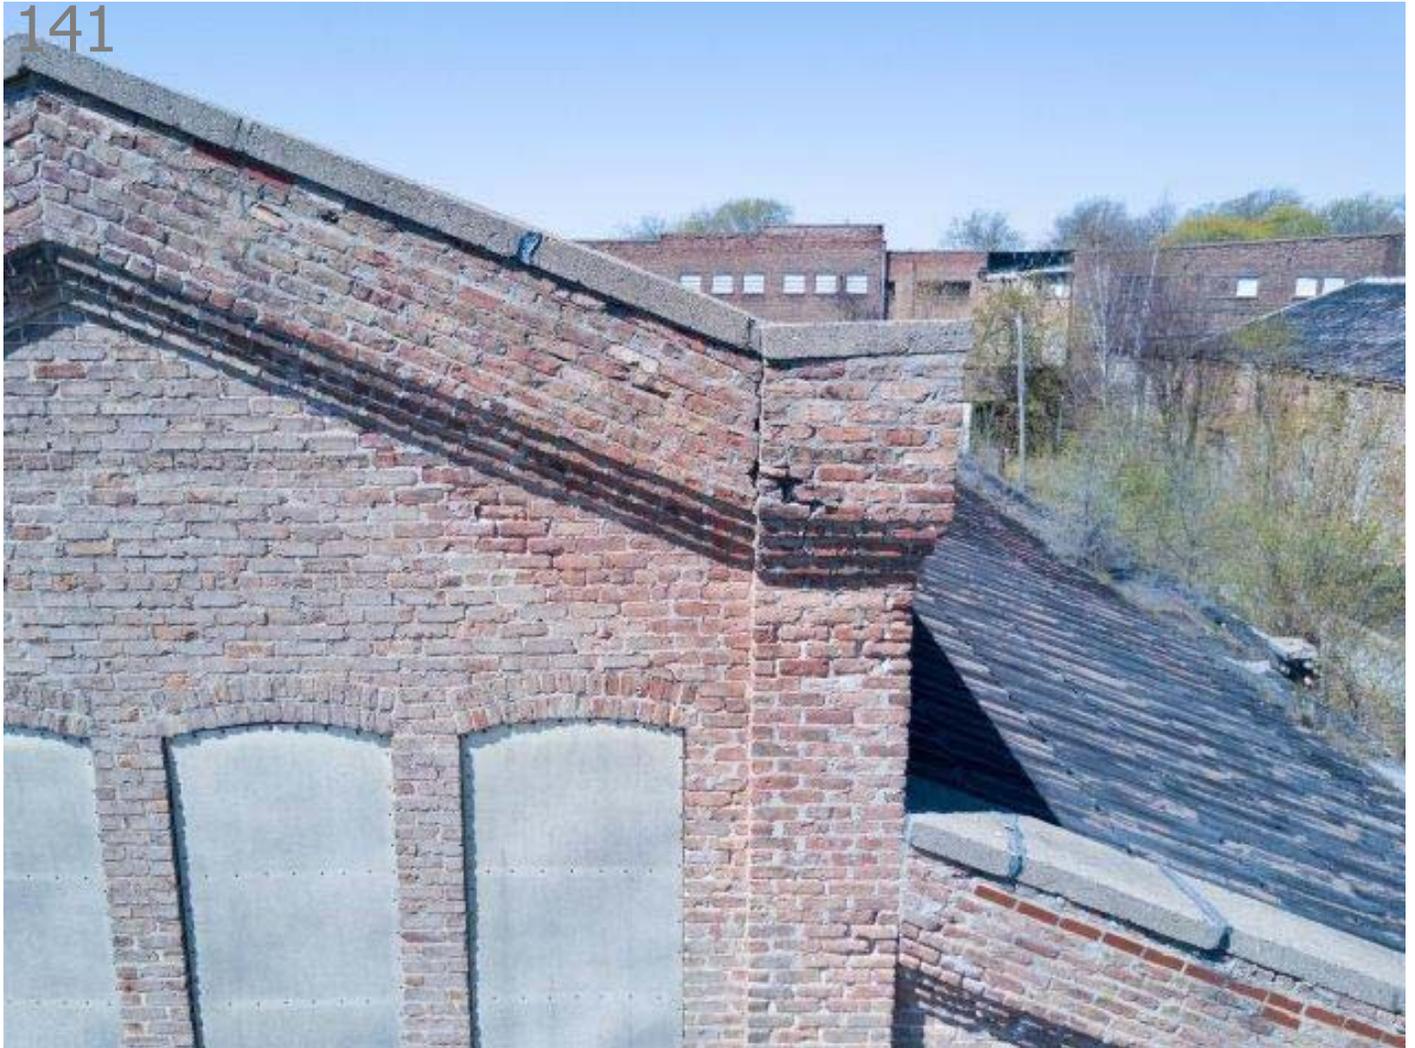
View of stepped gable at clerestory.

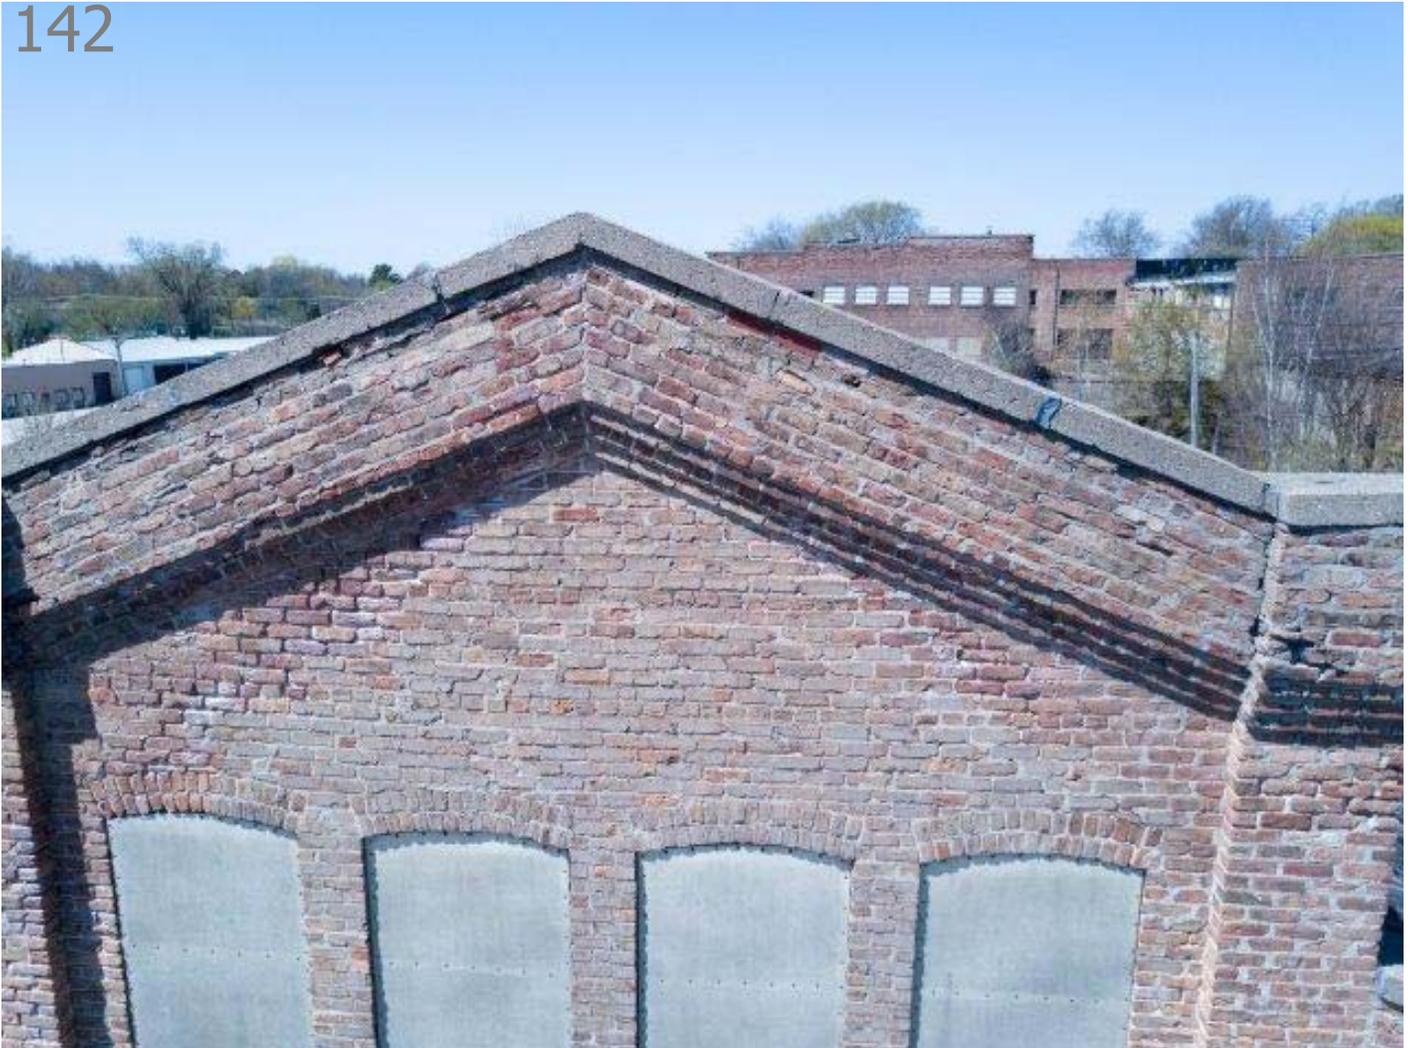
142

View of stepped gable at clerestory.

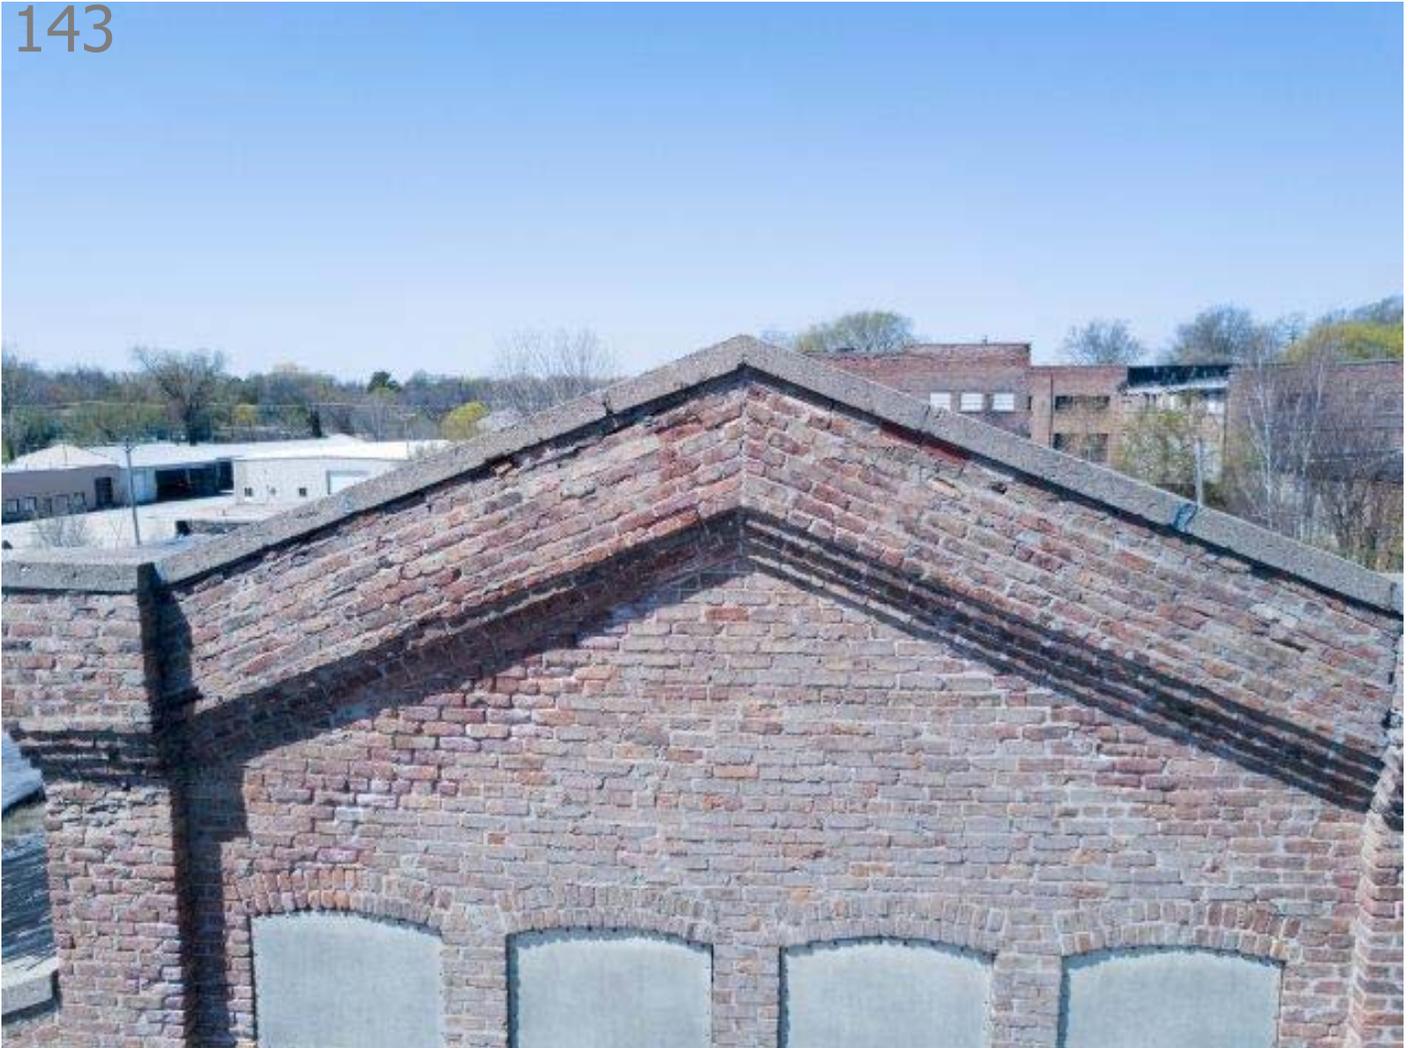
143

View of stepped gable at clerestory.

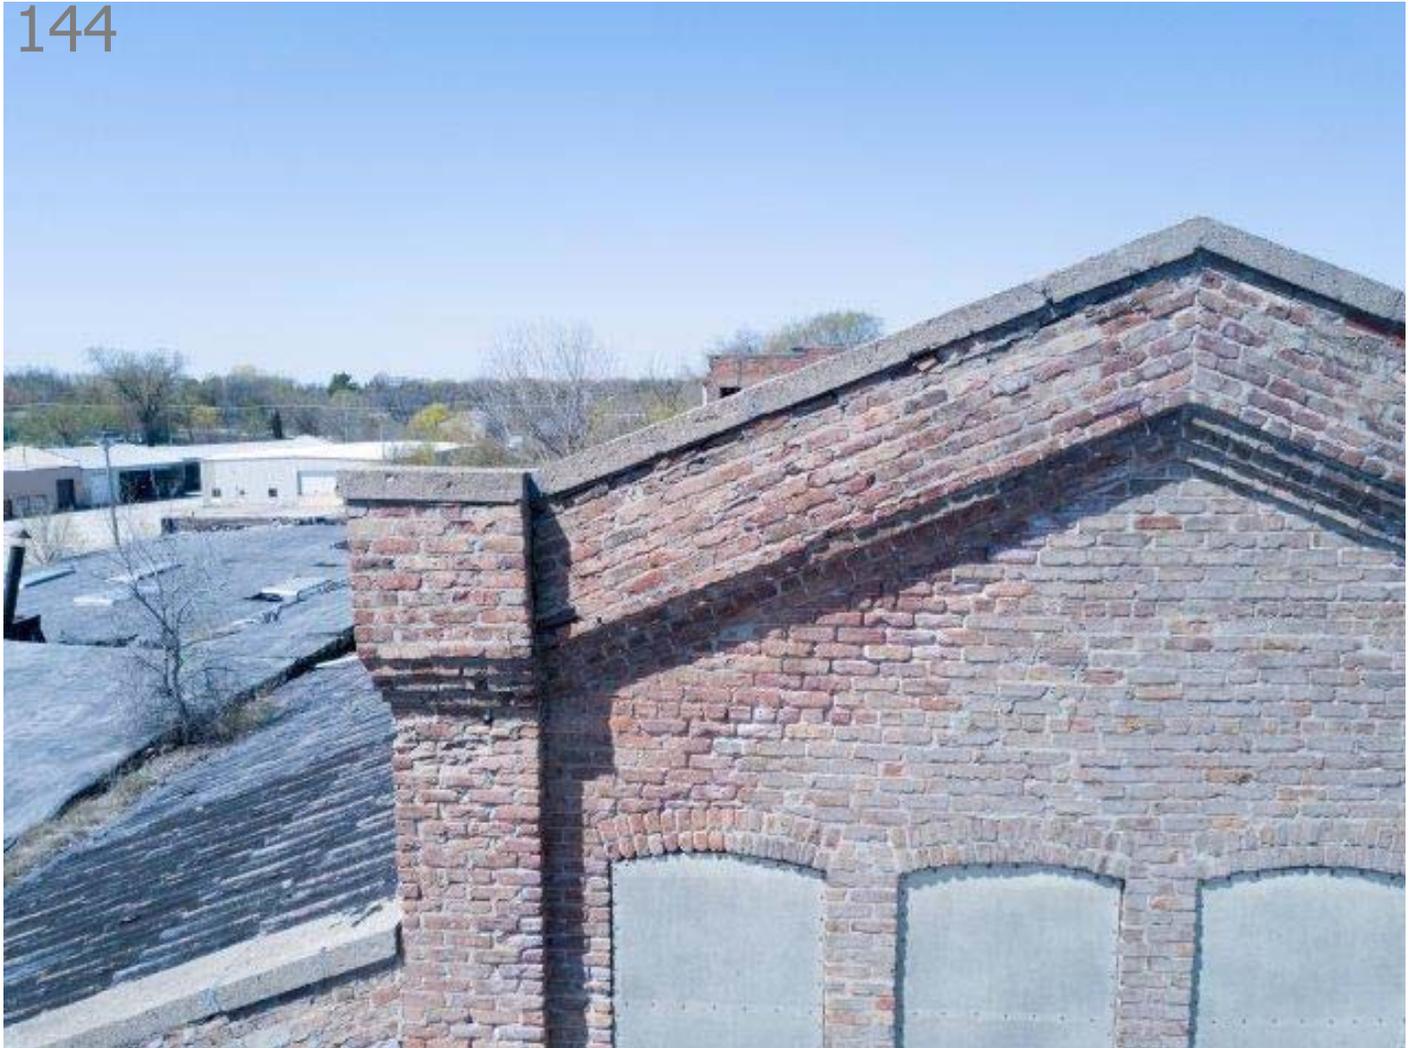
144

View of stepped gable at clerestory.

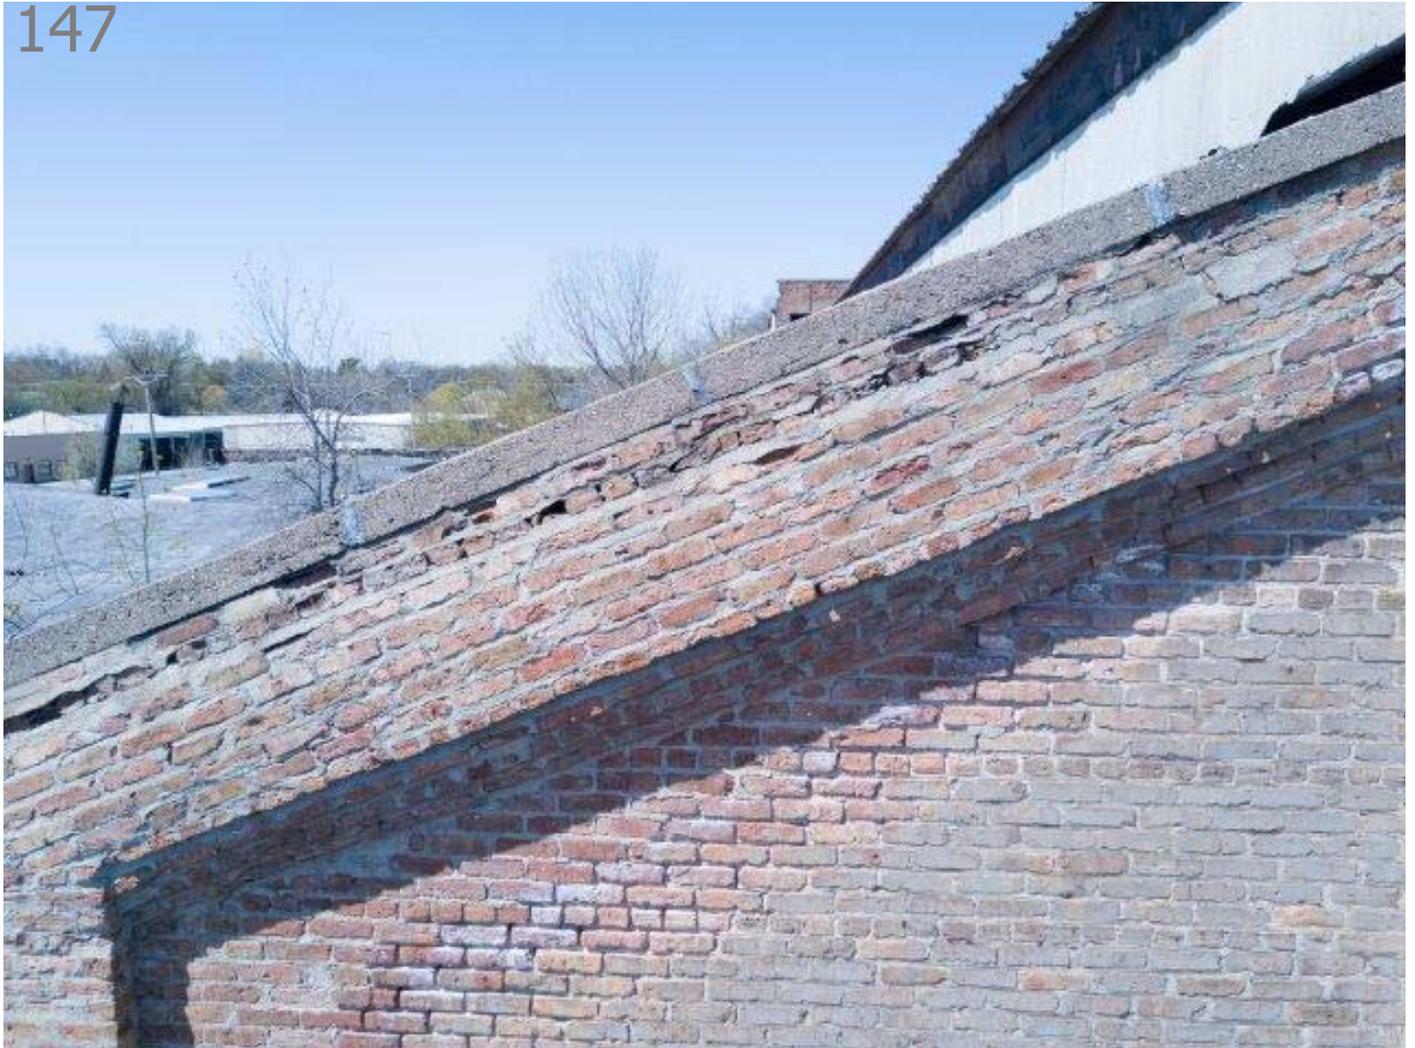
147

View of gable at Blacksmith Shop.

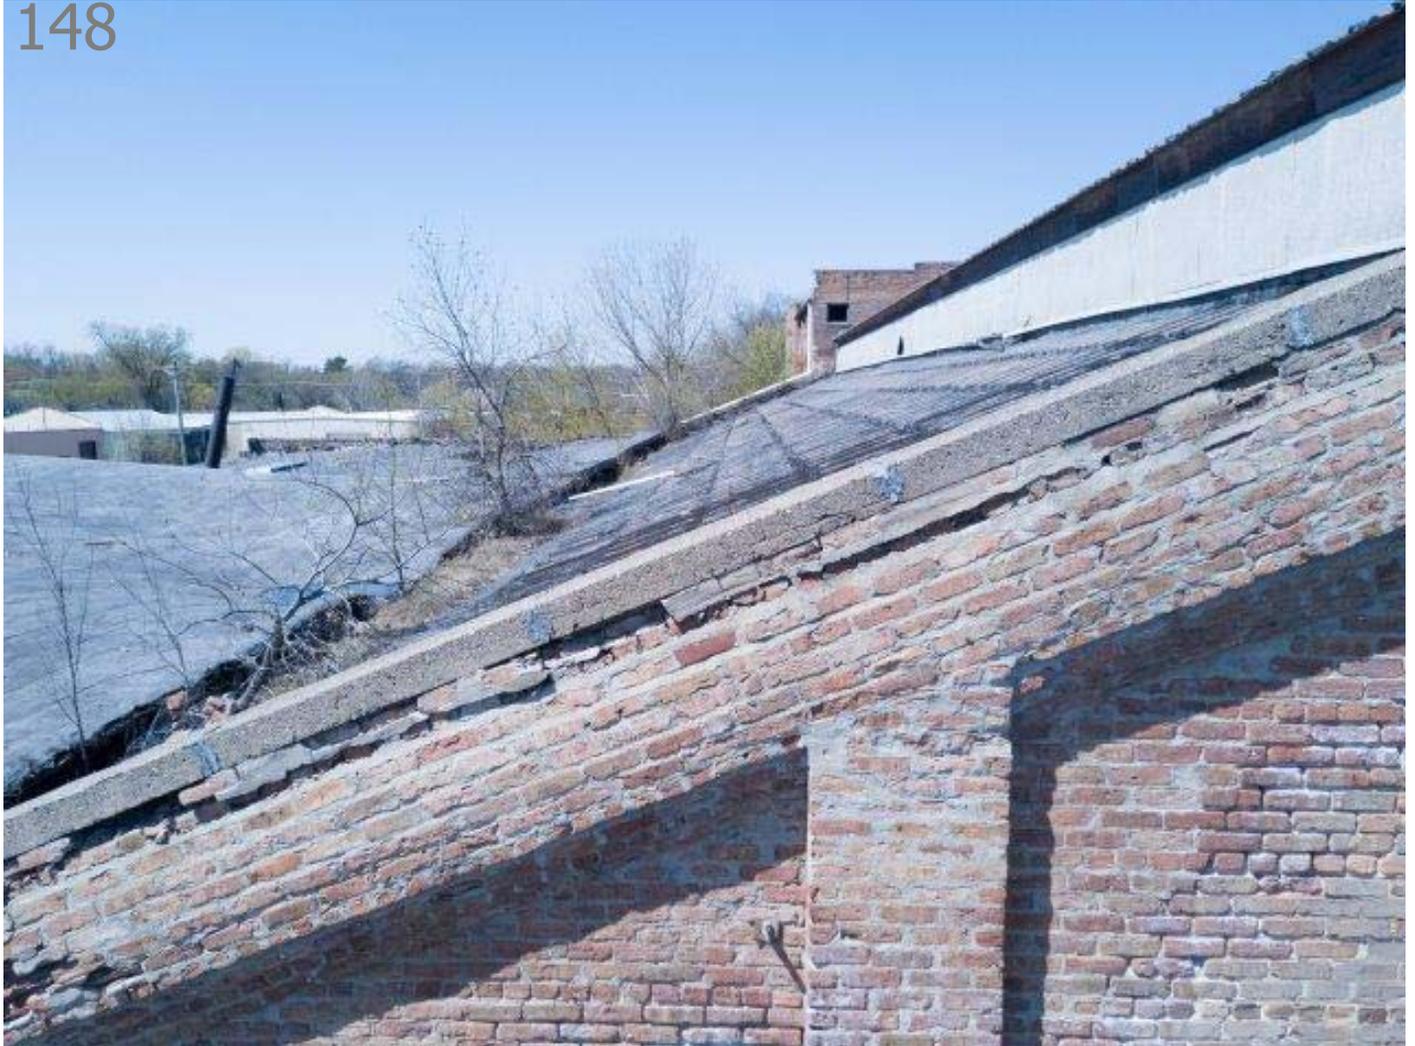
148

View of gable at Blacksmith Shop.
